SECTION 32 PROGRAM
STREAMBANK EROSION CONTROL
EVALUATION AND DEMONSTRATION
WORK UNIT 2 - EVALUATION OF EXISTING
BANK PROTECTION
INSPECTION OF SITES IN ALBUQUERQUE DISTRICT

Malcolm P. Keown

November 1977
Inspection Report 3

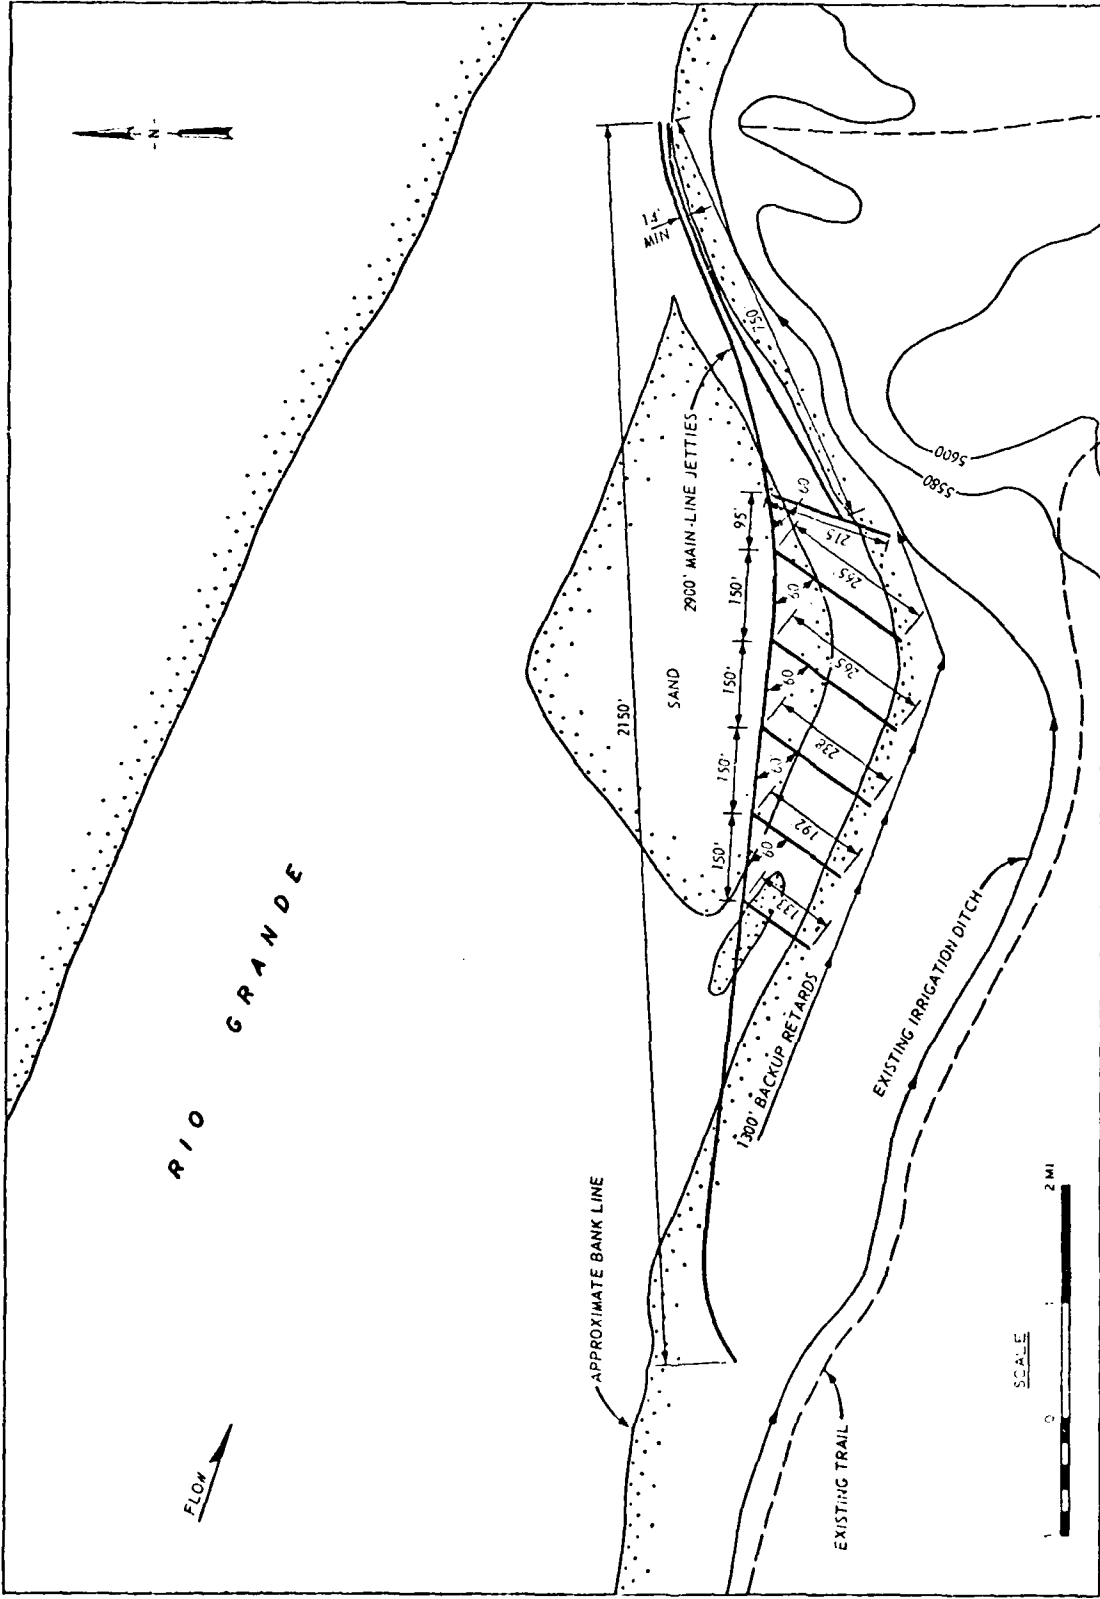
F. D. Shufflebarger, Inc. (Albuquerque) installed 4,313 lineal feet of permeable jetties (Kellner Jack Field) in 1951 (Figures 11 and 12). This installation consists of two main-line jetties (2,900 and 700 ft in length) and six backup retards varying from 133 to 265 ft in length. The jack units consist of three linear members (each being 15 ft in length) bolted together at their midpoints such that each member is perpendicular to the other two. The members are laced with #10 steel wire; the jack units are connected with cable (Figure 13). The Bureau of Indian Affairs sponsored this project at a funding level of \$24,108 (1951 dollars).

Figure 11. Project map for the Kellner Jack Field installed in 1951
