CONNECTICUT RIVER BASIN
GLASTONBURY , CONNECTICUT

BUCKINGHAM RESERVOIR DAM
CT 00244

PHASE I INSPECTION REPORT
NATIONAL DAM INSPECTION PROGRAM

APRIL 1980

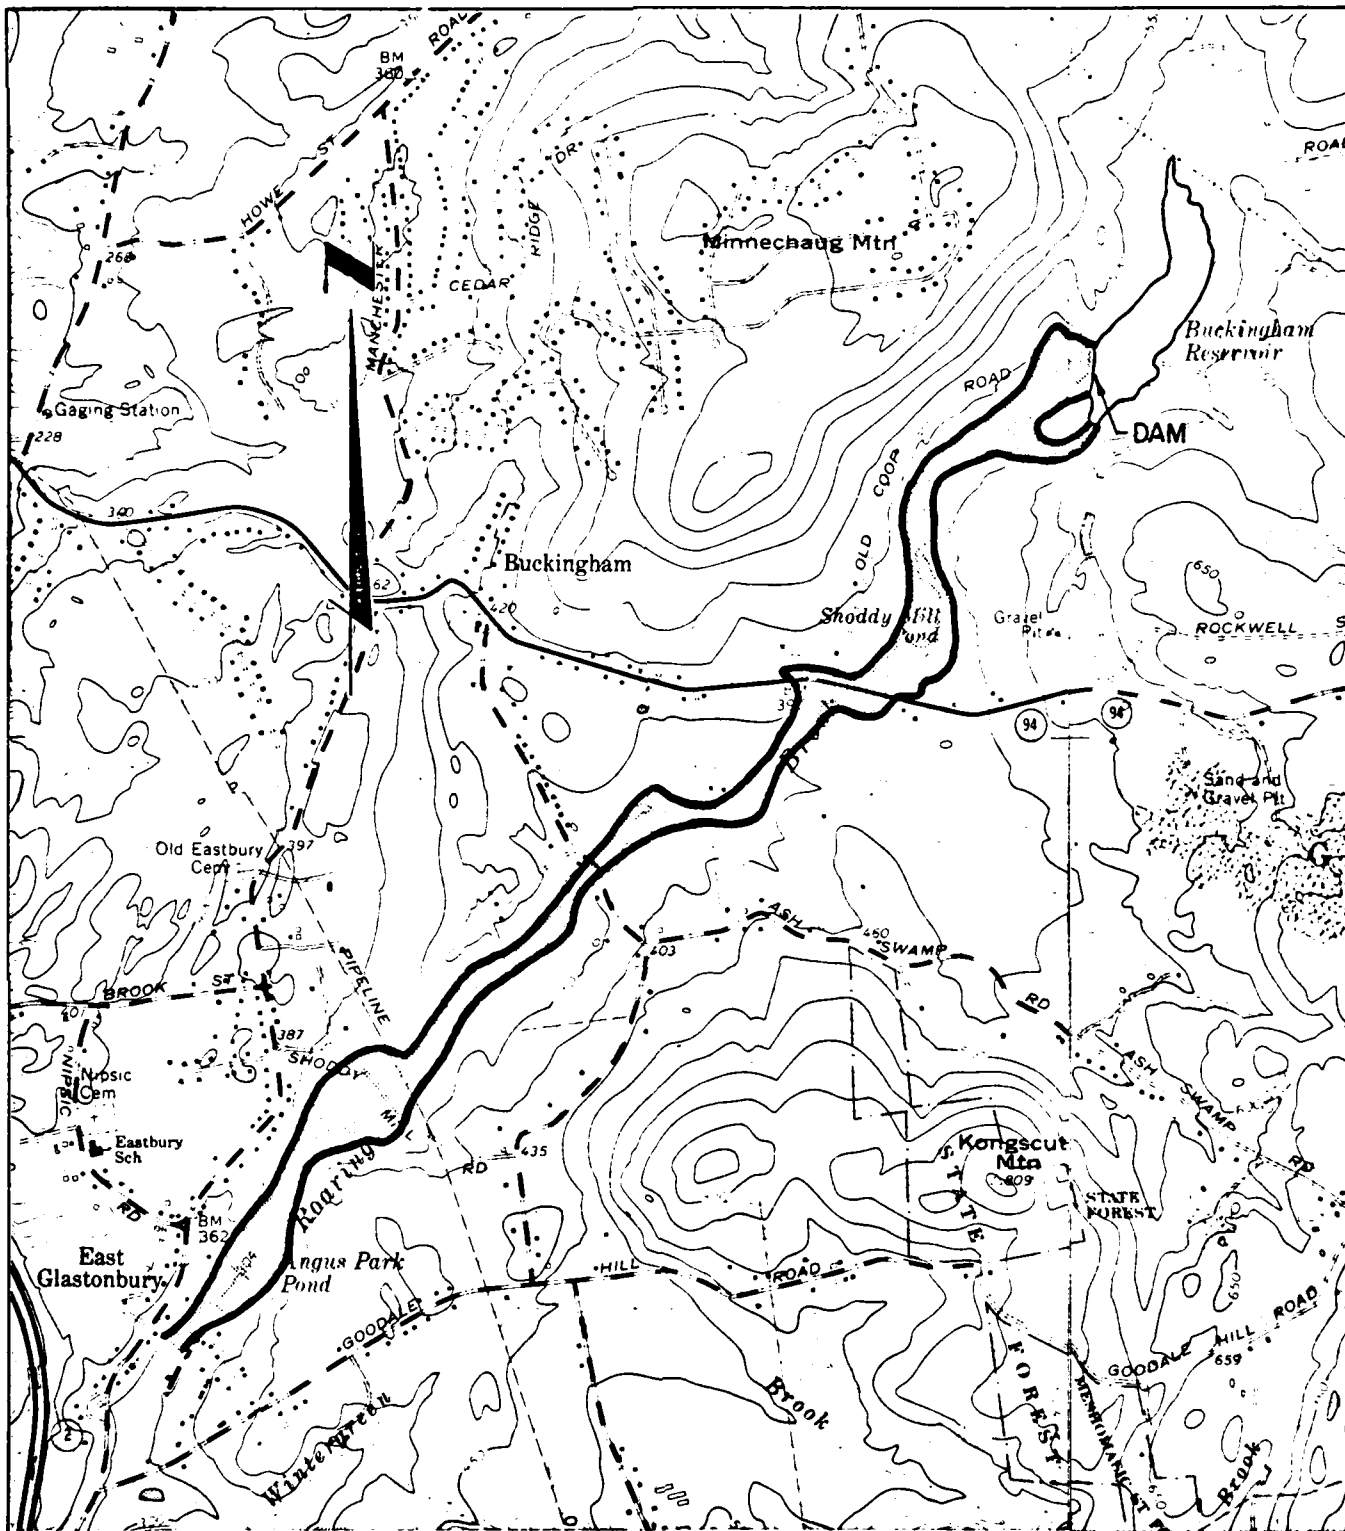
IMPACT AREA

BUCKINGHAM RESERVOIR DAM DAM FAILURE ANALYSIS
