## SECTION 32 PROGRAM STREAMBANK EROSION CONTROL EVALUATION AND DEMONSTRATION WORK UNIT 2-EVALUATION OF EXISTING BANK PROTECTION

# FIELD INSPECTION OF THE MILL CREEK MIDFLOODWAY GABION BARRIER IN THE LOS ANGELES DISTRICT

> April 1980 Inspection Report 9

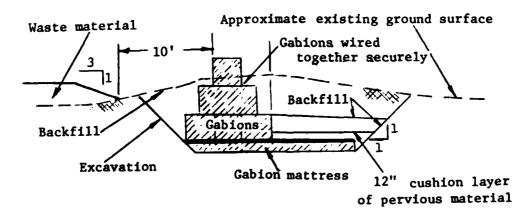
14. The principal feature of the 1967 project consisted of a two-part midfloodway gabion barrier, about 1,500 ft long, beginning just downstream from Garnet Street Bridge (Figure 3). This structure was designed to prevent development of the cross-channel flow that caused the destruction of the sloping, ungrouted-stone face of the project levee (paragraph 12). Bekaert gabions manufactured and supplied by Terra Aqua Conservation of Reno, Nev. (a division of Bekaert Steel Wire Corp.) were filled with stone from the streambed of Mill Creek. Figure 7 shows a detailed view of the gabion wire mesh and the variation in stone sizes used to fill the gabions. Cost (1967) of the gabion barrier was \$34,000. Figure 8 shows a photograph and a cross-sectional view of the

Figure 8. Photograph and cross-sectional view of midfloodway gabion barrier downstream from Carnet Street Bridge under construction after the 1966 flood
