SECTION 32 PROGRAM  
STREAMBANK EROSION CONTROL  
EVALUATION AND DEMONSTRATION  
WORK UNIT 2-EVALUATION OF EXISTING  
BANK PROTECTION

FIELD INSPECTION OF SITES IN THE VICKSBURG DISTRICT  
IN THE UPPER YAZOO BASIN

Malcolm P. Keown, E. A. Dardeau, Jr.

October 1978

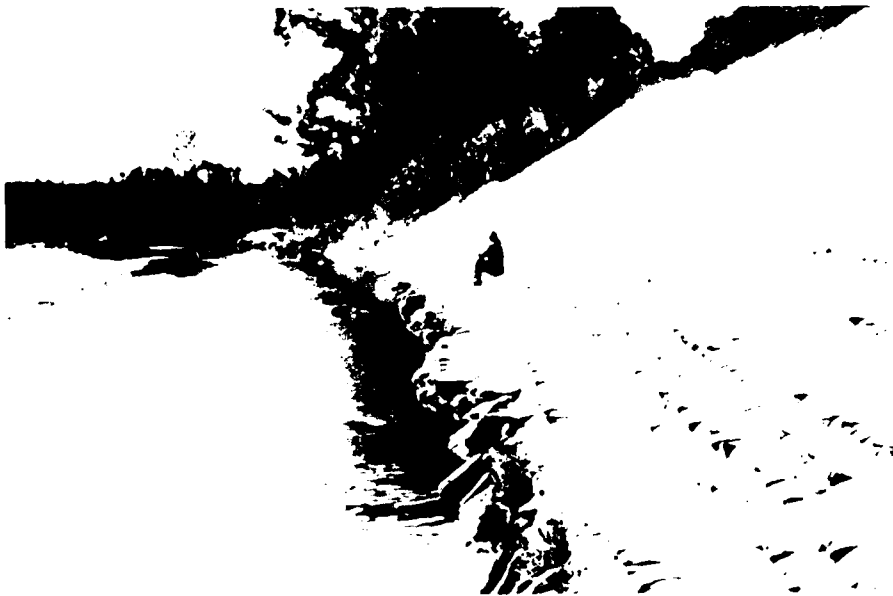
13. Sand-cement bag revetment approximately 600 ft in total length was placed in this reach (Figure 9).<sup>\*</sup> Reinforced paper or burlap bags were filled with a mixture of five parts sand to one part cement (Figure 22). The filled bags were then placed along the lowest level to be protected and then successively overlapped up the bank until the desired portion of the bank was covered. The revetment generally was intact at the date of both inspection visits, the only problem being the loss of bags along the toe of the revetment (Figure 23). This loss was attributed by LMK to an adjustment in the toe protection as a result of scour.

Figure 23. Completed sand-cement bag revetment, South Fork,  
Tillatoba Creek (12 October 1977)

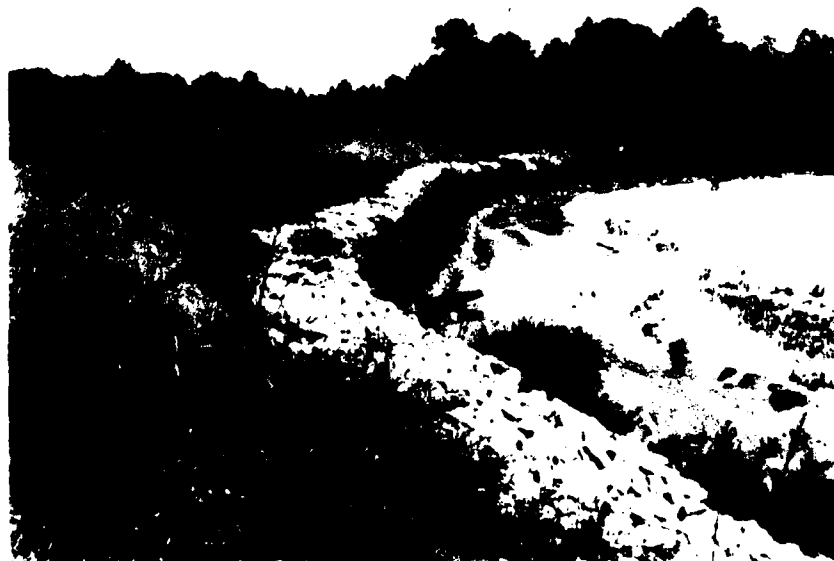
Figure 42. Longitudinal stone dike with berm on upper bank, North Fork, Tilted in Creek (12 October 1977)

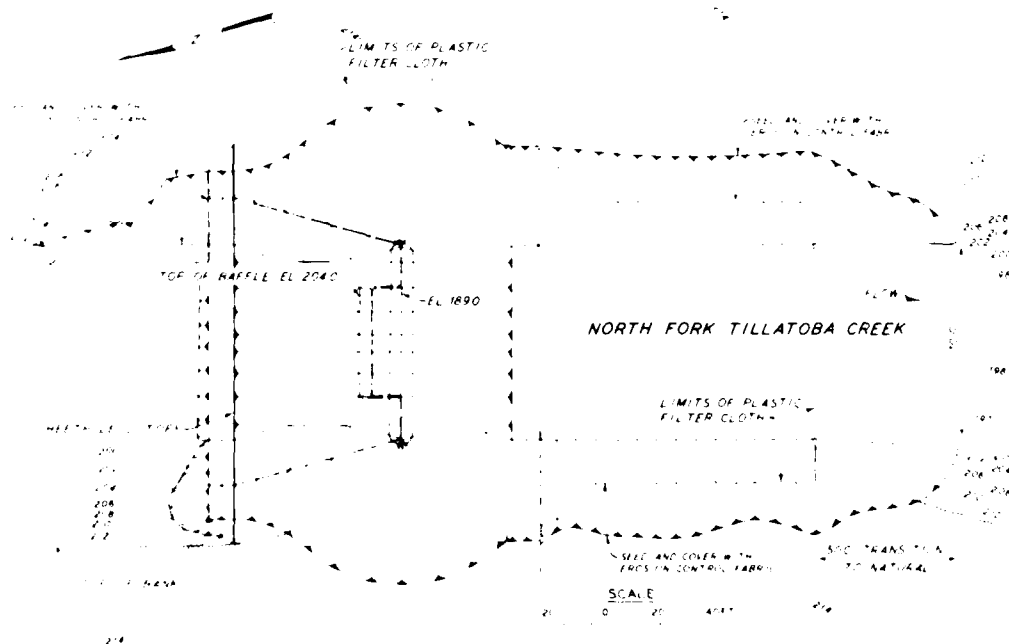
Figure 46. Plan view of grade-control structure (Source: Streambank Erosion Control, Item 3A, North Fork, Tillatoba Creek, Drawing No. 2, LMK, 1977)

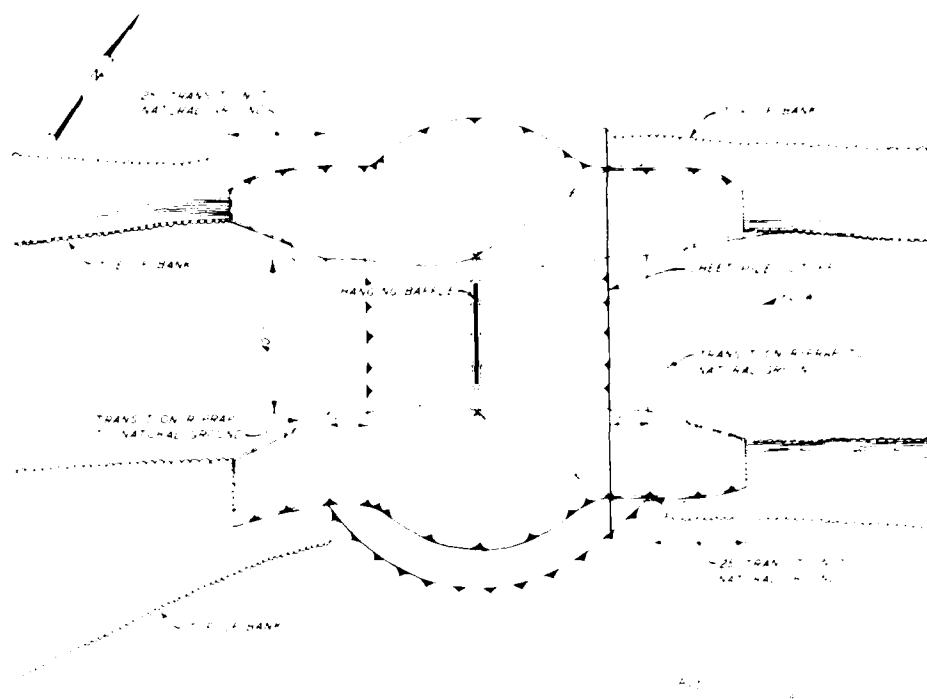
24. The second grade-control structure (Item 3C) consists of a sheet-pile sill and a hanging baffle as the downstream energy dissipator (Figure 49). The upper and lower banks and the bottom of the creek have been protected with filter cloth and are covered with limestone riprap (Figure 50). Both structures have experienced bank-full flows since completion of construction and have performed as designed.

Figure 49. Plan view of grade-control structure (Project: Floodplain Control, Item 49, North Fork, Tillatoba Creek, Lowland District, 1966, 1977).

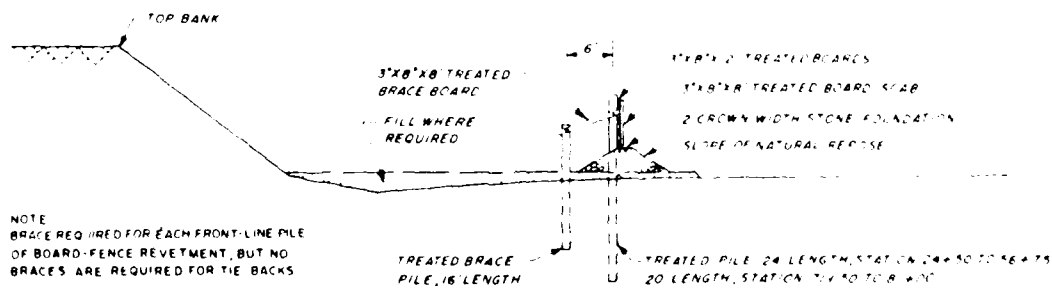
31. The board-fence revetment was constructed using 12-in.-diameter treated pilings (varying in length from 16 to 25 ft) and 3-in. by 8-in. by 12-ft treated boards (Figure 59, longitudinal view). Each piling was braced as shown in Figure 59, lateral view. The boards were bolted to the pilings as shown in Figure 60. The toe of the revetment was protected by a course of stone (Figures 59 and 60). To provide additional mechanical stability for the structure and to prevent formation of a secondary channel, tiebacks were constructed at approximately 75-ft intervals using the same materials as those used for the fence (Figure 61). The resulting structures (Figures 62 and 63) serve as permeable fences. When the bank is attacked by the stream the water velocity is significantly reduced by the fence, thus encouraging sediment deposition which then serves as a substrate for vegetation growth. At the time of both inspection visits, the fences appeared to be structurally sound, and measurable sediment deposition had occurred. The only problem appeared to be failure of the stone foundation at a few points (Figure 64); this failure could conceivably lead to scour around the pilings and failure of the fence.

Figure 59. Board-fence revetment construction details (Source: Bank Stabilization, Batupan Bogue, Drawing No. 4, LTR, 1973)

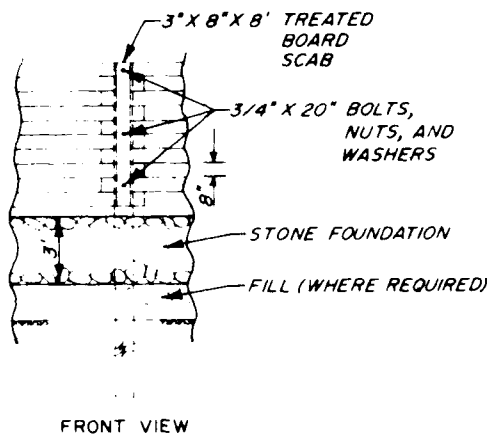
Figure 60. Boards attached to pilings with bolts (Source: Bank Stabilization, Batupan Bogue, Drawing No. 4, LMK, 1977.)

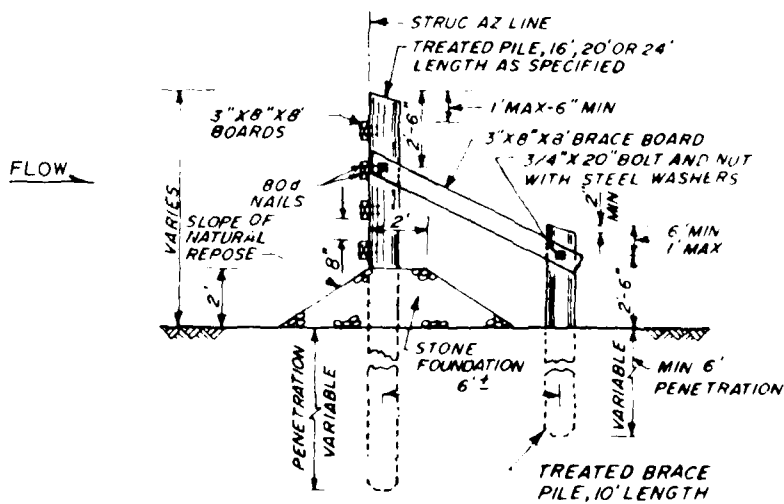
32. The board-fence dikes were constructed of 12-in.-diameter treated piles (varying from 16 to 25 ft in length) and 3-in. by 8-in. by 8-ft treated boards (Figure 65, longitudinal view). The dikes were braced laterally by boards nailed to the piling but bolted to a treated brace pile (Figure 65, lateral view). Scour was prevented around pilings by placement of a course of stone riprap (Figure 65). The resulting dikes function as permeable jetties. The velocity of the water flowing through the dikes is reduced, thus encouraging sediment deposition and eventual establishment of vegetation along the bank (Figure 66). In addition to encouraging sediment deposition, the dikes tend to deflect the erosive currents away from the banks toward midchannel. At the date of both inspection visits, very little damage to the dikes was apparent; measurable sediment deposition had occurred. The minor damage noted consisted generally of broken boards, possibly as the result of impact by debris.

Figure 65. Board-fence dike construction details (Source: Bank Stabilization, Batupan Bogue, Drawing No. 4, L&K, 1972)
