WEST HILL POND DAM

CT. 00377

PHASE I INSPECTION REPORT
NATIONAL DAM INSPECTION PROGRAM

Identification No. CT 00377
Name of Dam: West Hill Pond Dam
Town: Barkhamsted
County and State: Litchfield County, Connecticut
Stream: Morgan Brook
Date of Inspection: 9 November 1978

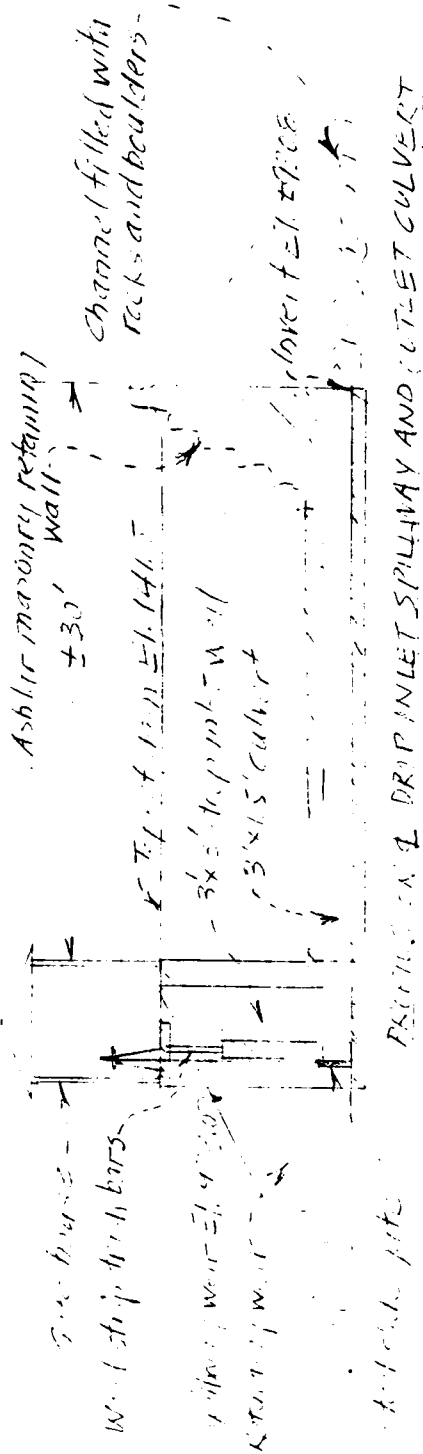
FIGURE 3
SHEET D-5

For determining reservoir areas and capacities below normal storage level, a contour map (Fig. 3, Sheet D-5, Appendix D) prepared by the State of Connecticut Department of Environmental Protection showing lake soundings was planimetered and capacities were computed. For determining surface areas and surcharge capacities, planimetered areas were taken from contours delineated on USGS 2,000 ft. per in. quadrangle sheets. Area and capacity curves and tables, for use in flood routings, are shown on Sheets D-6 and D-7, Appendix D.

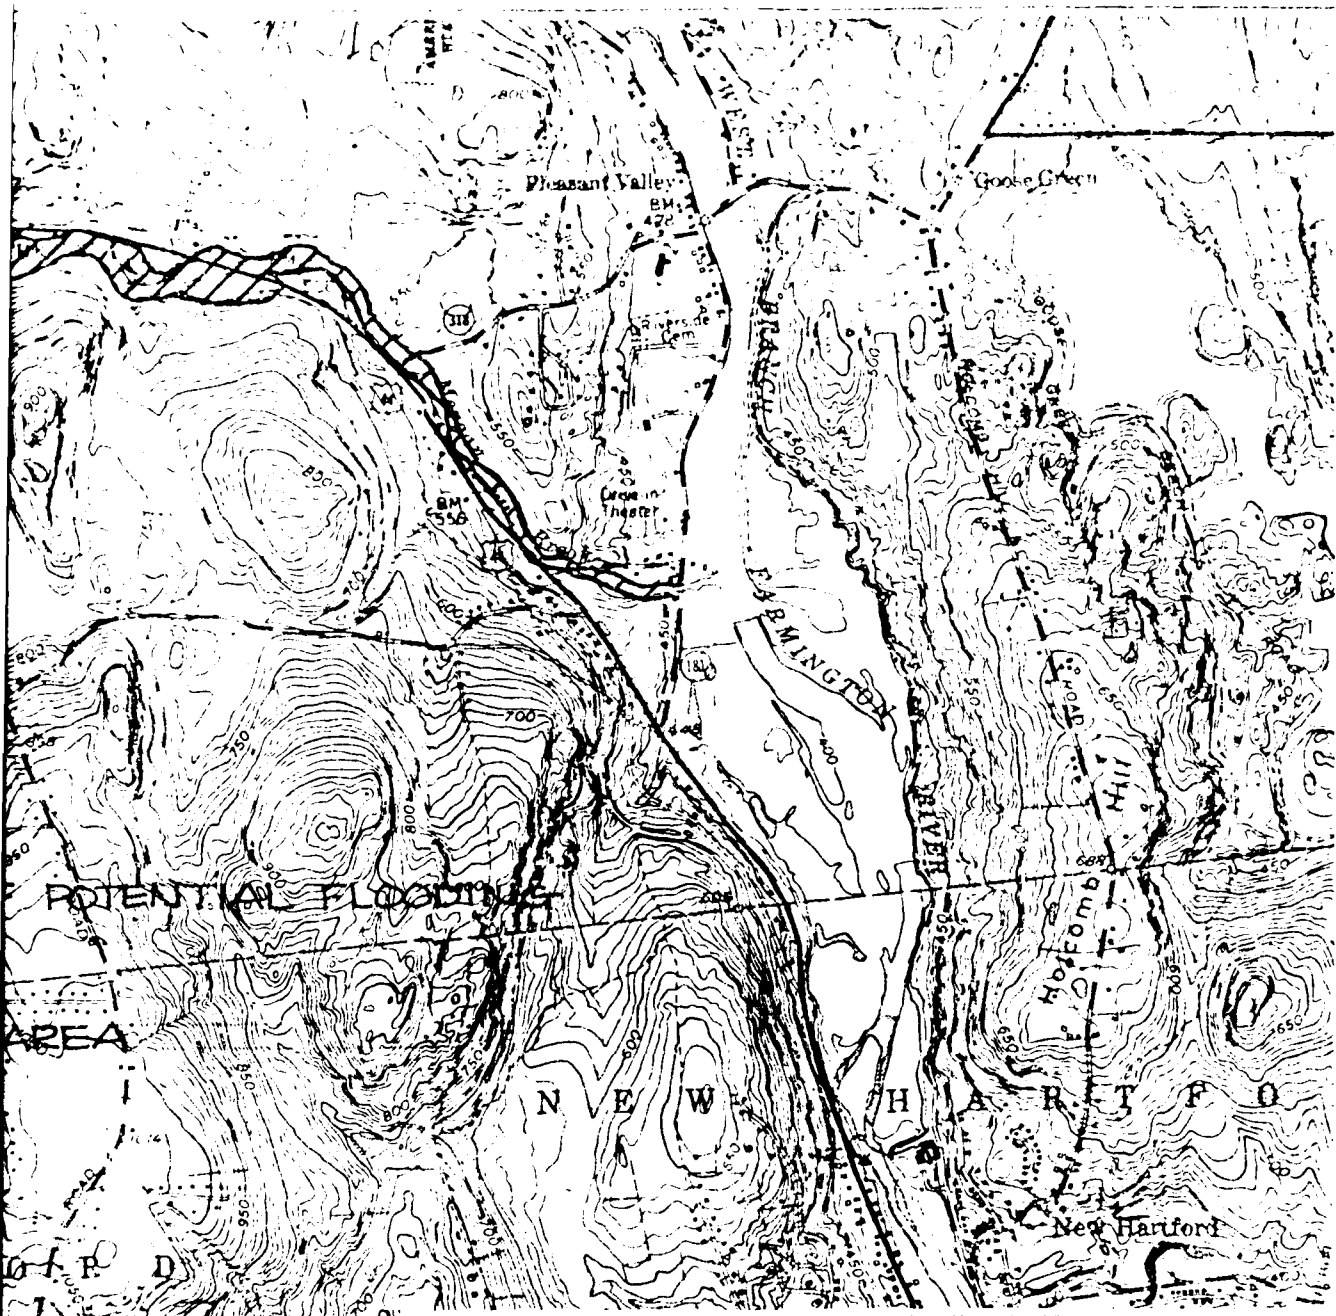
FIGURE 7 0-3

In the event of a breach in the dam either from an overtopping or from piping or sloughing, an outflow of about 4,000 cfs. could be released from the reservoir, based on a breach failure about 80 ft. wide. With a stream slope of about 210 ft. per mile downstream from the dam, it is estimated that a flood wave with a flow depth of about 7 ft. would prevail in the approximately 150 ft. wide valley channel. The local road about 300 ft. downstream from the dam would be overtopped. Because of small valley storage, this 7 ft. stage would prevail for about 3 miles down Morgan and Mallory Brooks, with some lower stage in the West Branch Farmington River, as far as Collinsville and beyond (see Section 3.1e). The effect on life and property for the entire reach of river has not been evaluated in detail, but it is reasoned that some loss of life and appreciable economic losses would be likely to occur. Delineated on the USGS quadrangle sheet (Figure 7, Sheet D-13, Appendix D) is the approximate extent of the river valley which will be affected.
