QUINEBAUG RIVER BASIN
UNION, CONNECTICUT

MASHAPAUG POND
SPILLWAY (CT 00640)
DIKE (CT 01699)
DAM (CT 01700)

PHASE I INSPECTION REPORT
NATIONAL DAM INSPECTION PROGRAM

84 08 20 030
MARCH 1981

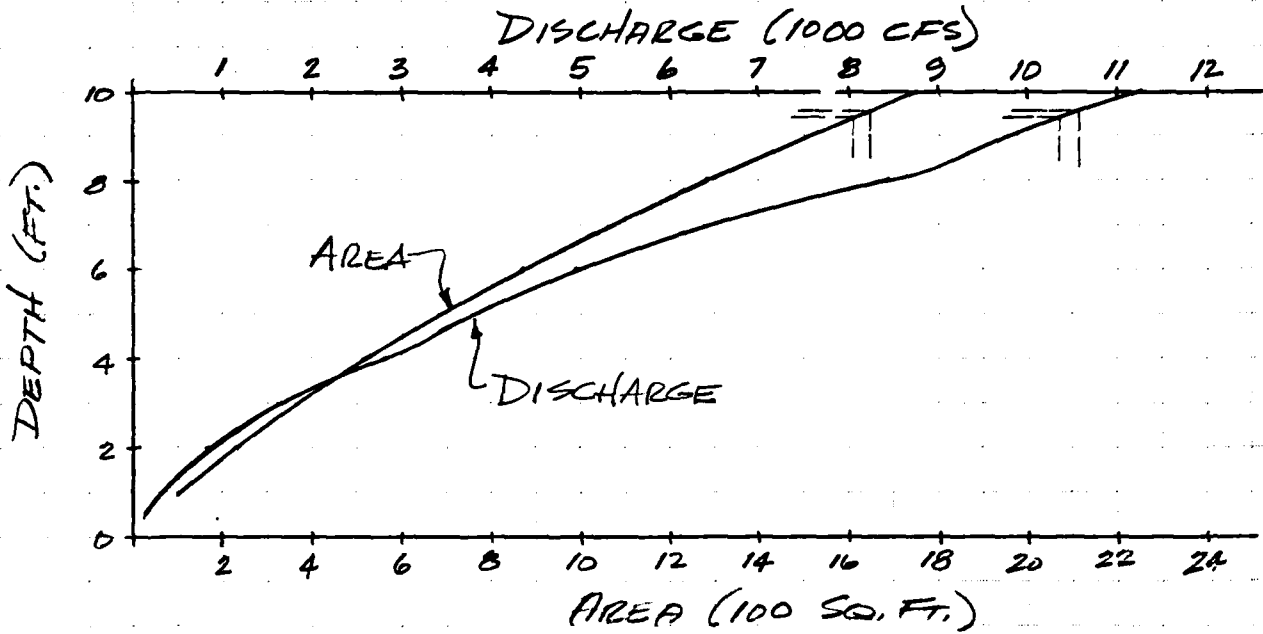
SECTION II (CONT.)

$Q_{P11} = 10,582 \text{ cfs}$

$H = 9.6 \text{ ft.}$

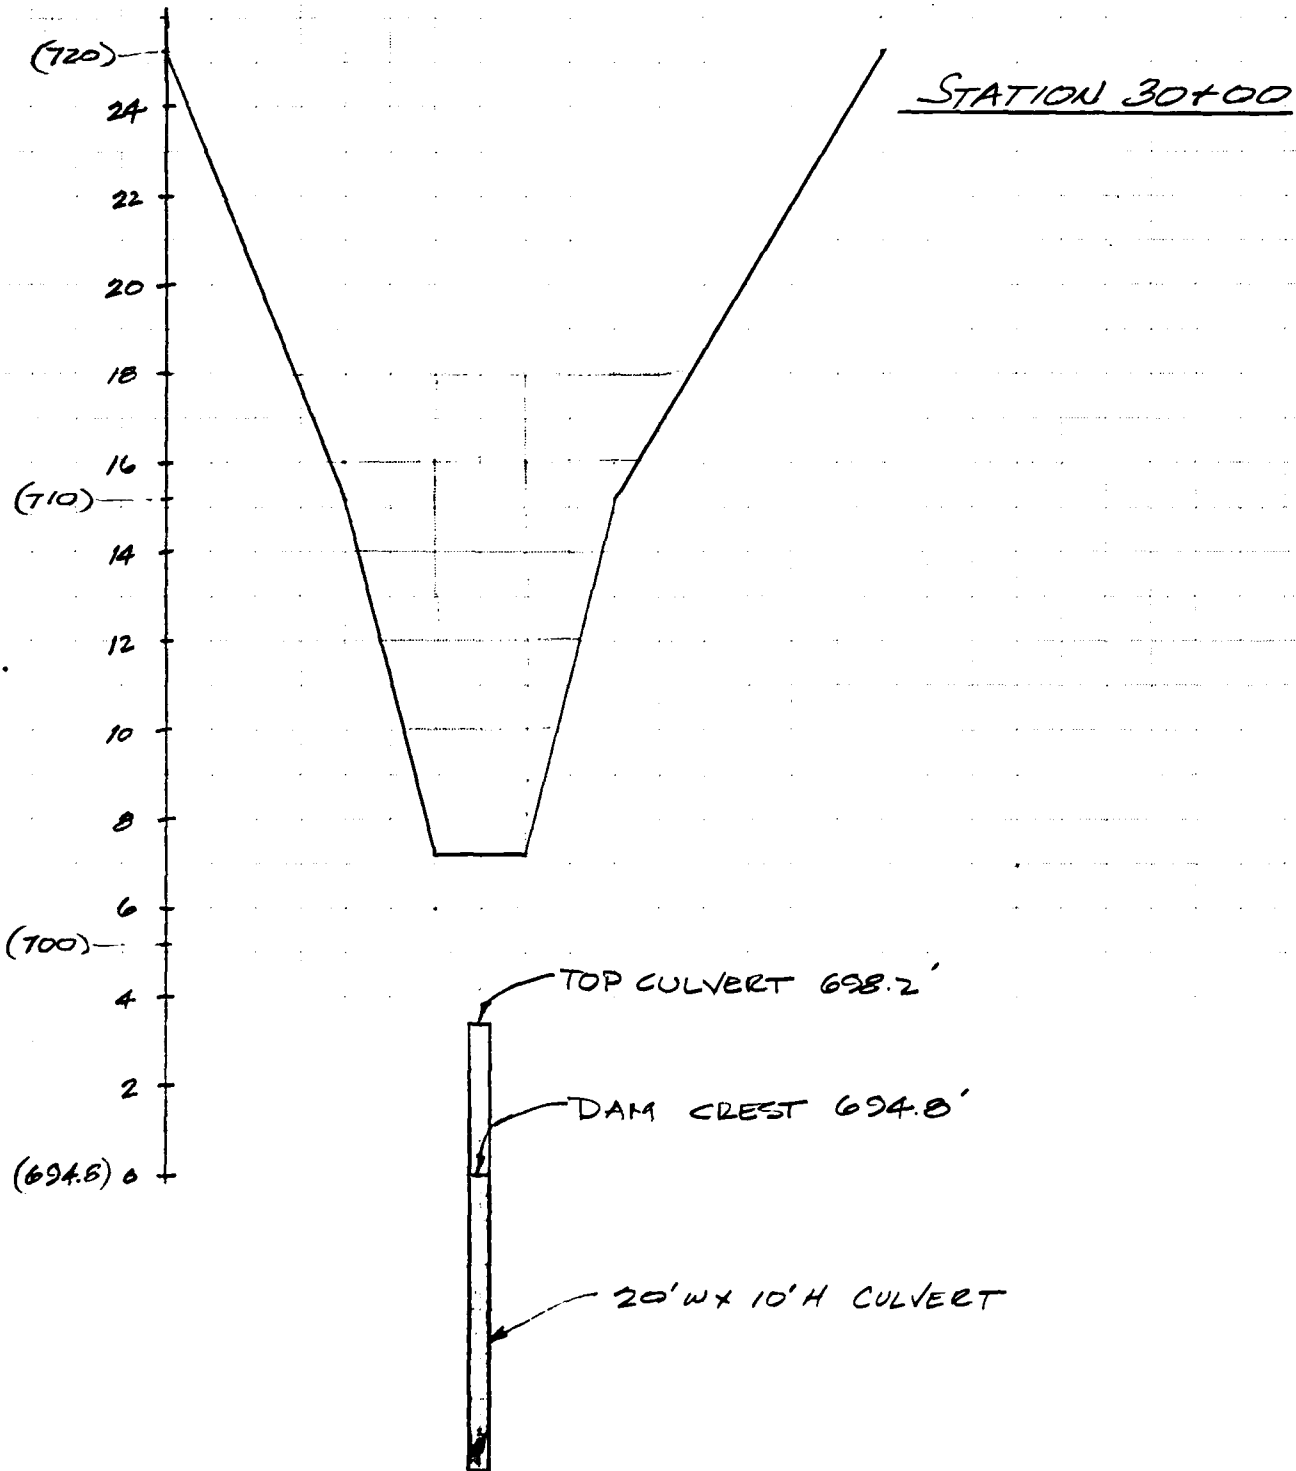
SECTION 1-A

DISCHARGE AT I-86

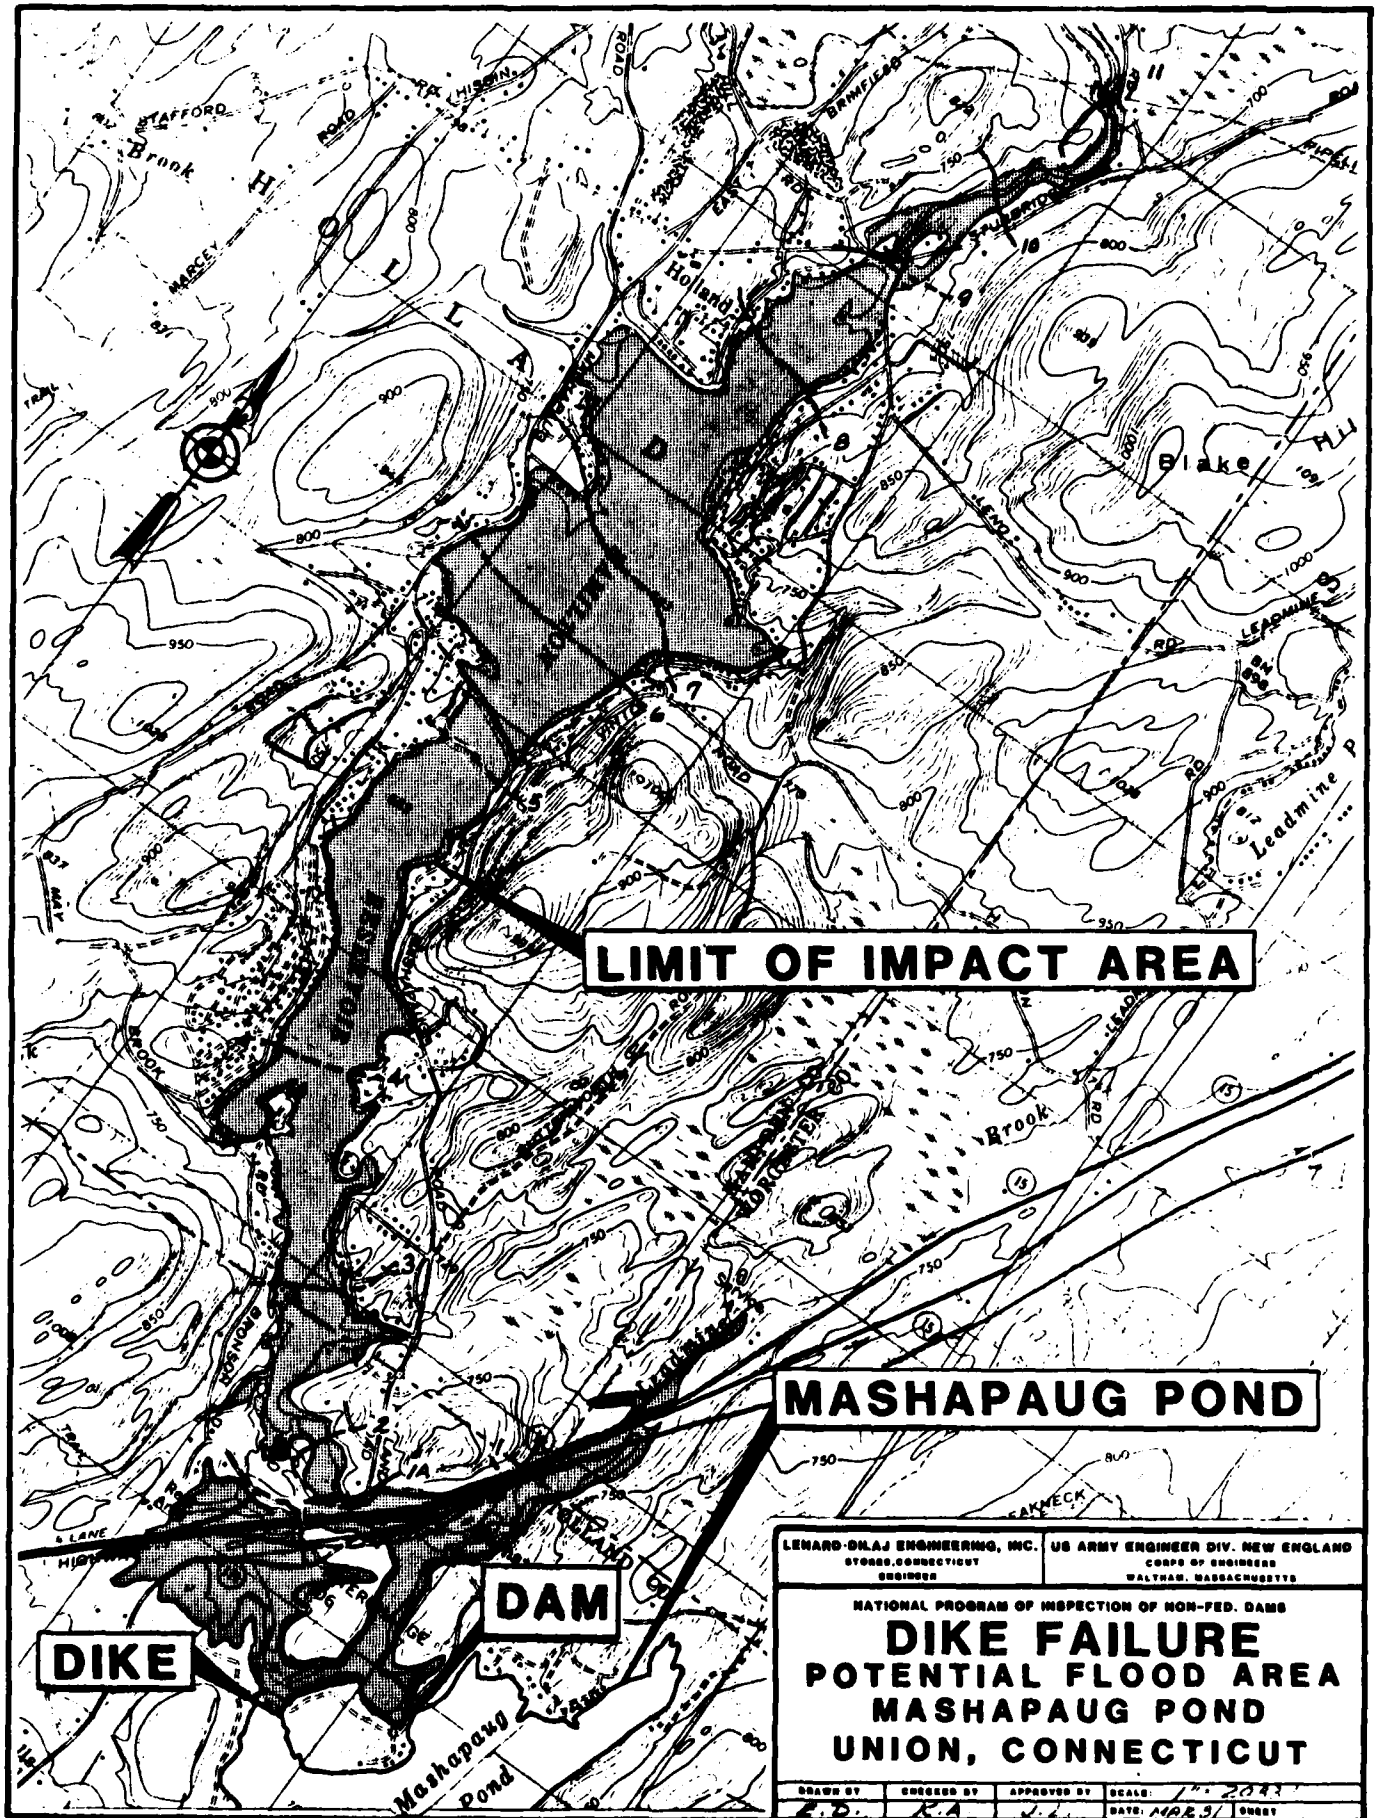
NATIONAL PROGRAM OF INSPECTION OF NON-FED. DAMS
**DIKE FAILURE
 POTENTIAL FLOOD AREA
 MASHAPAUG POND
 UNION, CONNECTICUT**

LIMIT OF IMPACT AREA
