BARRE RESERVOIR DAM AND DIKE
MA 00094

**PHASE I INSPECTION REPORT
NATIONAL DAM INSPECTION PROGRAM**

DEPARTMENT OF THE ARMY
NEW ENGLAND DIVISION, CORPS OF ENGINEERS
WALTHAM, MASS. 02154

JUNE 1980

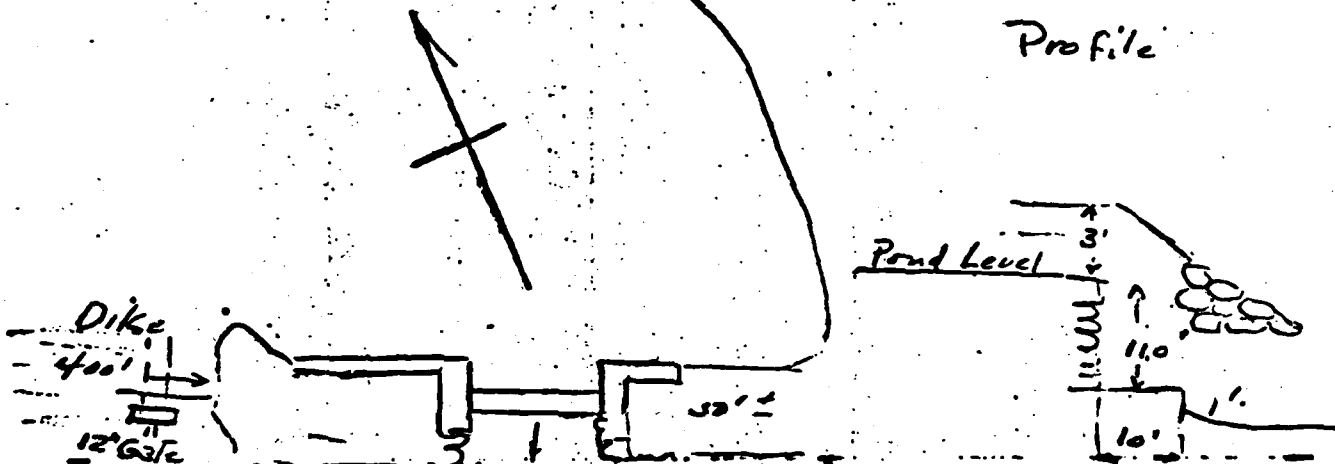
Sketch (Not to Scale):

Earth dam with stone & concrete spillway 70' wide
& 11' high. 3' to crest of dam above spillway, 400' ± Dike
to west of spillway has 12" metal pipe & screw gate

* No turf on dike, several leaks noted, Trees & brush on dam should be cut
