AMMRC TR 84-39

MOBILE ACCELERATOR NEUTRON RADIOGRAPHY SYSTEM

W. E. DANCE, S. F. CAROLLO, AND H. M. BUMGARDNER
LTV AEROSPACE AND DEFENSE COMPANY
VOUGHT MISSILES AND ADVANCED PROGRAMS DIVISION
P. O. BOX 650003
DALLAS, TEXAS 75265-0003

FINAL REPORT

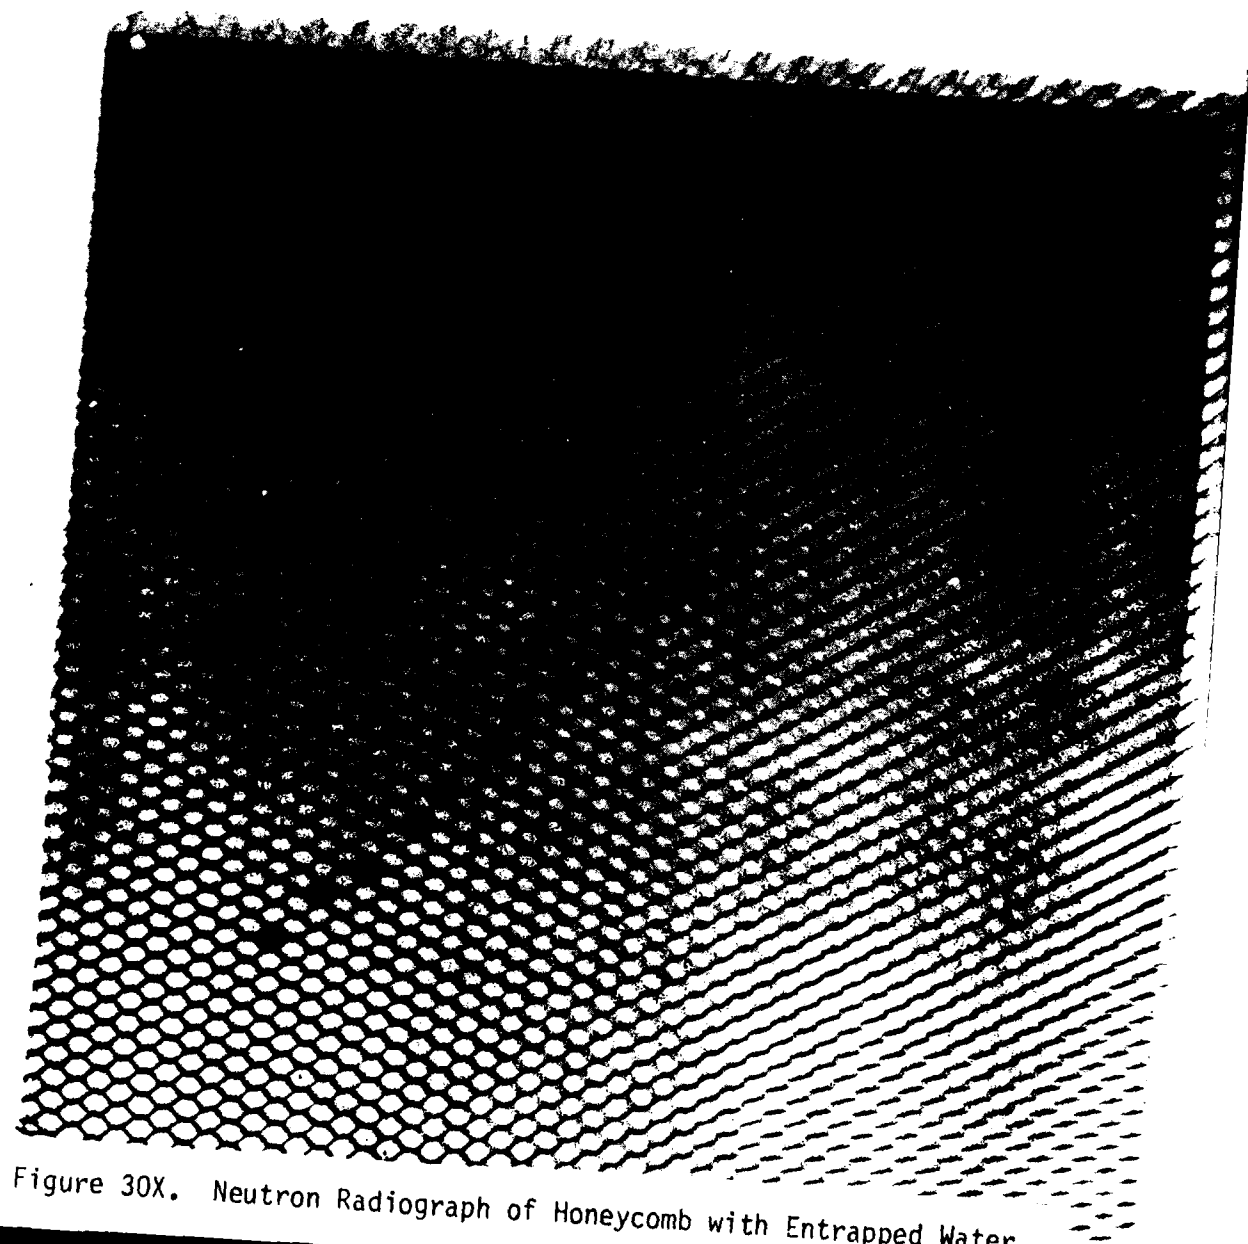
The next pair of radiographs (Figures 30N and 30X) is a comparison of n- and x-ray for imaging water in honeycomb structures. The series of spots are images of water droplets confined to single core cells, in various amounts, and at various depths in the honeycomb. In the upper right portion, it is seen that the quantity of water decreases as the filled cells progress toward the upper right hand corner. It is seen also that the neutron radiograph has greater contrast sensitivity for imaging water droplets than the X-ray. Also, from the neutron radiograph the relative depth of the water drops in the panel

Figure 30X. Neutron Radiograph of Honeycomb with Entrapped Water

is indicated, since the image sharpness decreases as the object-to-film distance increases, due to the low L/D (~ 12) of this exposure. For example, beginning at lower left, the fifth droplet is sharpest and hence is the closest one to the film side of the specimen; the third one is next in closeness; nos. 6 through 11 all appear to be at the same depth; and nos. 2 and 12 through 16 all appear at approximately the same depth, farthest from the specimen's film side of the specimen. The x-ray image cannot be used in a similar manner to ascertain depth since all the spots appear with rather uniform sharpness, due to the "point source" nature of x-ray exposure geometry. The neutron radiograph also indicates that the adhesive layer is highly non-uniform in thickness, which is a condition not readily detected in the X-ray.

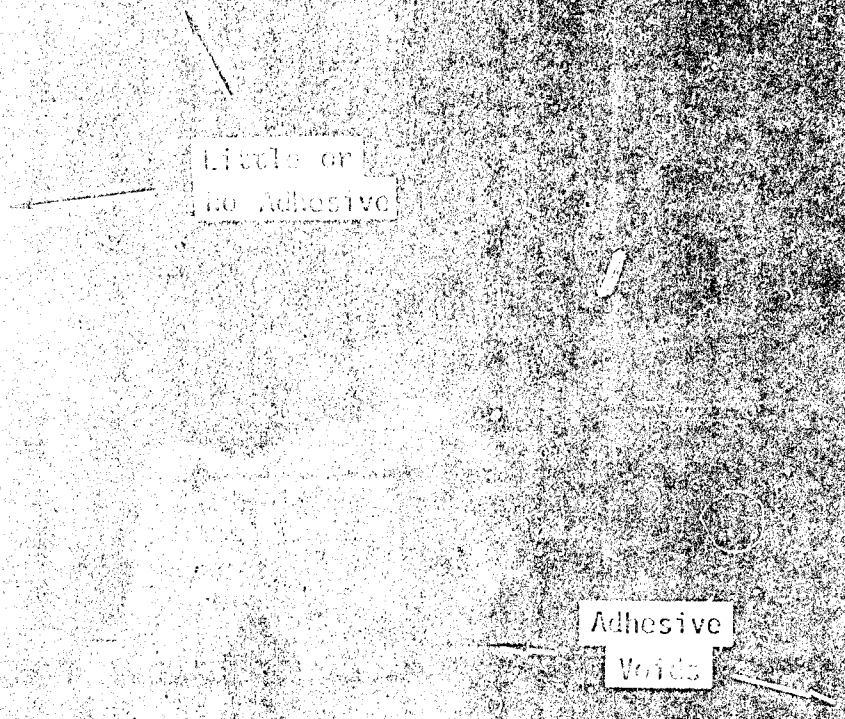
Figures 37X and 37N are the result of radiographic inspection of a simulated F-111 engine nacelle panel which is a lamination of ceramic tiles and metal skins, adhesively bonded. The x-ray images the tiles in high contrast, while the neutron radiograph (Figure 37N) images the adhesive bonding material between the tiles and the distribution of the adhesive layer between tiles and metal skin. In the latter case, the image shows large inhomogeneities in the adhesive thickness and several "worm-hole" adhesive voids. A real production panel imaged in the radiograph of Figure 38N shows greater inhomogeneities in adhesive distribution, both between tiles and between tiles and skin. Radiographic results from additional Air Force specimens are presented in the next section on field operations.

Figure 37N. Neutron Radiograph of Simulated F-111 Engine Nacelle Panel Showing Bonding Anomalies

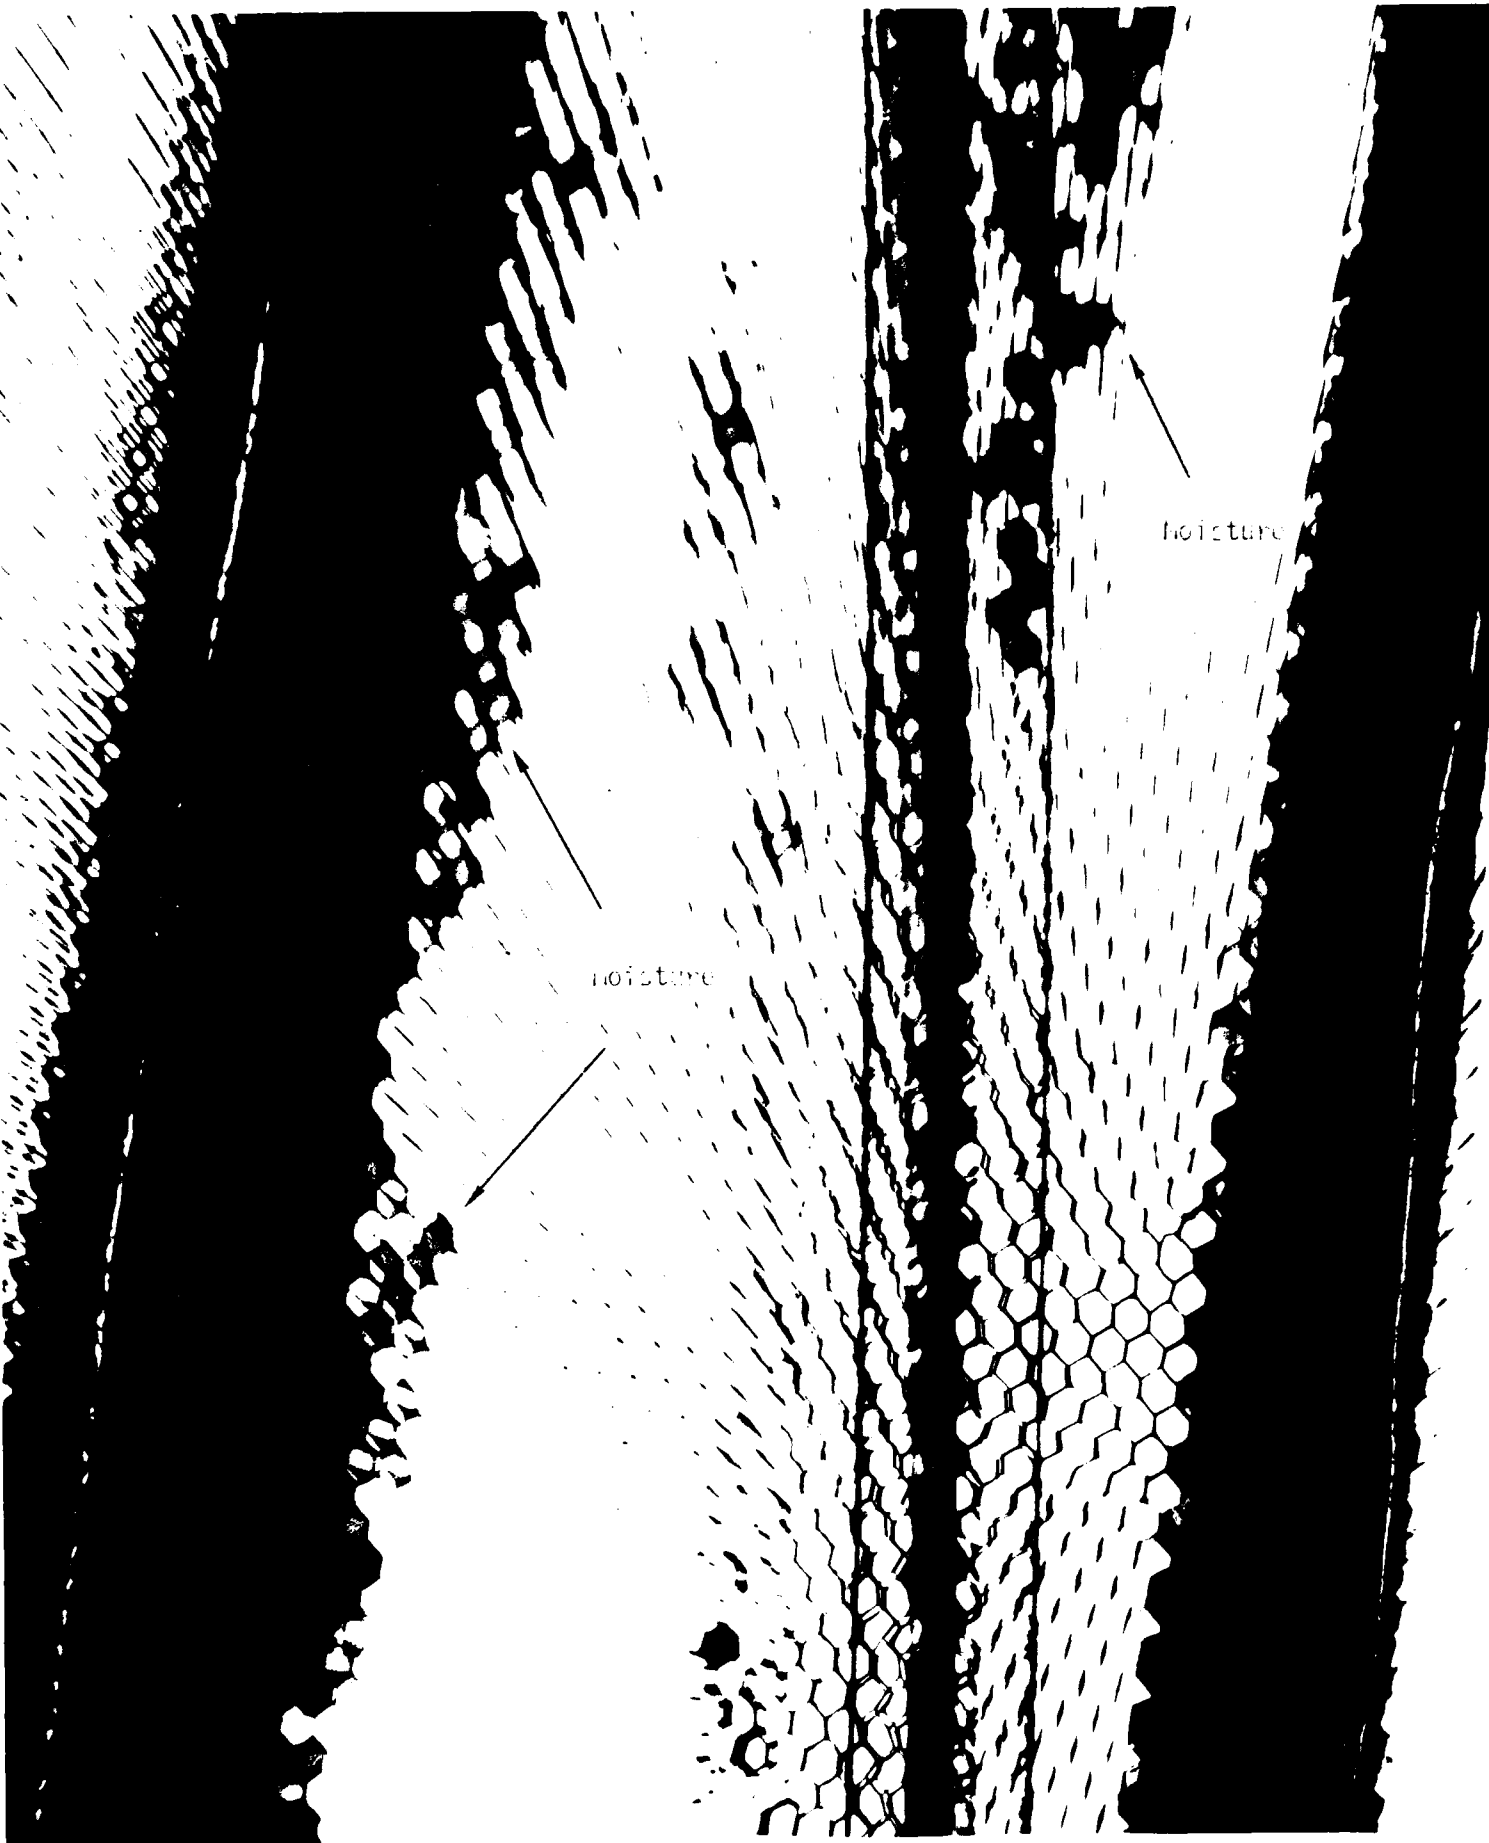
The first neutron radiograph made after arrival and setup at SM-ALC was a fast (12 minute) exposure of an F-111 right hand horizontal stabilizer attached to the aircraft. As seen in the neutron radiograph, Figure 43N, the detail is sufficient to indicate that this area was in a normal "as bonded" condition and free from significant quantities of moisture or corrosion. Subsequently, a similar component which had been removed from a different aircraft for rework because of indications of moisture and corrosion was made available by SM-ALC personnel for comparison, and the same area was neutron radiographed. This radiograph, Figure 44N, shows a very large amount of moisture and corrosion, in striking contrast to the previous radiograph of the "clean" component. The x-ray of the same area as that is shown in Figure 44X. The neutron radiograph dramatically shows more of the moisture and corrosion than does the x-ray and provides a clear indication of the boundaries and severity of these defects. Neutron inspection of a different area of the same stabilizer resulted in the radiograph shown in Figure 45N. Additional moisture and corrosion is revealed in this area of the stabilizer.

Figure 44N. Neutron Radiograph of F-111 Horizontal Stabilizer Showing Substantial Quantities of Moisture and Corrosion

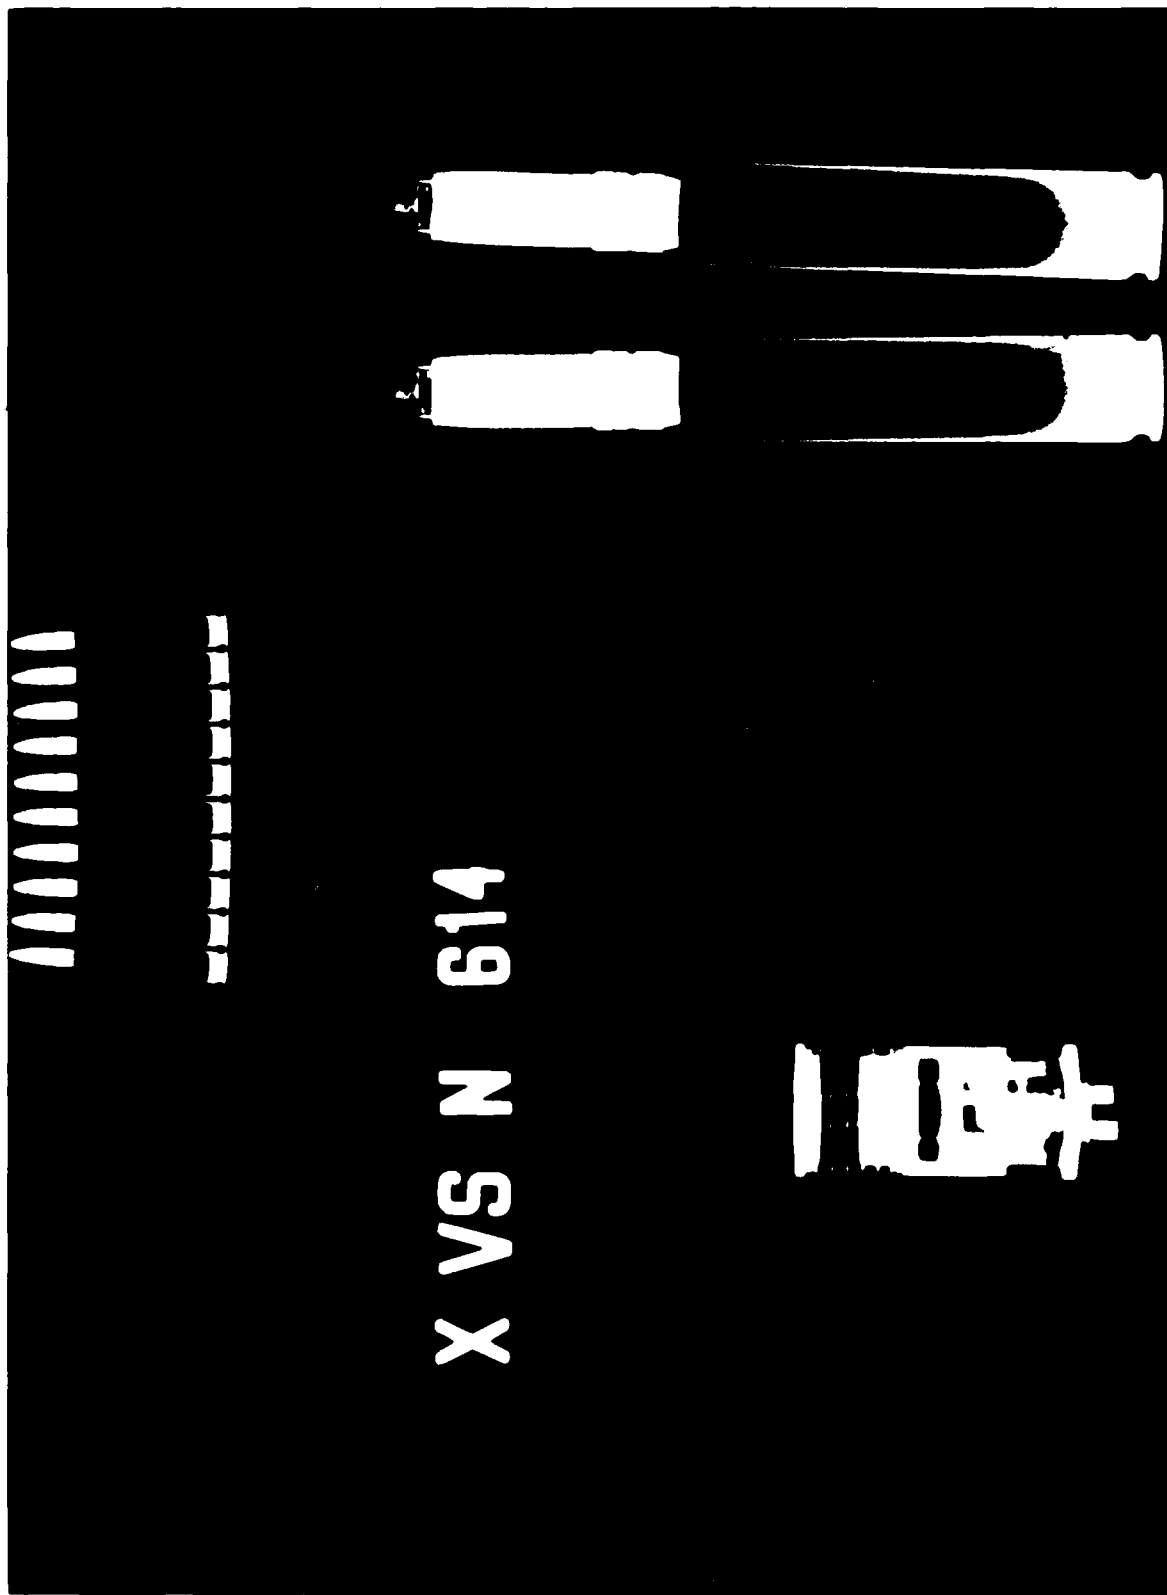
On the X-ray, Figure 63X, in addition to the usually good definition of the metal parts and S&A device, it is seen that two fuze detonators below the fuze base ring of the 2.75 rocket fuze also are imaged. On the 20 mm XM599, the x-ray does not image the case detonator. The projectile body and metal fuze parts show the usual good definition, and the usual lack of good definition of the case charge is apparent. The 7.62 projectile image shows only the case and shell projectile body.

Figure 63X. X-Ray Radiograph of 2.75 Rocket Fuse, 20 mm XM599 Projectile, 7.62 mm Projectiles

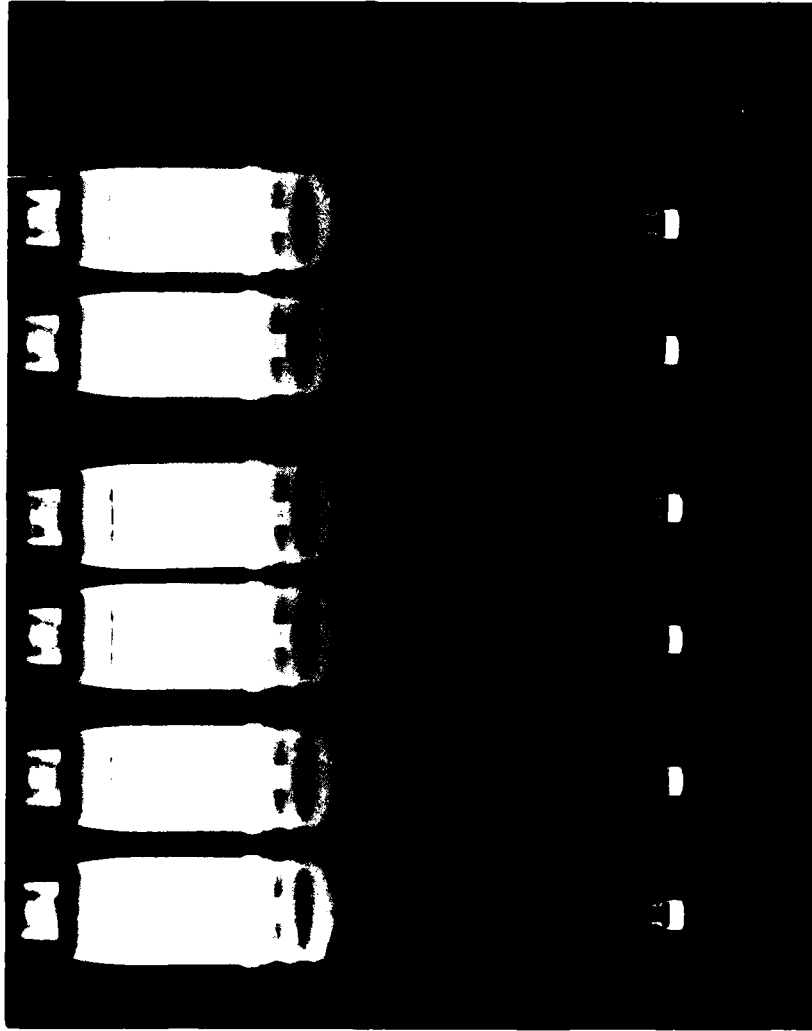
The neutron radiograph presented in Figure 67N images a faulty condition in 30 mm XM789 projectiles which cannot be determined with x-ray inspection. Inside the flash tubes of the projectiles (bottom end) can be seen the independent flash elements. The positions of the elements along the projectile axes are seen to be random. This random positioning can result in an unacceptable "hang-fire" functioning. As seen in the X-ray radiograph of these projectiles, Figure 67X, the internal portions of the flash tube are not imaged and hence, as mentioned above, the X-ray method cannot be used to detect this unsafe condition.

Figure 67X. X-Ray Radiograph of 30 mm XM Projectiles
