PTPD REPORT NO. 84-R-02
AFPEA PROJECT NO. 84-P-111
AD NO. 538026

BI-PAC F-15 EXTERNAL FUEL TANK CONTAINER MODIFICATION

HQ AFLC/DSTZ
AIR FORCE PACKAGING EVALUATION AGENCY
Wright-Patterson AFB OH 45433-5999

September 1984

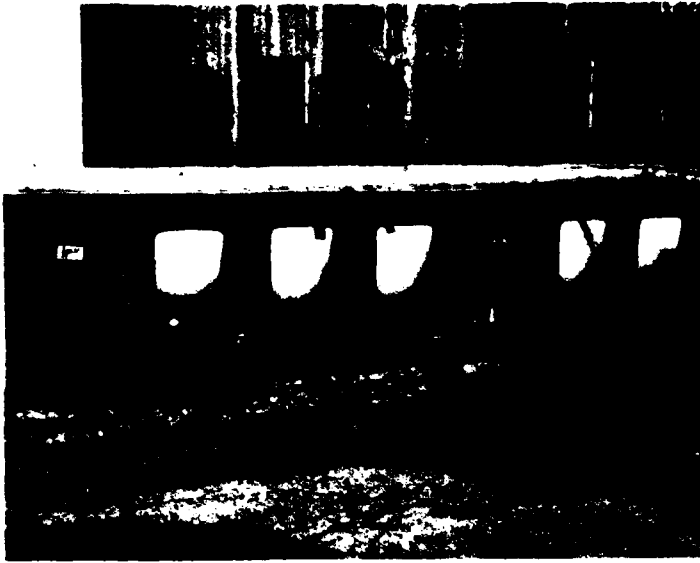
Figure 1, Bi-Pac Container
NSN 1560-01-017-0858FX

Two each BI-PAC containers, NSN 1560-01-017-0858FX, with F-15, 600-gallon fuel tanks were received from WR-ALC/MMT, Robins AFB, Georgia 31098. The containers were fabricated in 1976 and are of fiberglass material. The container exterior size is 272 x 85 x 45 inches, cube is 602 ft³ and the gross weight is 1,325 pounds. (Figure 1)

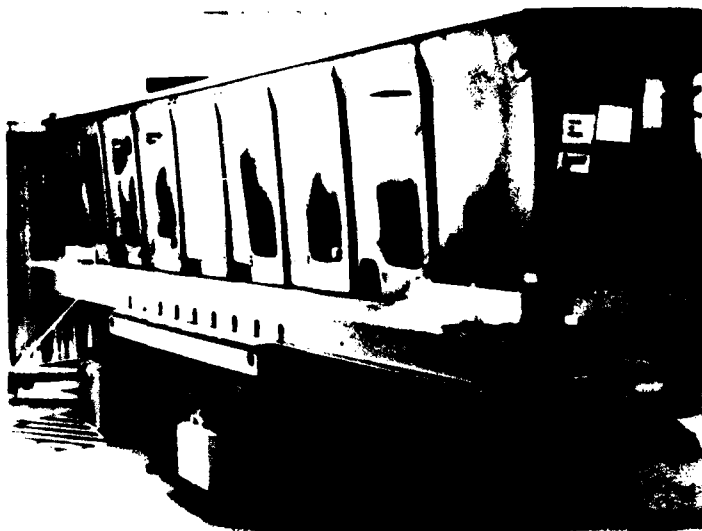
Figure 25, Vibration Test

Test No. 2a: The Vibration Test was conducted in accordance with FTMS No. 101, Method 5019.1. The container was placed on a vibration table and vibrated for two hours at 3.6 Hz, 1.0 G (Figure 25).

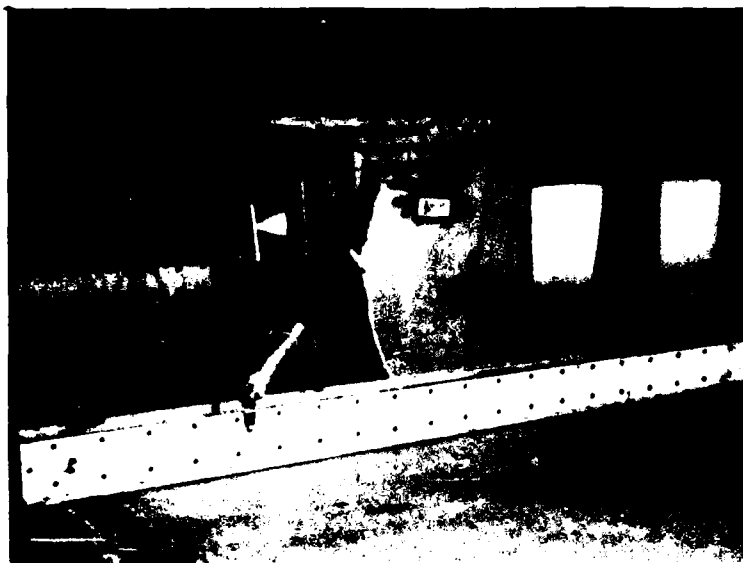
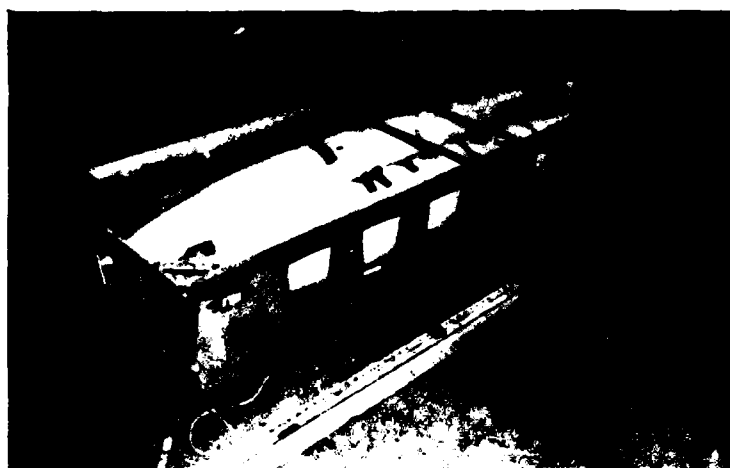
Figure 31, Tie-Down Ring Test

Test No. 3: The Tie-Down Strength Test was conducted in accordance with MIL-STD-648, paragraph 5.8.4, and MIL-A-8421, paragraph 3.3.4. A 6,000 pound maximum load was required for the Tie-Down Strength Test (Figure 31 and 32).
