UPPER AMMONOOSUC DAM

AUG 1981

The dam is in FAIR condition at the present time. It is recommended that the owner retain the services of a qualified registered professional engineer to conduct a detailed hydraulic and hydrologic study to further define the need for and means to increase the project discharge capacity and the ability of the dam to withstand overtopping; to conduct a detailed inspection of the spillway under low flow conditions; and to evaluate the condition of the left abutment and make recommendations for its restoration. Remedial measures to be undertaken by the owner include implementing annual maintenance and inspection programs, and developing a plan for dam surveillance during flood periods and a formal, written system for warning downstream residents and appropriate officials in the event of an emergency. These engineering studies and remedial measures should be implemented by the owner within one year of receipt of this Phase I Inspection Report.

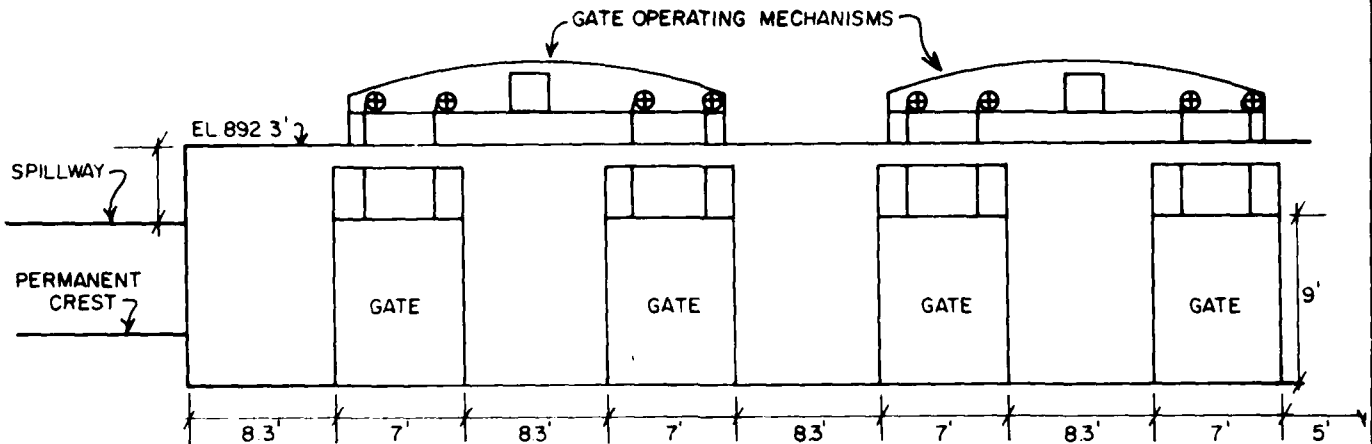
RIGHT GATE STRUCTURE

This structure is constructed with timber cribbing and sheeting, filled with boulders and gravel, and houses a waste gate. The main supporting members are generally 15-inch-diameter logs laid up horizontally, with 3-inch planking fastened in the vertical position. The outboard end of this structure consists of square logs and horizontal planking. Visual observations revealed that the horizontal logs, the vertical planking, and the outboard crib are partially rotted. Vertical planks are missing, and there is evidence of ground erosion. Two sinkholes were noted at the downstream end (see Photo 3). Considerable seepage (50 to 100 GPM) is passing through the outboard crib.

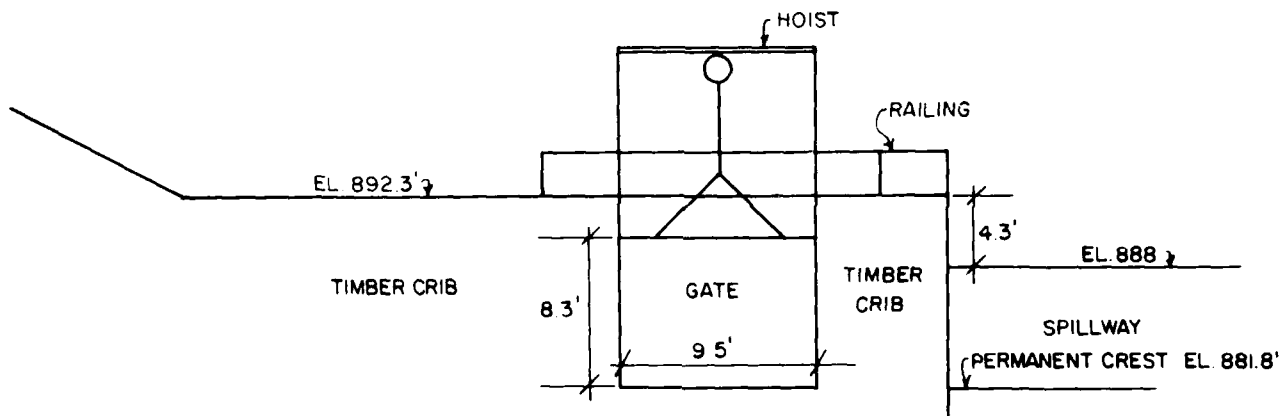
LEFT GATE STRUCTURE

upstream side walls of the waste gate openings are faced with 3/8-inch steel plate. Wood planking has been fastened to the top of the structure. Visual observations revealed that this structure is in good condition, with no any evidence of rot or distress.
