MASSACHUSETTS COASTAL BASIN
GLOUCESTER, MASSACHUSETTS

FERNWOOD LAKE EAST DAM
MA 01336

FERNWOOD LAKE WEST DAM
MA 01337

PHASE I INSPECTION REPORT
NATIONAL DAM INSPECTION PROGRAM

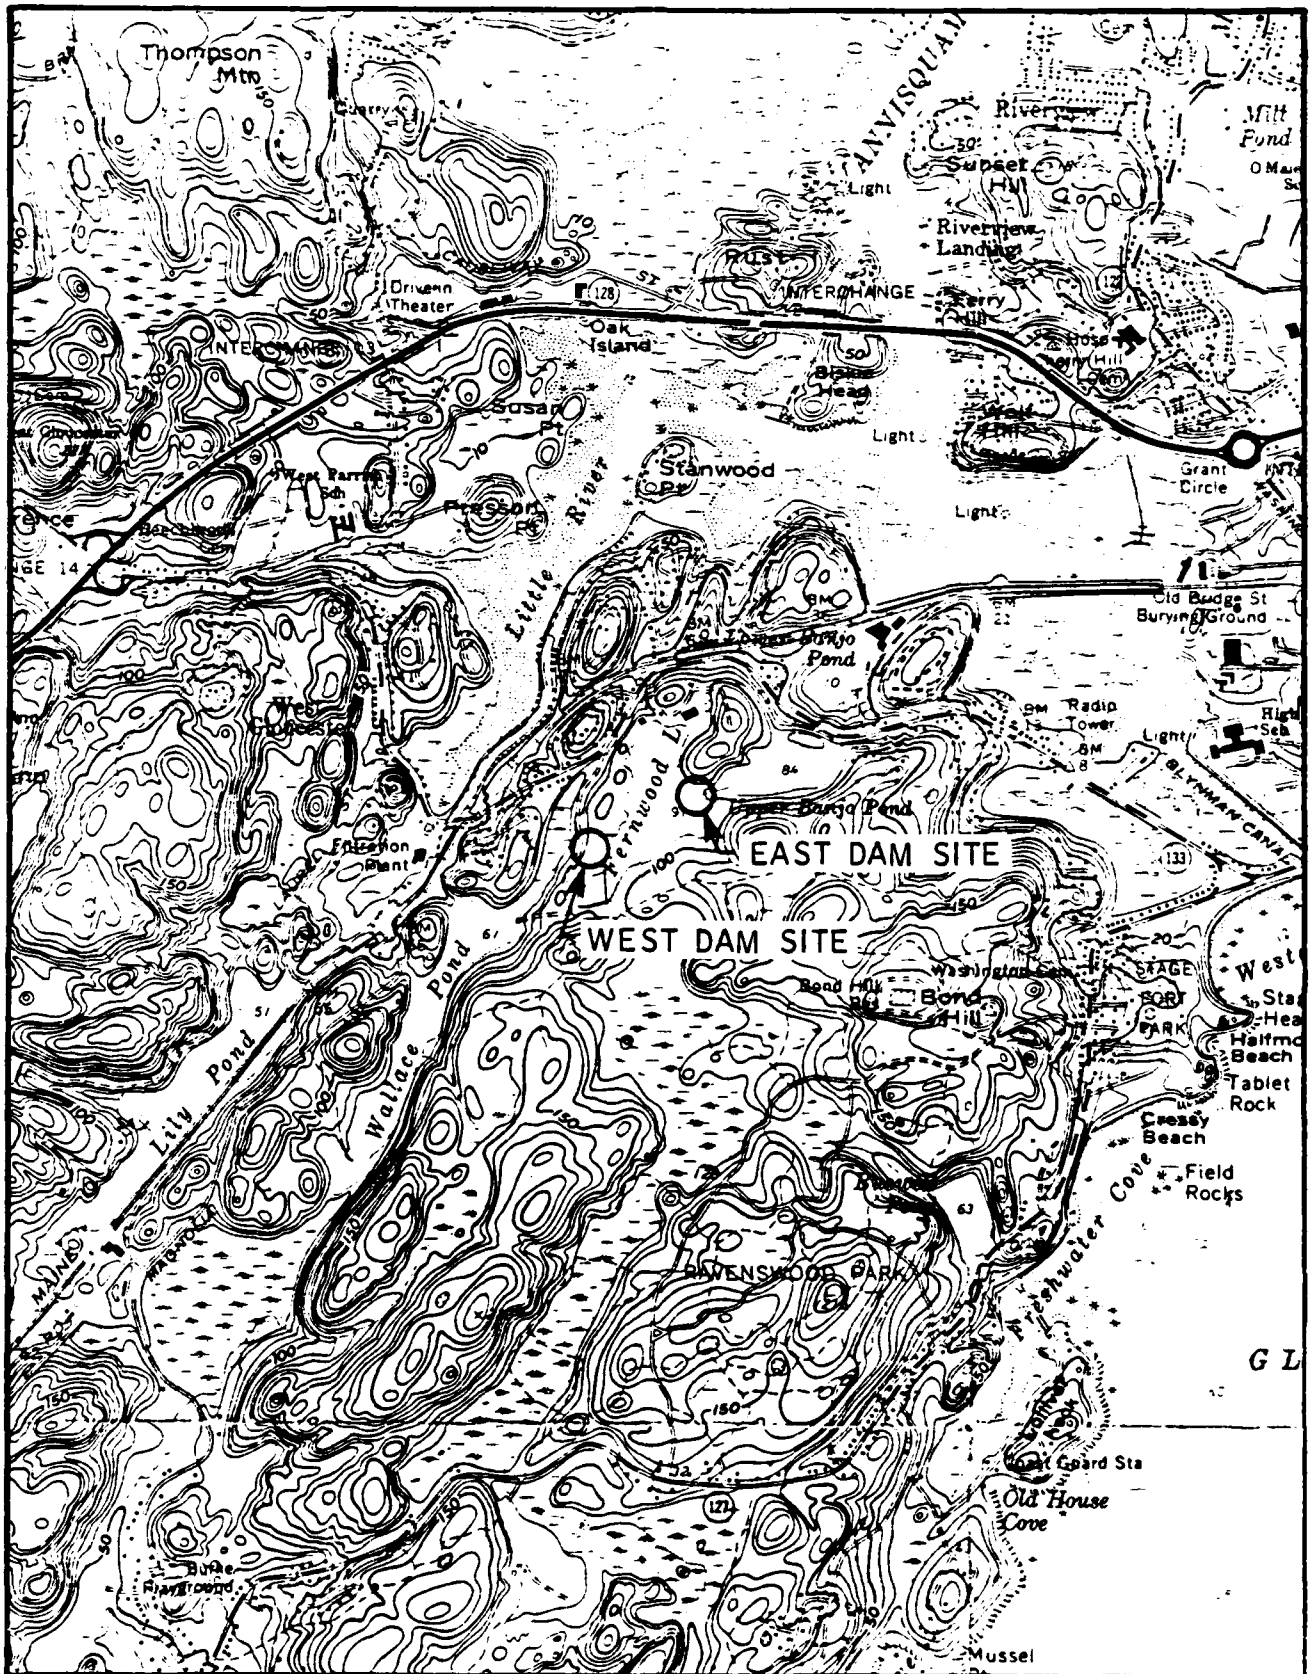
2. Overview photo of Fernwood Lake West Dam taken when lake level was low (6 December 1978)

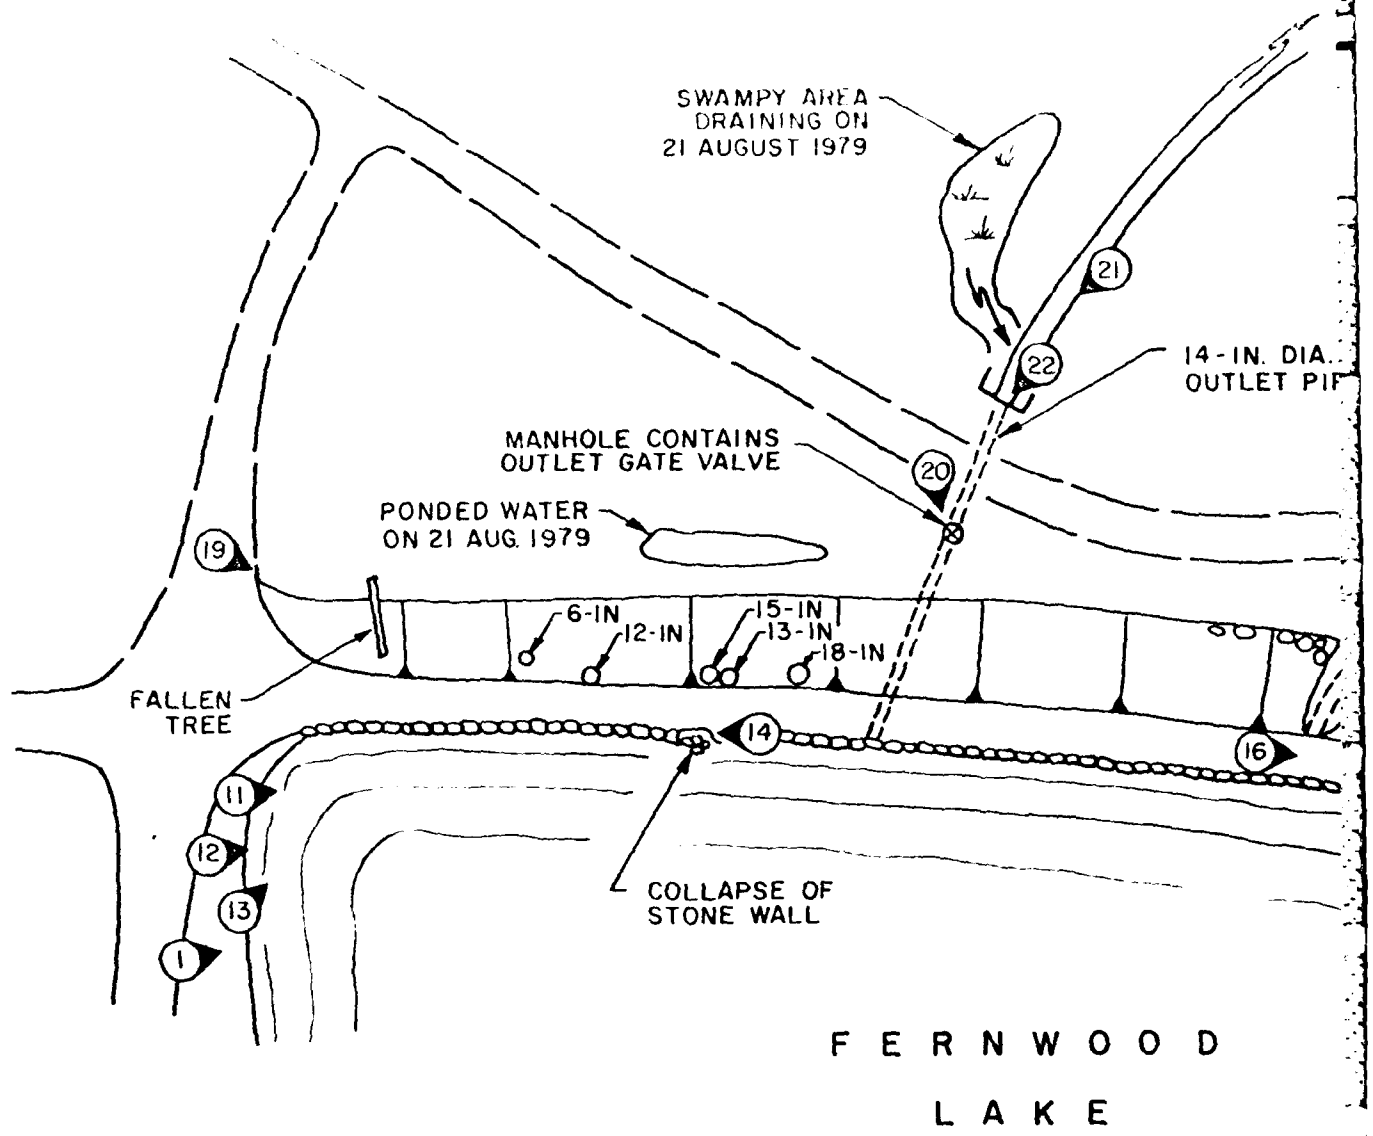
A pool of rust stained still water was observed below the 8-in. pipe on 21 August 1979, Photo No. 10. There was also ponded water there on 2 May 1980, but the water was clear. This water may be a result of drainage characteristics of the lowlying area and/or may indicate seepage along the abandoned pipe.

10. Outlet pipe and
ponded water at
downstream toe
(21 August 1979)
