MERRIMACK RIVER BASIN  
CHELMSFORD, MASSACHUSETTS

RUSSELL MILL POND  
MA 01219

PHASE I INSPECTION REPORT  
NATIONAL DAM INSPECTION PROGRAM

MARCH 1980 06 6 034

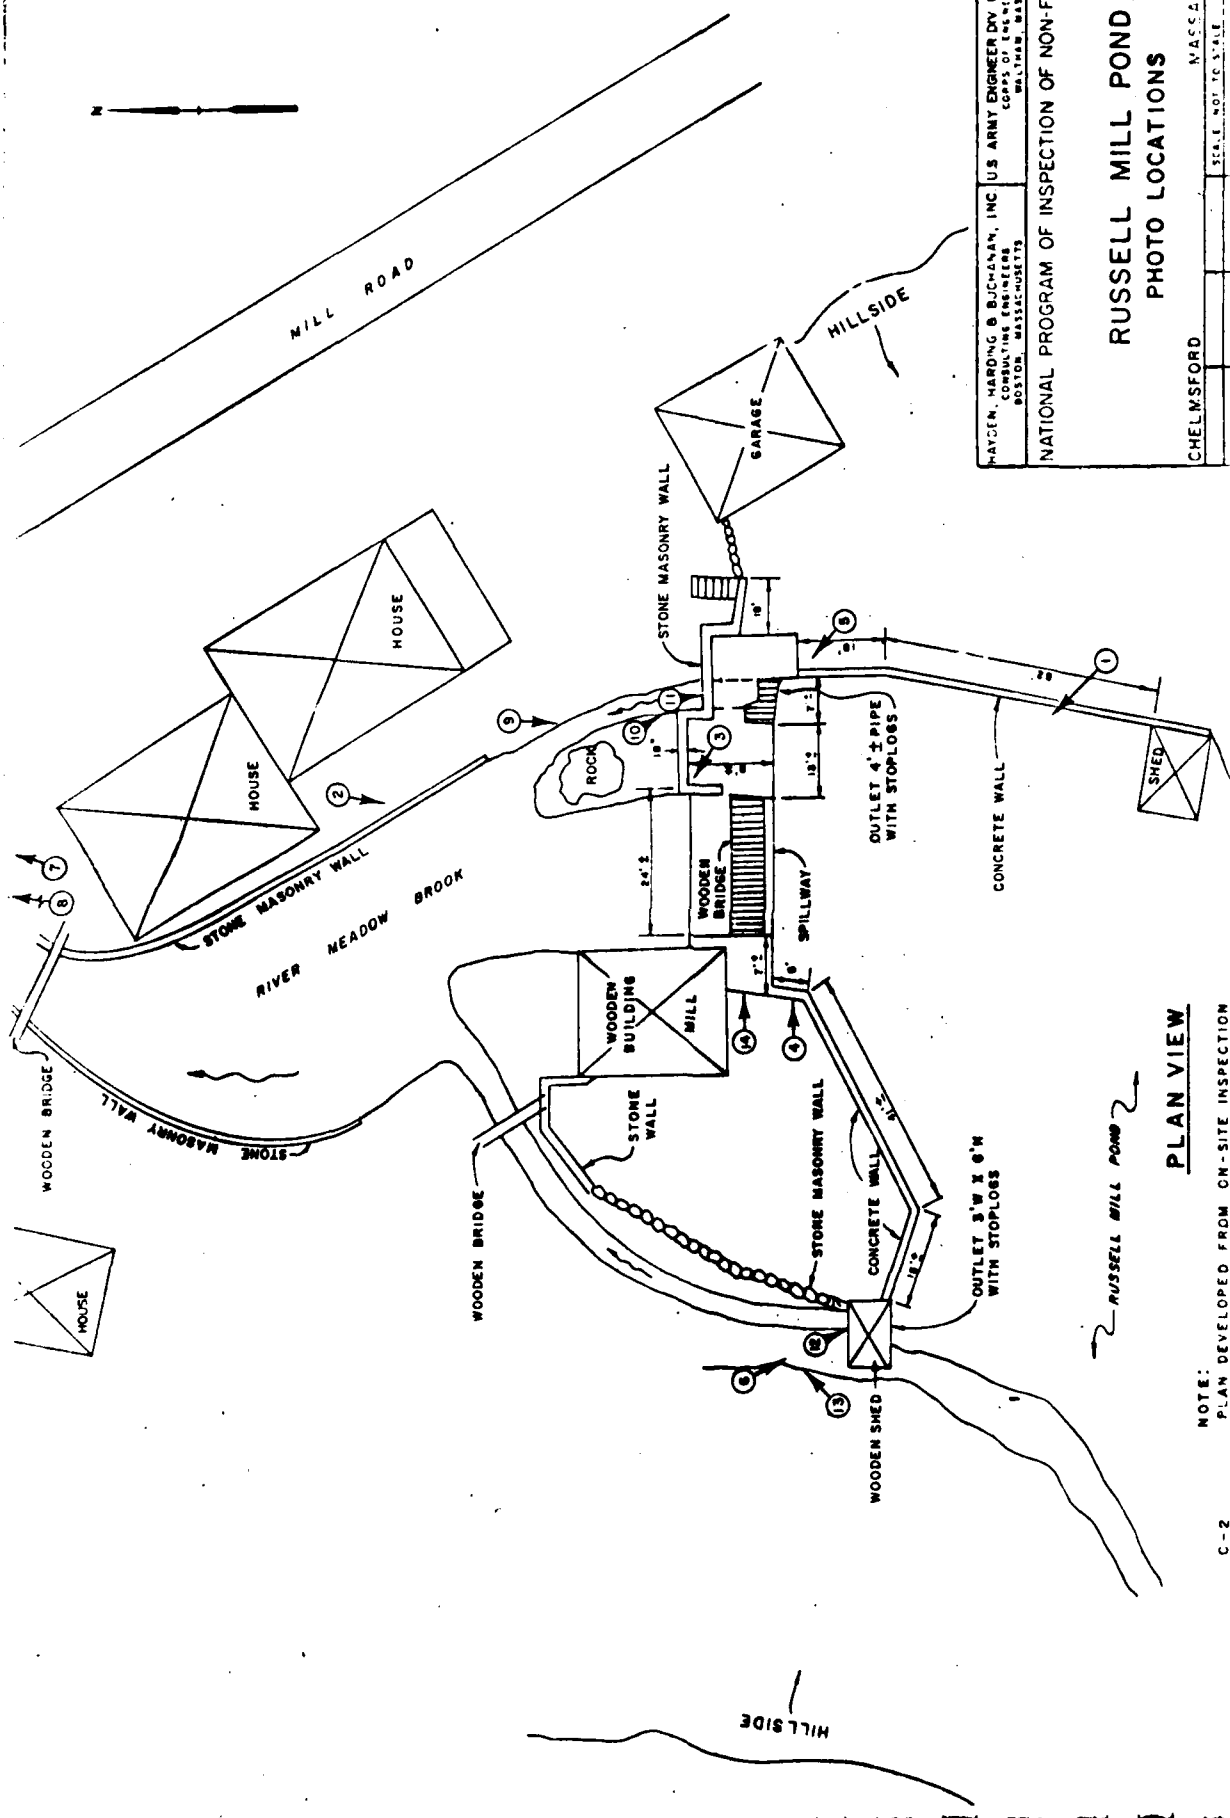
The dam is of irregular composition consisting of stone and earth embankments, 2 outlet sluiceways, a spillway and several stone masonry wall sections, photograph 1, Appendix C. The dam has a height of approximately 11 feet and an overall length of about 120 feet. The spillway is 24+ feet long, having an 18 inch upstream concrete sill, a wood deck foot bridge and a stone masonry downstream face. It is divided into three bays with provisions for 8+ inches of flashboards. Without flashboards, the spillway has a 1'-2" freeboard. The right sluiceway, photograph 5, has an upstream slotted opening with provisions for stoplogs. The sluice opening outlets into a 4 foot diameter pipe which discharges at the downstream face as shown at left side of photograph 2. The left sluiceway, photograph 6, has a 3 foot long by 6 foot high opening. During the field inspection, there were 3'-3" of wood stoplogs in place to keep the pond at its normal level of elevation 124+. There is a small

wooden frame structure located atop this sluiceway, photograph 6. Between the left sluiceway and the spillway is a 60+ foot long wall. Downstream of this wall there is a variable width earth embankment (or natural ground) having a vertical stone masonry wall on the downstream face, photographs 1, 4 and 6.

PHOTO NO. 1 - View of upstream face of Dam. Shown are the spillway, the 3 x 6 foot sluiceway below the small wood shed at the far left of the spillway, and the 4 foot pipe sluiceway to the right of the spillway, below the wood deck area. Beyond the spillway is the outlet channel area of Photo No. 3.
