**MILL POND RESERVOIR NORTH DIKE
MA 01122**

**MILL POND RESERVOIR SOUTH DIKE
MA 01123**

**PHASE I INSPECTION REPORT
NATIONAL DAM INSPECTION PROGRAM**

JANUARY 1980

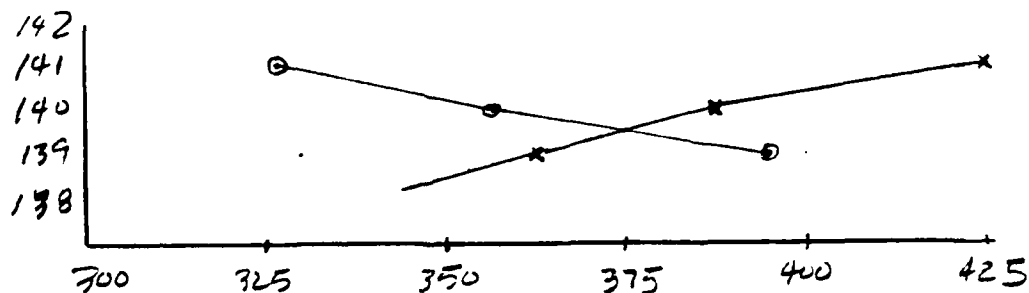
Maximum depth of water in So. dike inlet valley at elev $139.5 \pm$ due to a failure of the So. dike.
 Impact of failure: 11 homes, 2 roads, school play field.
