CONNECTICUT RIVER BASIN
AGAWAM, MASSACHUSETTS

**PROVIN MOUNTAIN RESERVOIR
MA 00528**

**PHASE I INSPECTION REPORT
NATIONAL DAM INSPECTION PROGRAM**

JUNE 1981

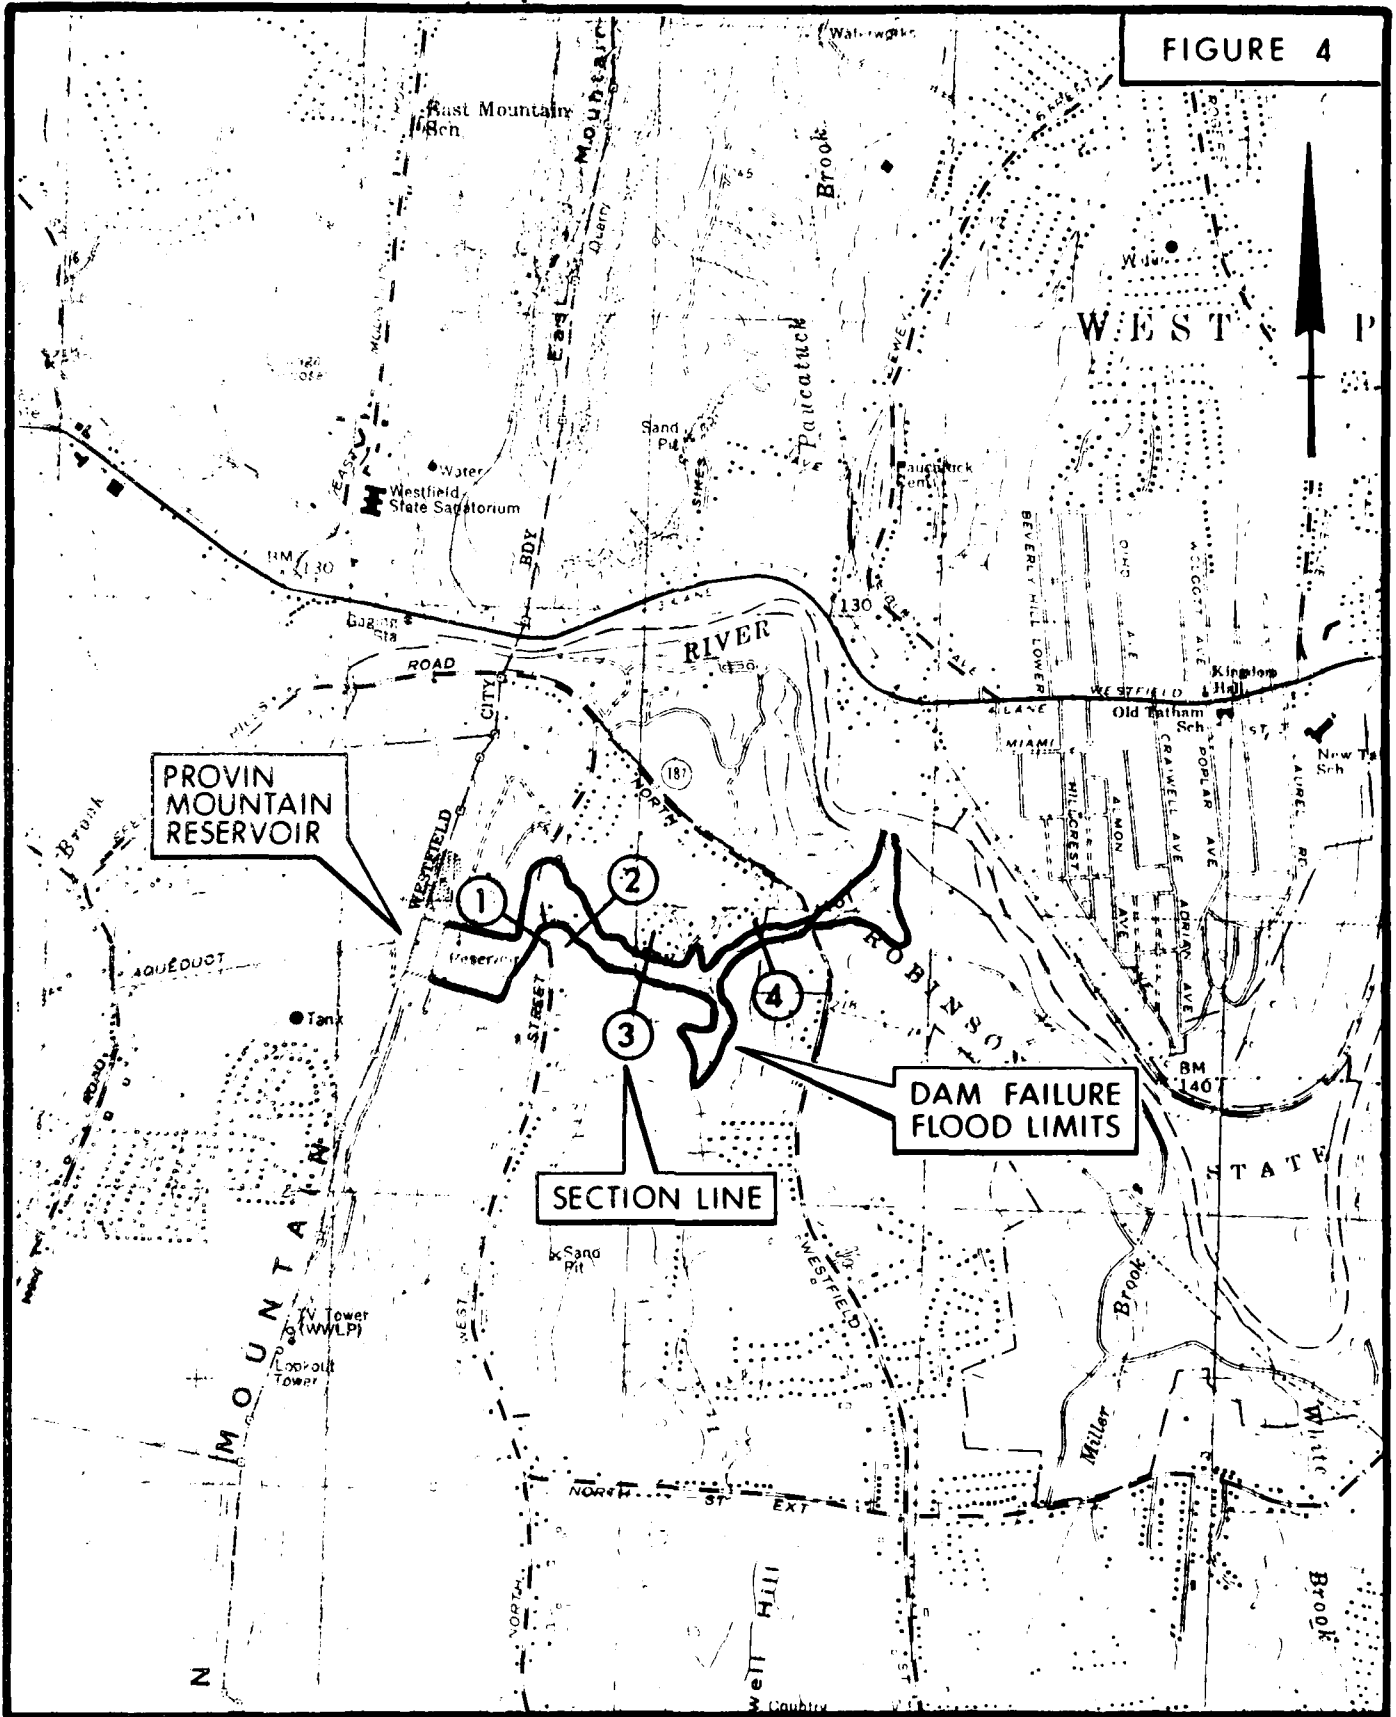
FIGURE 4

DAM FAILURE FLOOD LIMITS

Rupture of the dams for Piccola Mountain Reservoir will cause flooding downstream (east of the reservoir) with flow depths in the channel generally averaging 10 to 15 ft. Extreme damage (including possible loss of life) will occur to two buildings at the reservoir site and at least two residential structures. In addition, North West St. and North Westfield St. would both be overtopped before the failure outflow would be attenuated by the Westfield River. The hazard potential, therefore, is High.

Based upon the results of the downstream failure analysis, the failure outflow would overtop North West Street by 8 to 9 ft., would cause flow depths of 5 to 10 ft. at at least two residential structures, and would overtop North Westfield St. by approximately 10 ft. Also, at least one building on the reservoir would receive damage due to the street flow and several homes adjacent to the stream may receive 1 to 2 ft. of water. The sill elevations of the two dams are approximately 200 and 205, the expected post failure water surface elevation is approximately 210 at the houses.

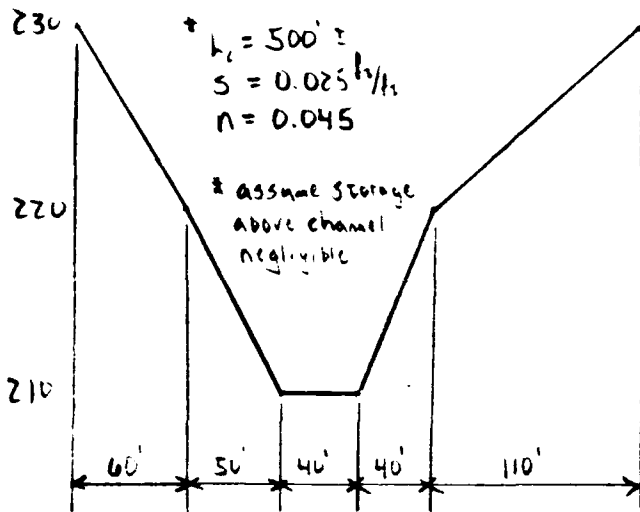
① Section 1200' ± downstream of reservoir (from ASGS) $\frac{1'' = 100' \text{ Horiz.}}{1'' = 10' \text{ Vert.}}$

Following the rupture of the tanks, the failure outflow would travel eastward down the mountain as sheet flow, most likely inundating and doing severe damage to the access road and two buildings, for approximately 800 ft. before reaching a stream channel flowing north.

ELEV.	A (sf)	W (ft.)	R (ft.)	$Q = \frac{1.49}{n} AR^{2/3} S^{1/2}$
215	313	86	3.63	3860 cfs
220	850	132	6.43	15,346 cfs
225	1713	212	7.87	35,387 cfs
230	3000	303	9.84	72,171 cfs

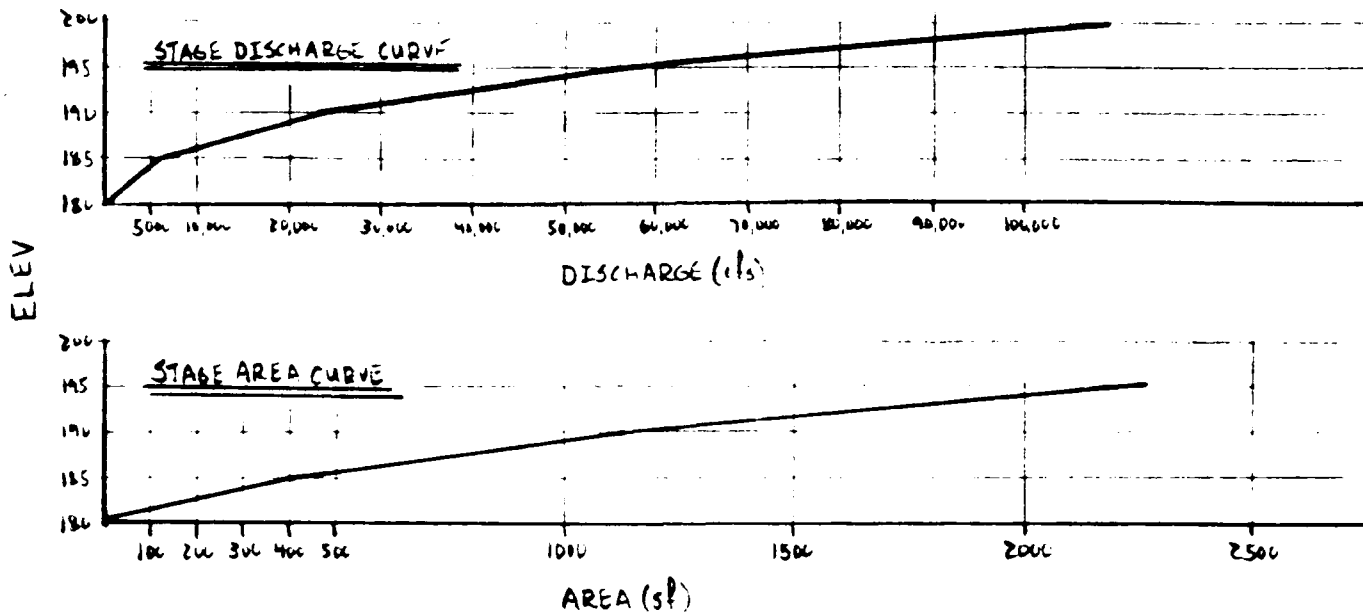
III. Downstream Failure Analysis: cont.

$$\textcircled{c} Q_{P_2} = 55,574 \text{ cfs}$$

$$H = 15.1 \text{ ft} \pm (\text{El. } 195.1 \pm)$$

Assuming a constant water surface slope between the first two sections, the roadway (North West Sec.) would be overtopped by 8 to 9 ft \pm and at least 2 buildings in a residential area would be damaged.

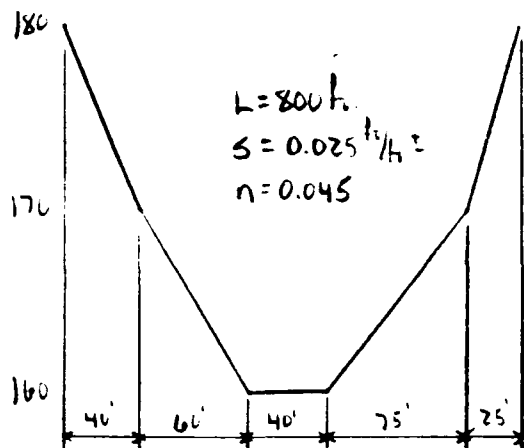
③ Section 2900 ft ± downstream of reservoir (from USGS) $\frac{1'' = 100' H.V.}{1'' = 10' V.H.}$

ELEV.	A (sf)	W (ft)	R (ft.)	$Q = \frac{1.49}{n} AR^{2/3} S^{1/2}$
165	369	108	3.41	4365 cfs
170	1075	176	6.04	18,718 cfs
175	2031	210	9.67	48,132 cfs
180	3150	244	12.9	90,465 cfs

$Q_{P_3} = 41,173 \text{ cfs}$
 $H = 13.8 \text{ ft} \pm (E1.173.8 \pm)$
 $V_1 = \frac{1760 + 1805}{2} \times 800 \times \frac{1}{43500} = 33.0 \text{ Ac. Ft.} < \frac{1}{2} S \therefore \text{Remains OK}$
 TRIAL
 $\therefore Q_{P_{HT}} = Q_{P_3} \left(1 - \frac{V}{S}\right) = 41,173 \left(1 - \frac{33.0}{184}\right) = 33,786 \text{ cfs}$

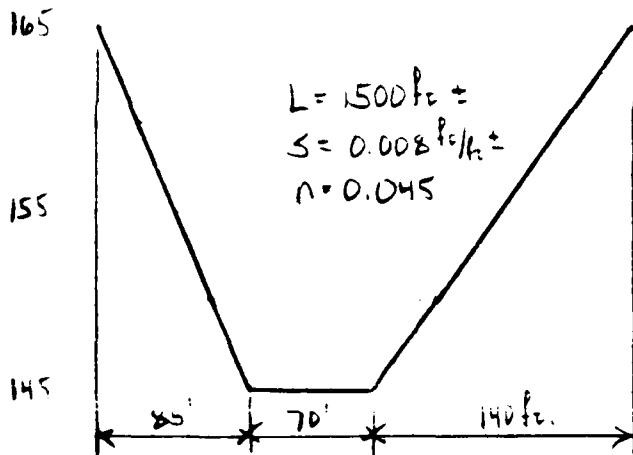
④ Section 4400 ft. \pm downstream of reservoir (from USGS) $\frac{1'' = 100' \text{ Horiz.}}{1'' = 10' \text{ Vert.}}$
 NOTE: Base flow in channel neglected since peak failure outflow is not directly related to rainfall

ELEV.	AREA	WETTED PERIMETER	HYDRAULIC RADIUS	$Q = \frac{1.486}{n} AR^{2/3} S^{1/2}$
150	4915 ^{sf}	126 ft	3.89 ft.	3587 cfs
155	1263	183	6.92	13,546
160	2316	239	9.70	31,113
165	3650	295	12.4	57,755

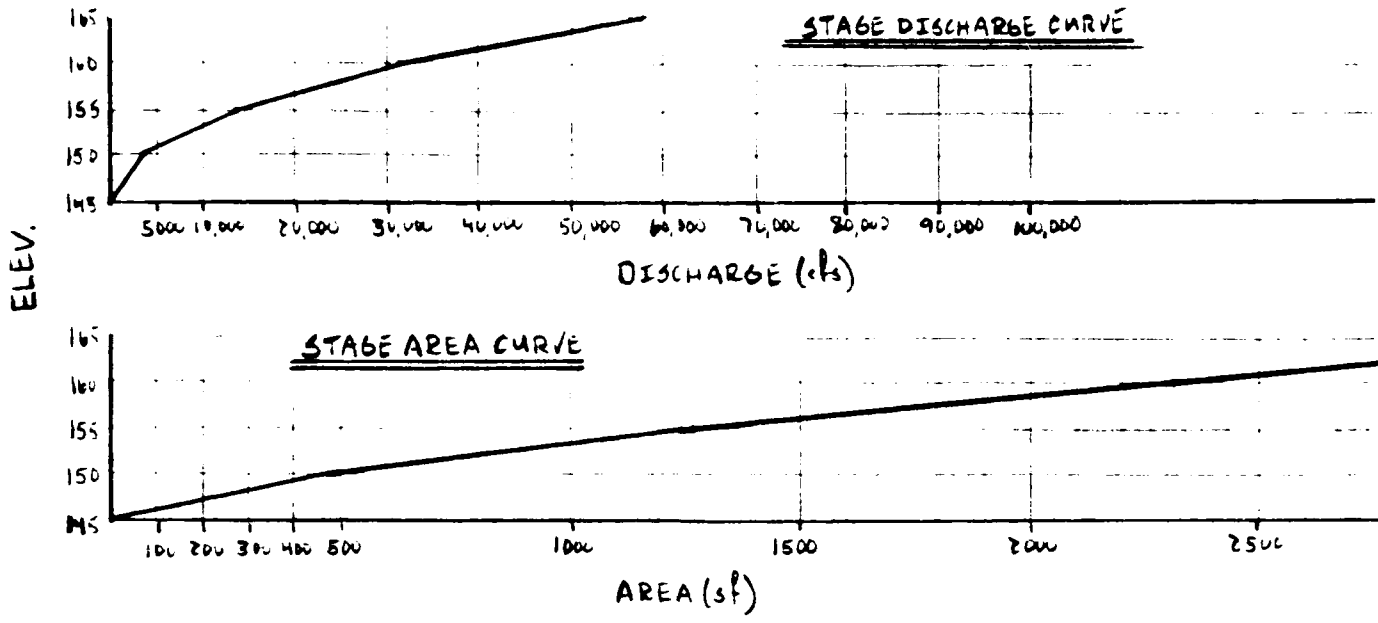
III. Downstream Failure Analysis: cont.

$$\textcircled{a} Q_{P_4} = 34,034 \text{ cfs}$$

$$H = 15.5 \text{ ft.} \pm (\text{El. } 160.5 \pm)$$

At this elevation, North Westfield S. would be overtopped by 4 to 5 ft. due to the peak failure outflow. Approximately 2000 ft. downstream of this section, the flow would be attenuated by Dr. Westfield River.
