BLACKSTONE RIVER BASIN
GRAFTON, MASSACHUSETTS

FISHERVILLE POND DAM
MA 00577

PHASE I INSPECTION REPORT NATIONAL DAM INSPECTION PROGRAM

OCTOBER 1978

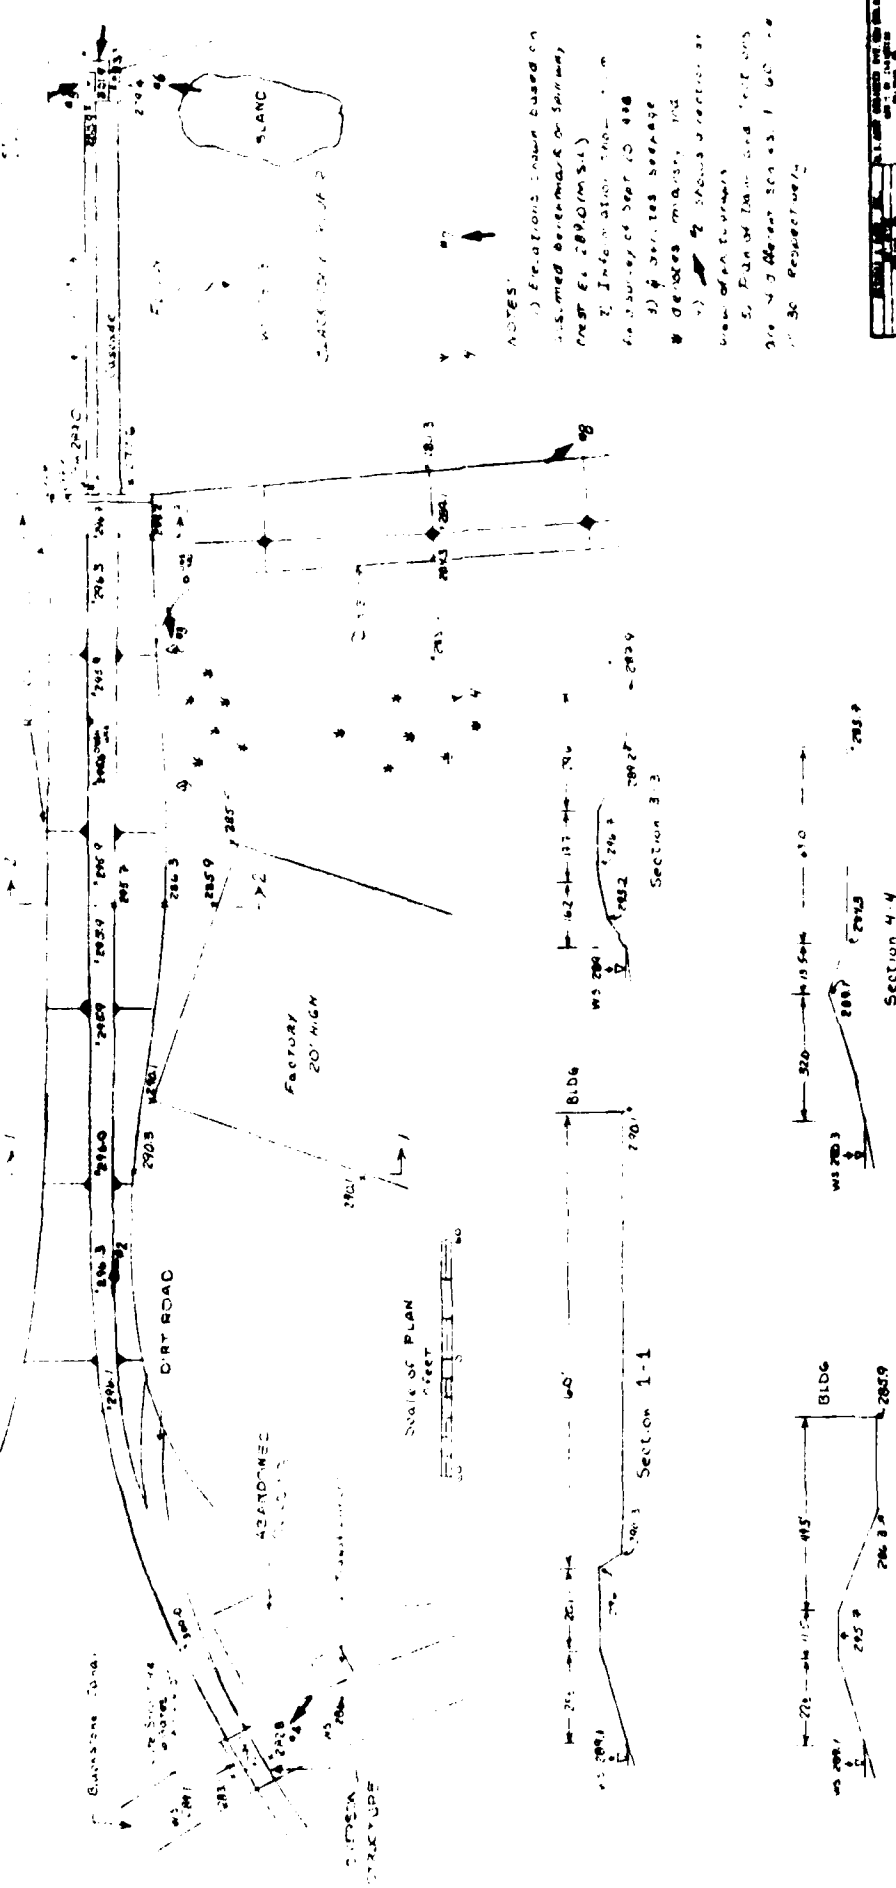
NATIONAL PROGRAM OF INSPECTION OF DAMS	
FISHERVILLE POND DAM	
FIGURE 8-1 PLAN OF DAM AND SECTIONS	
PROJECT NO.	100-10000-1000
DATE OF DRAWING	APRIL 1938

NOTES:
 1) Elevations shown based on assumed benchmark on Summit West of 2800 (M.S.L.)
 2) Information from survey of Sept 10, 1938
 3) 4' vertical scale
 4) Details in 1/4" = 1' scale
 5) Shows structure as seen from East
 6) Elevation of Dam crest 285.3
 7) 4' vertical scale
 8) 1/4" = 1' scale
