CONNECTICUT RIVER BASIN
WARE, MASSACHUSETTS

WINSOR DAM MA 00588
QUABBIN SPILLWAY MA 00589
GOODNOUGH DIKE MA 00590

PHASE I INSPECTION REPORT
NATIONAL DAM INSPECTION PROGRAM

SEPTEMBER 1978

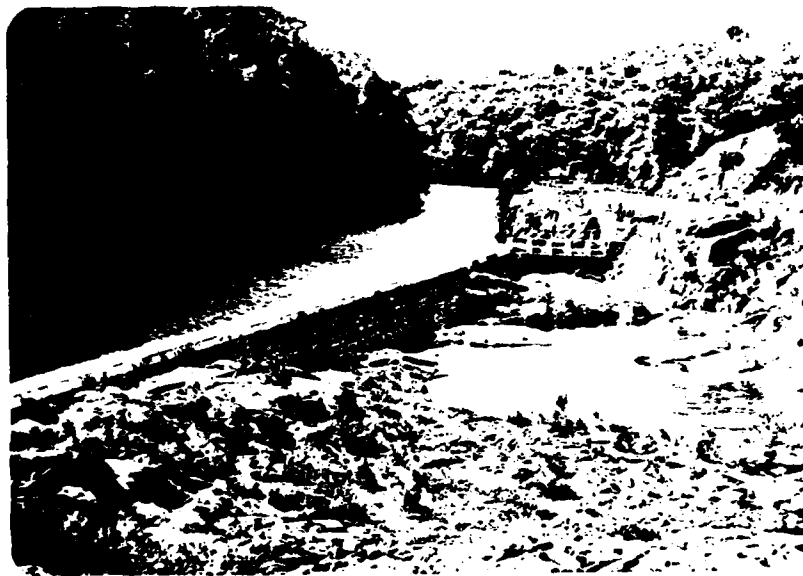
Overview Photo of Quabbin Spillway

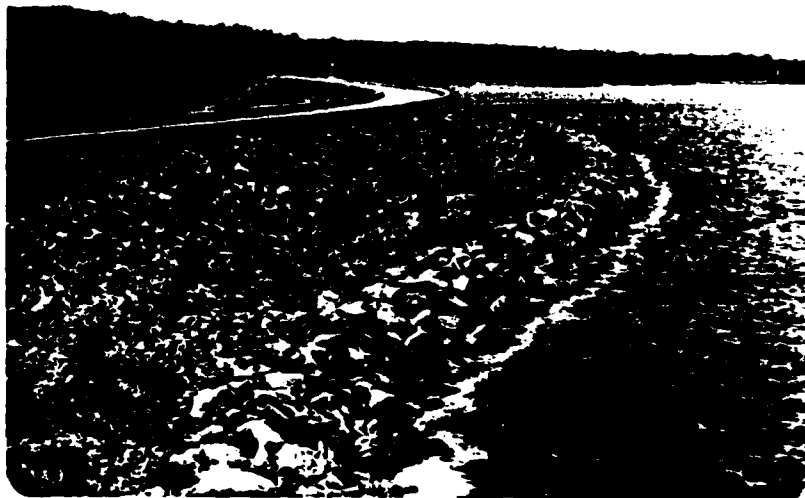
3. Roadway Crest and Downstream Slope, From Right Abutment

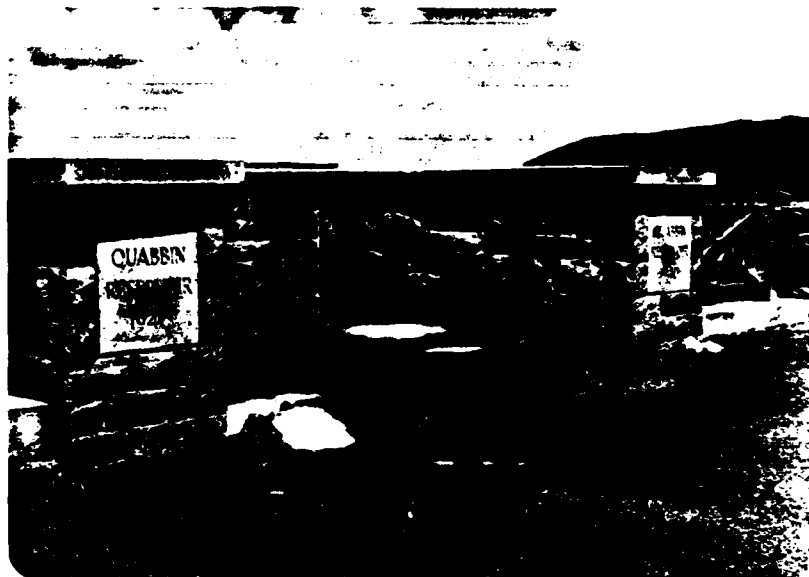
6. Entrance to Intake Structure, at Crest of Dam

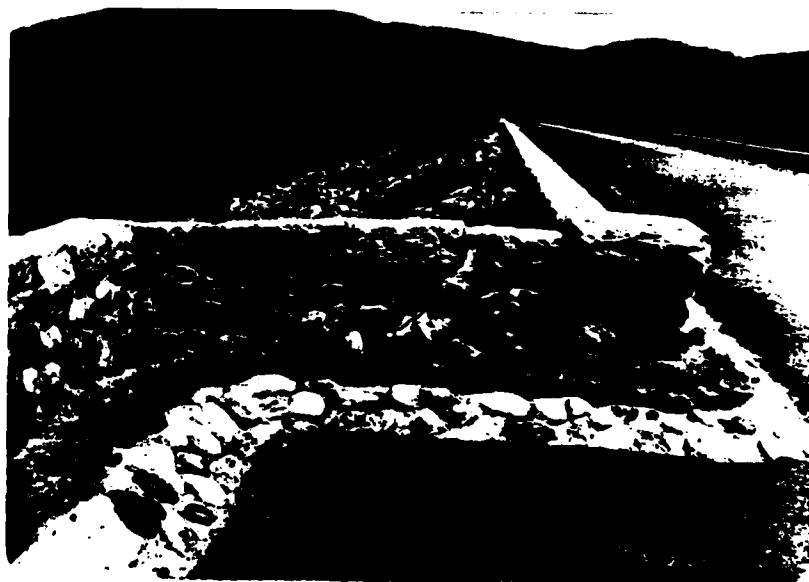
7. Stone Masonry Walls at Roof Level, Intake Structure

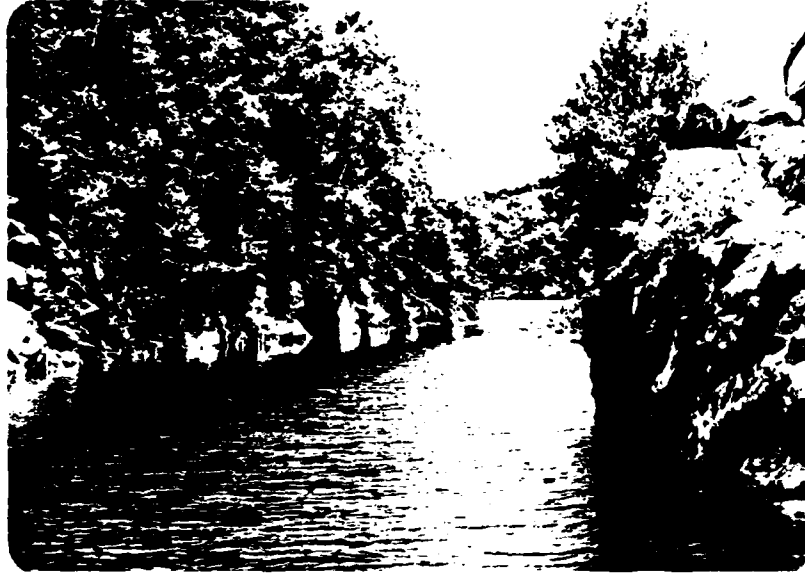
20. Side Spillway and Walkway

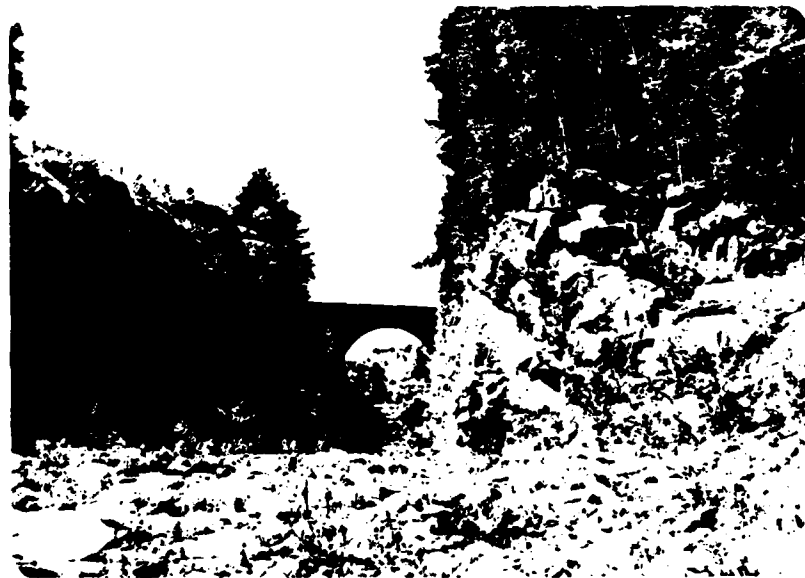
21. Approach Channel to Spillway

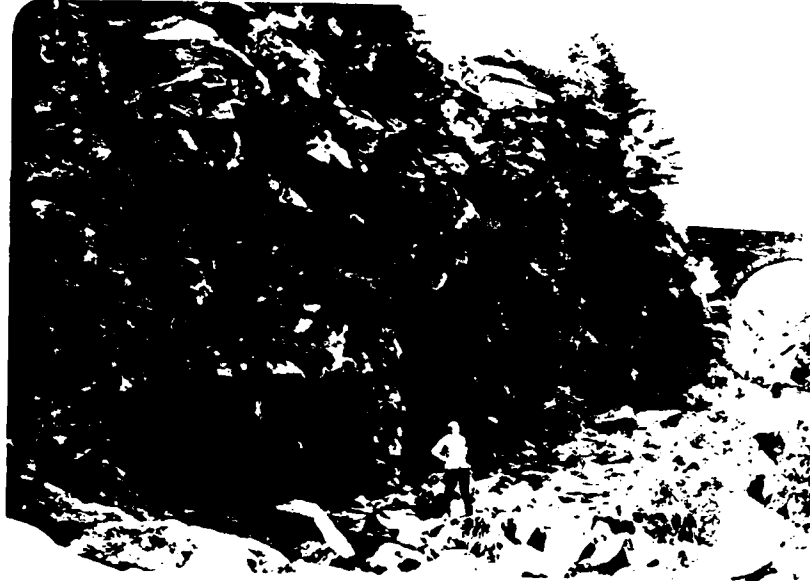
22. Discharge Channel From Spillway

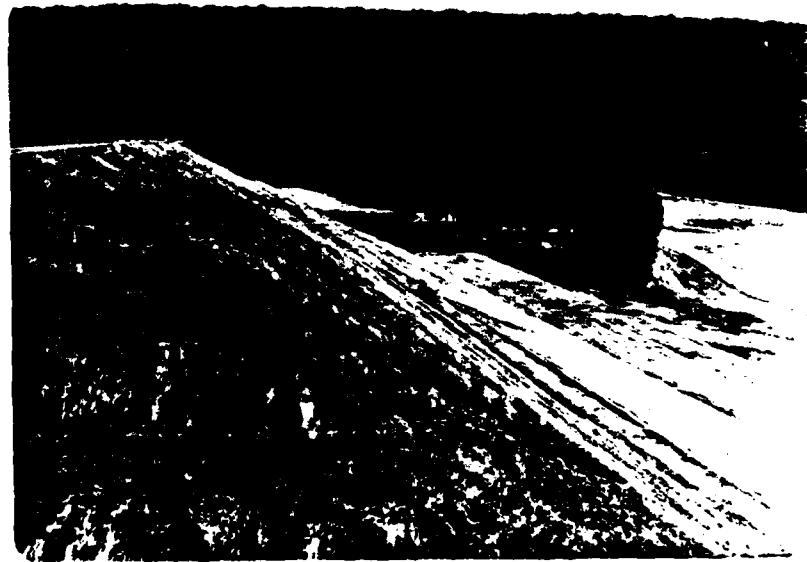
27. Roadway Across Embankment

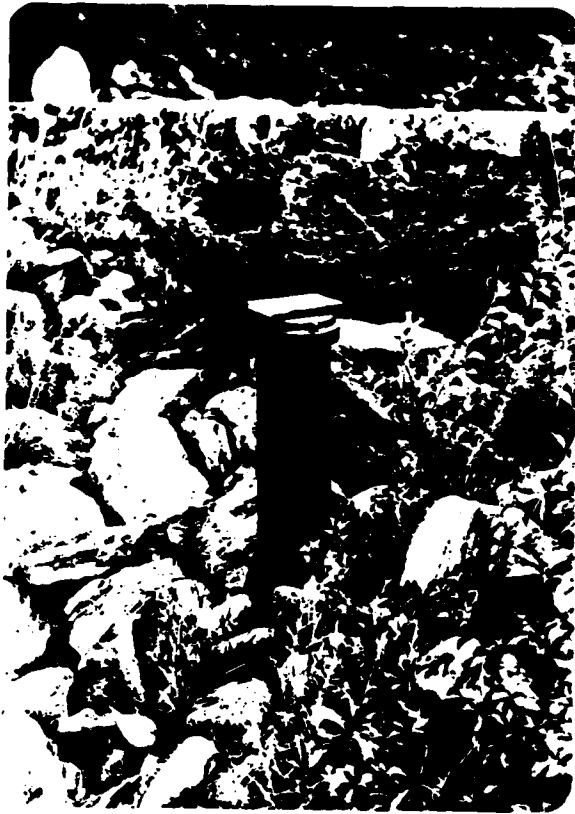
32. Upstream Slope
