MERRIMACK RIVER BASIN
CLINTON, MASSACHUSETTS

LANCASTER MILLPOND DAM
MA 00887

PHASE I INSPECTION REPORT
NATIONAL DAM INSPECTION PROGRAM

JUNE, 1981

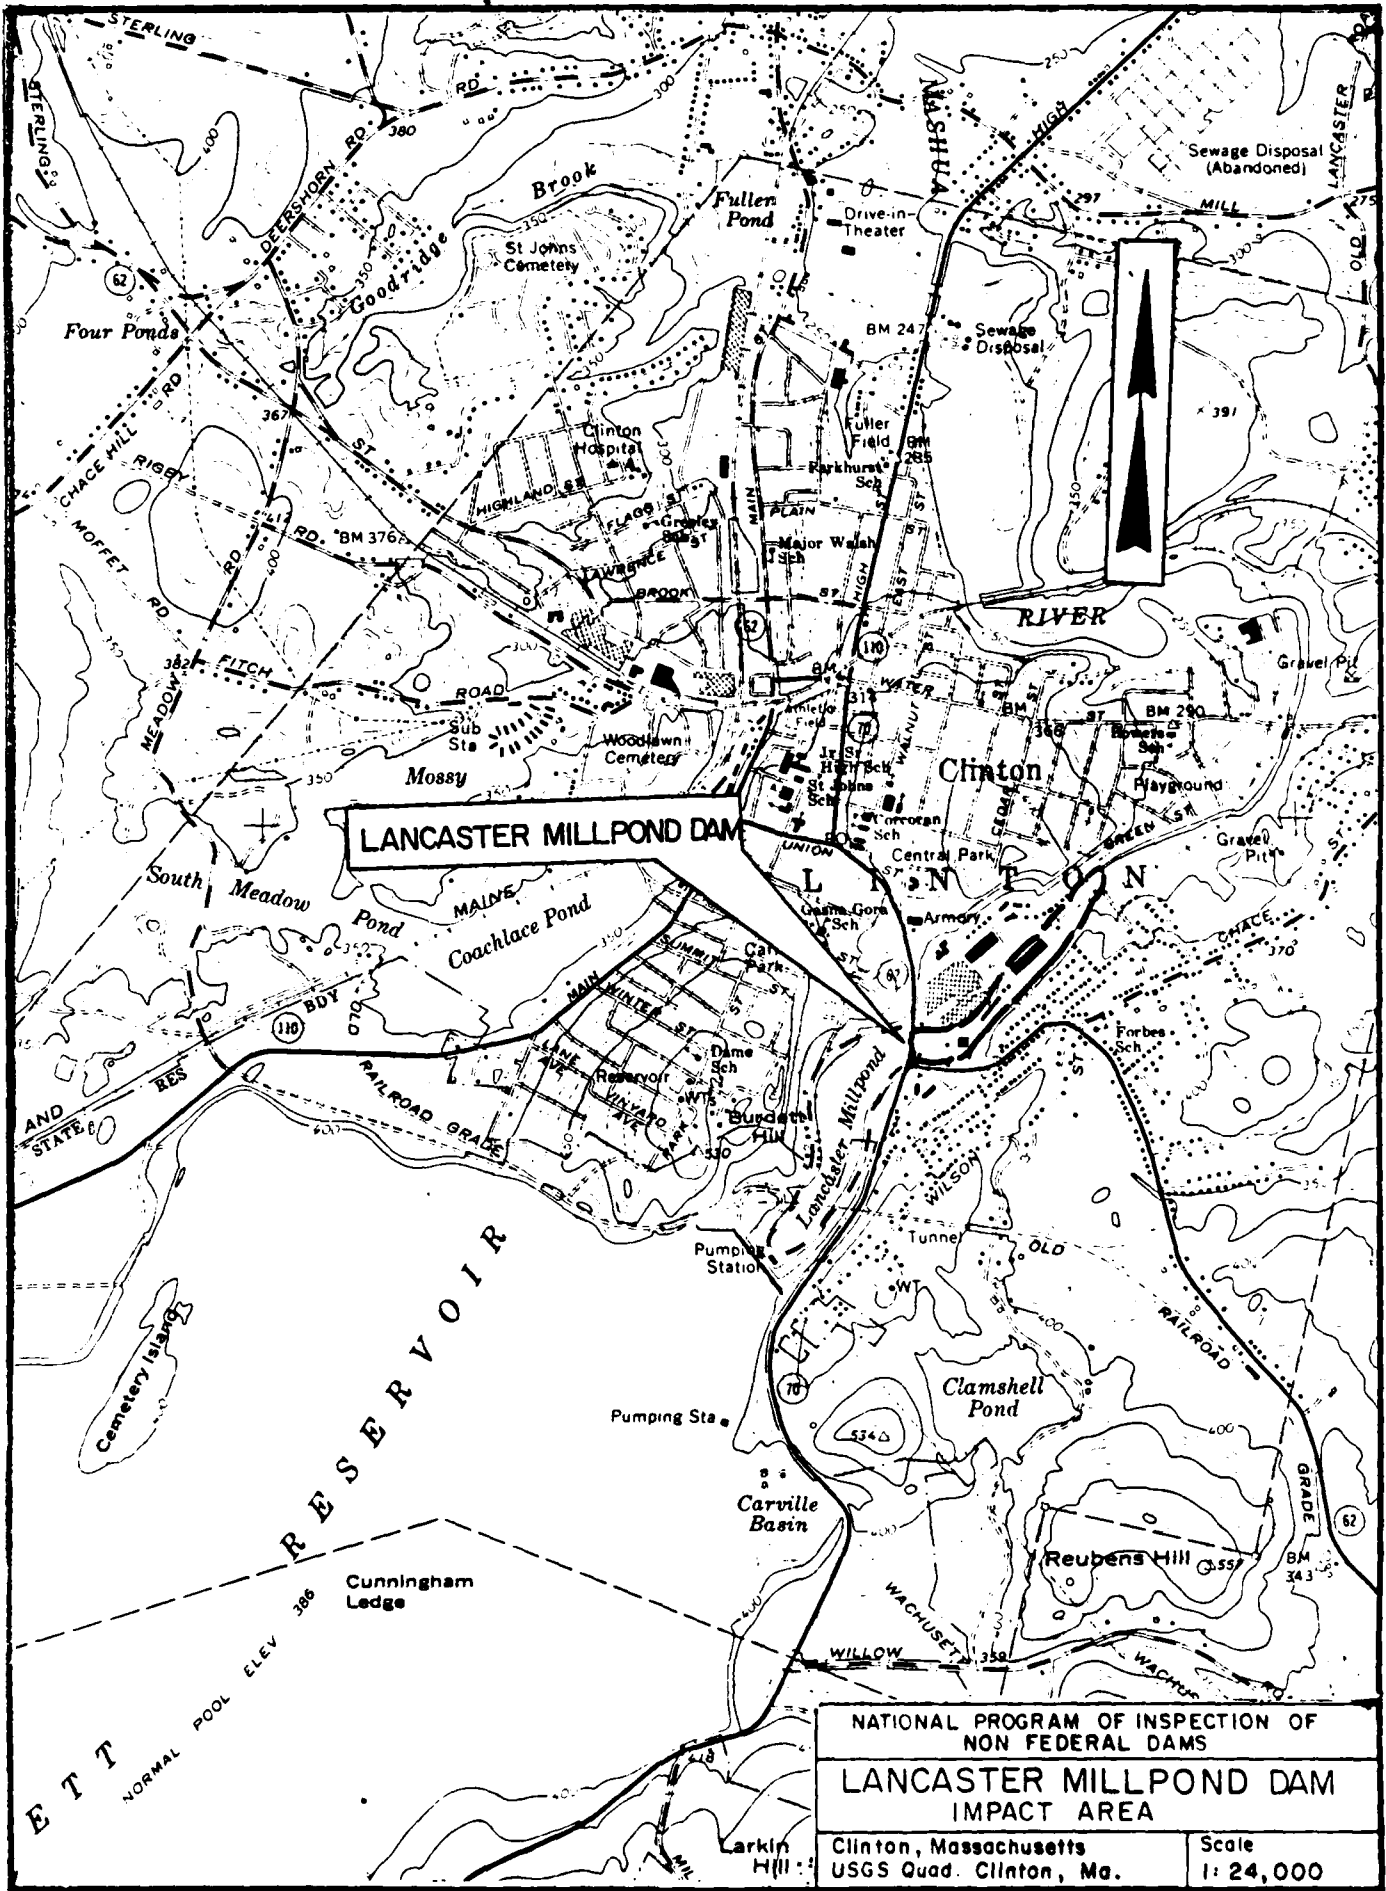
TEST FLOOD ANALYSIS

At $Q = 14800 \text{ cfs}$, stage = 12.7 ft. Water would rise to within about 1.3 feet of the top of Routes 62-70. The drop spillway would be subject to much turbulence due to pressure flow occurring under Rtes. 62-70, located only about 20 feet upstream of the dam. Therefore, although the spillway itself would be overtopped by somewhat less than 12.7 feet, serious damage to the spillway could result.
