MERRIMACK RIVER BASIN
WESTMINSTER, MASSACHUSETTS

MEETINGHOUSE POND DAM
MA 01018

PHASE I INSPECTION REPORT
NATIONAL DAM INSPECTION PROGRAM

NOVEMBER 1978

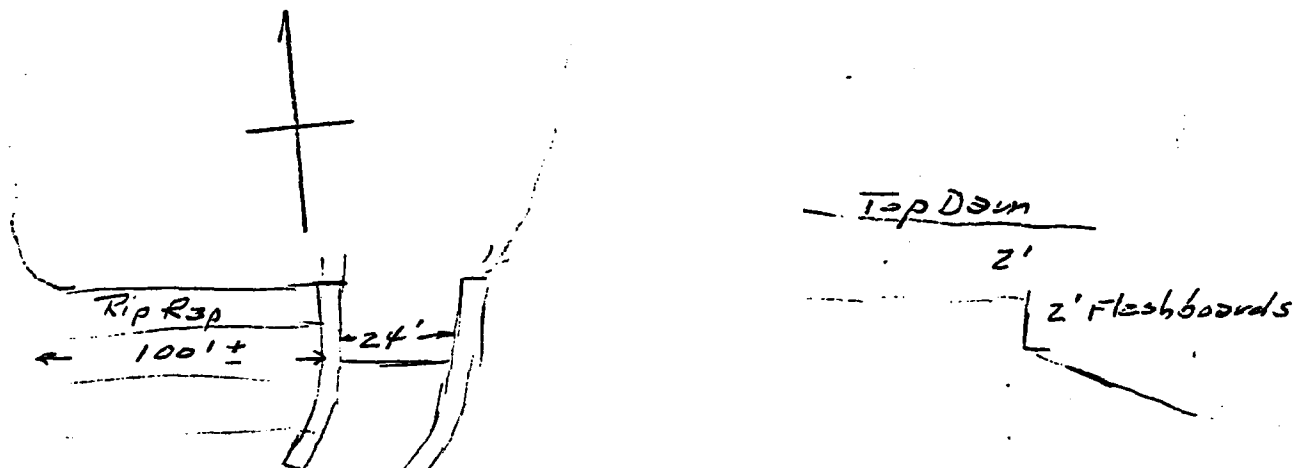
Sketch (Not to Scale):

Rip rapped earth dam with gunited stone spillway 24' wide
 3" of boards in place + stone walls are 2' additional feet higher
 No gate at this location

* Brush on dam should be cut
