PENOBSCOT RIVER BASIN
BUCKSPORT, MAINE
SILVER LAKE DAM
ME 00147

PHASE I INSPECTION REPORT
NATIONAL DAM INSPECTION PROGRAM

OCTOBER 1978

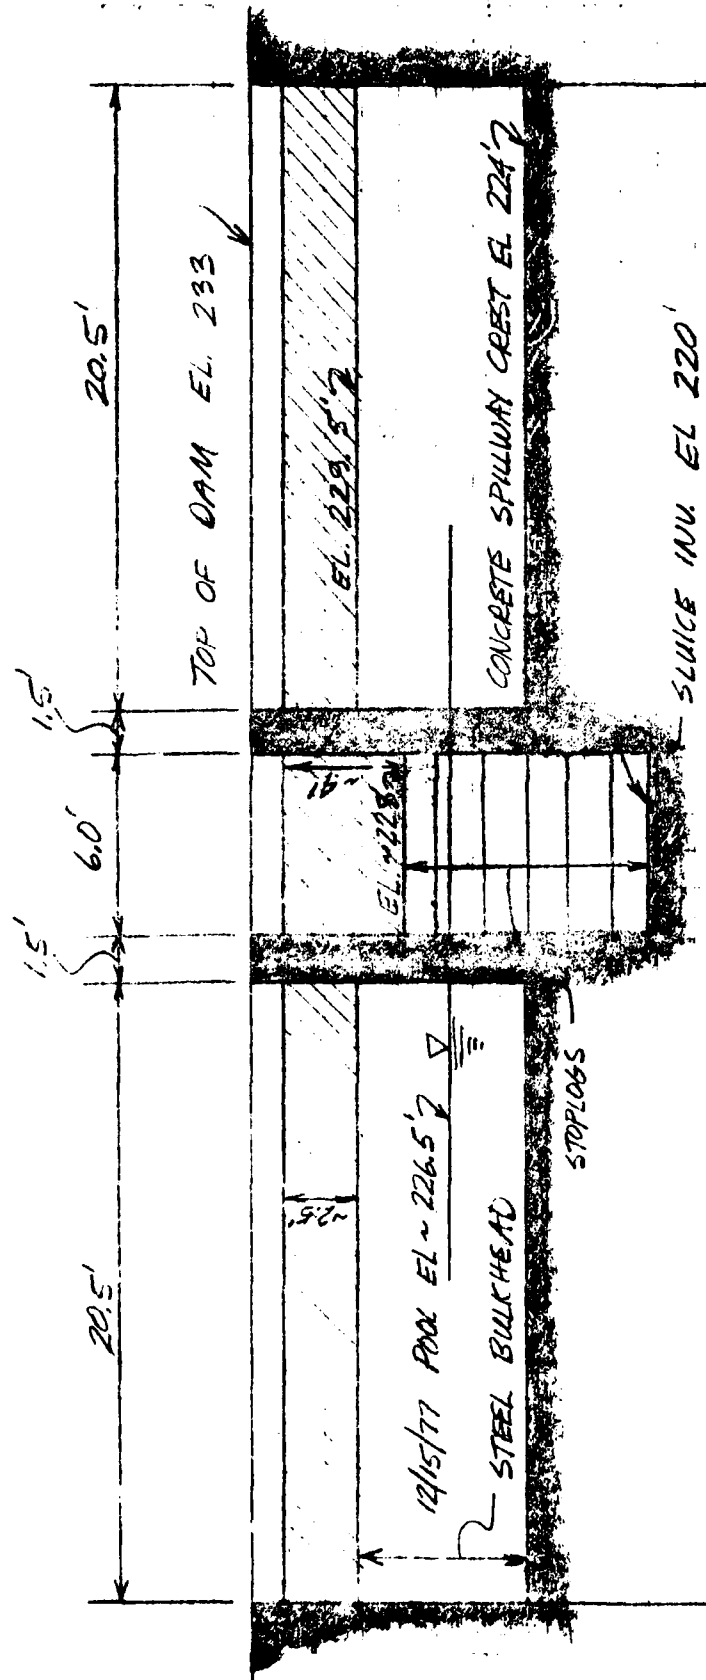
FIG. 1

Area available for spillway
discharge to be overtopping
occurs to shaded area

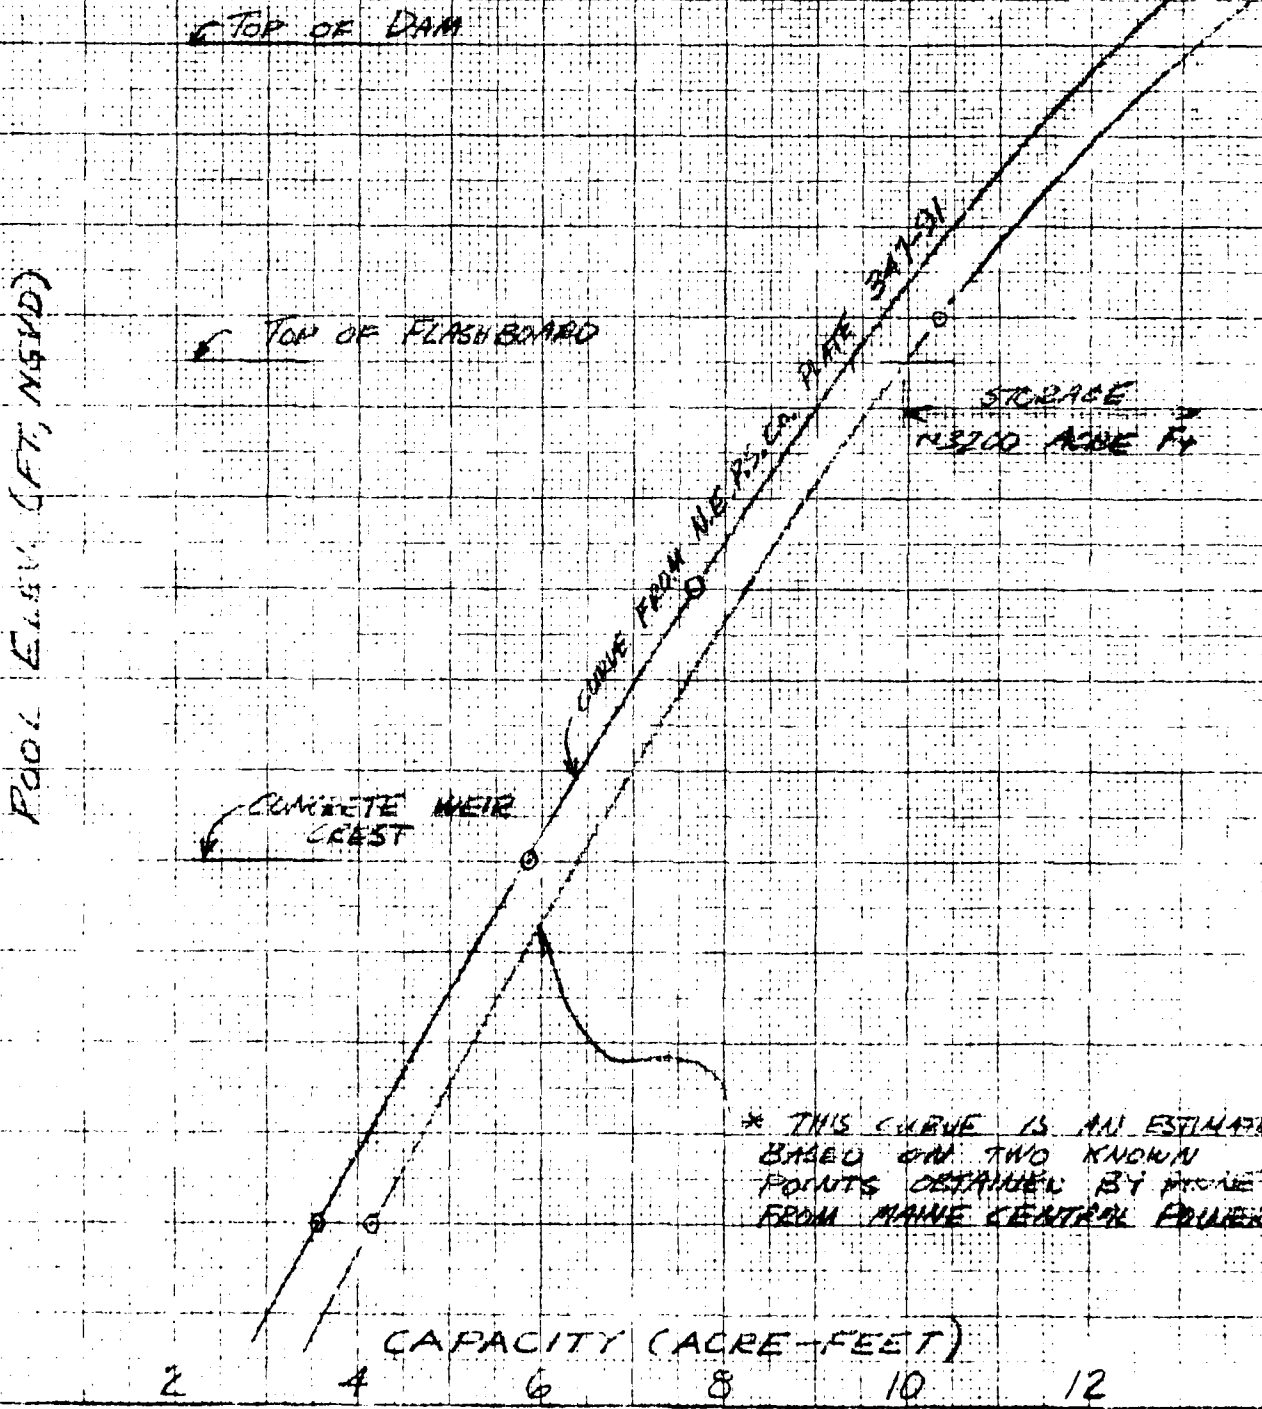
FIG. 3

b. Design Data. The dam was designed by the New England Public Service Company which has now been absorbed by the Maine Central Power Company. The only hydraulic design data available is a stage-capacity curve which is included as Fig. 3 of Appendix D.

RES. STORAGE $S = 13,100$ AF (SEE FIG. 3)

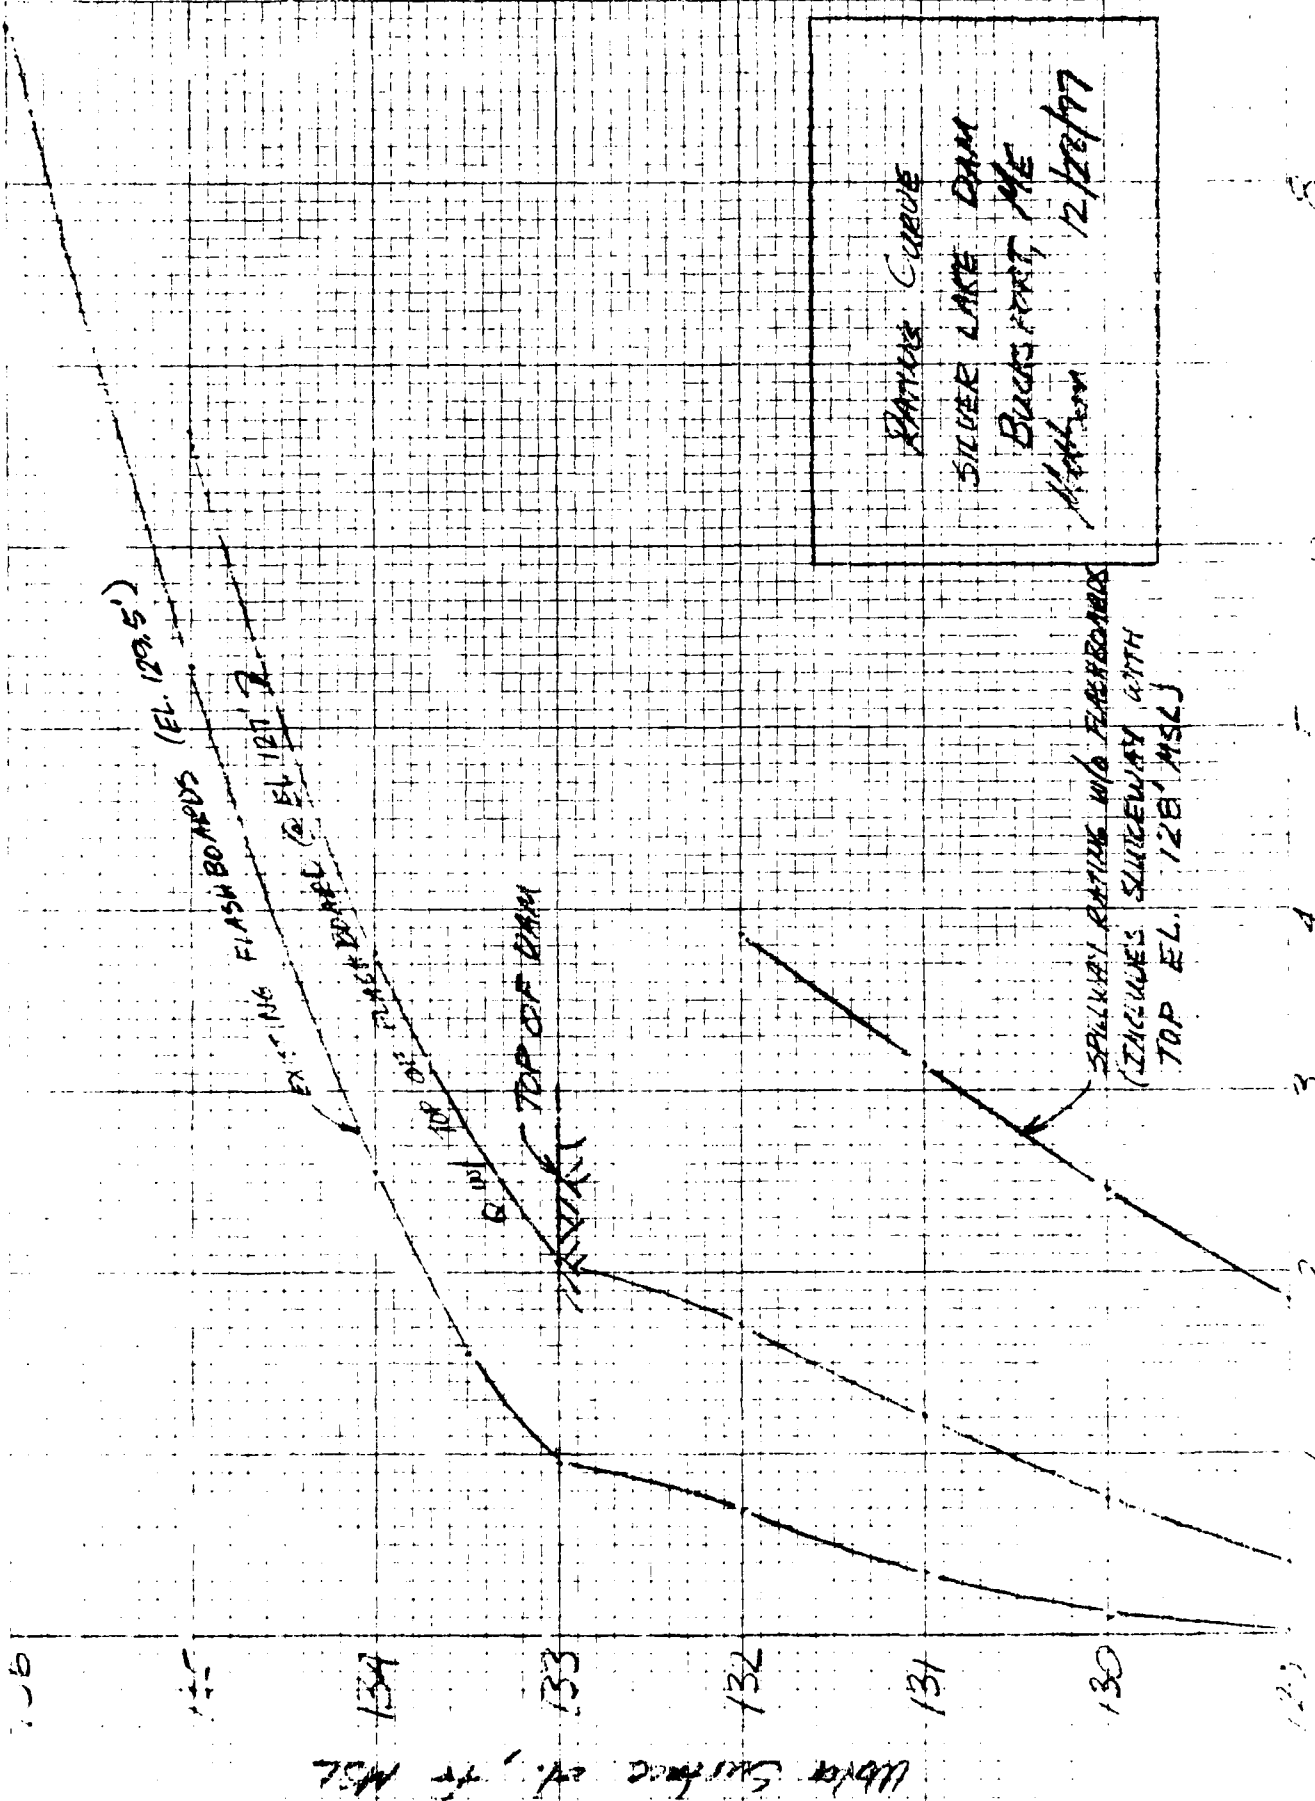
FIG 4

A check on Fig. 4 shows $Q_{allow} \approx 1600 \checkmark \text{ CFS}$ ∴ OK
