COLTON POND DAM

VT 00114

PHASE I INSPECTION REPORT NATIONAL DAM INSPECTION PROGRAM

OCTOBER 1979

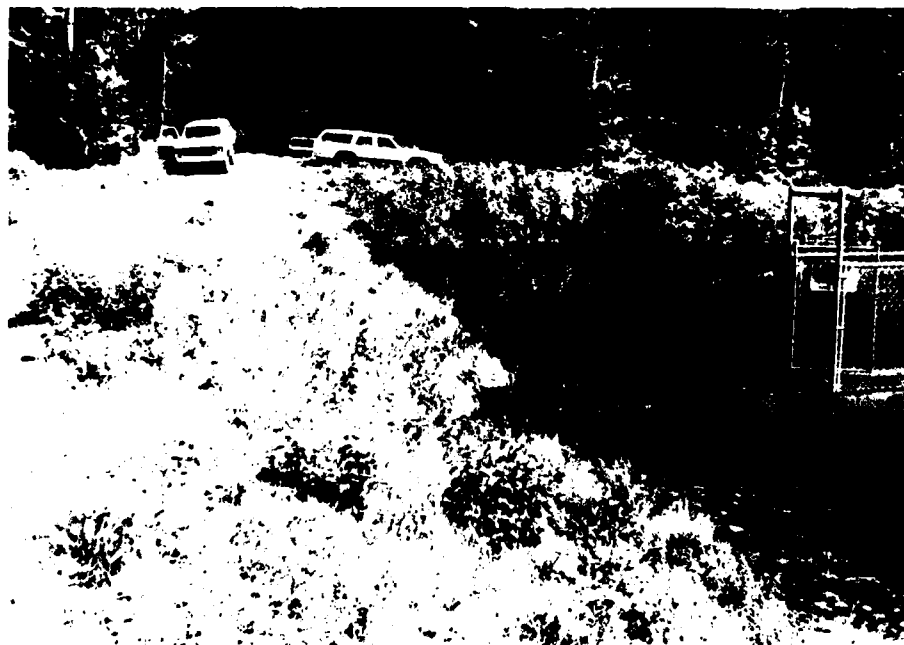
PHOTO NO. 5 - View of right abutment from center of dam.

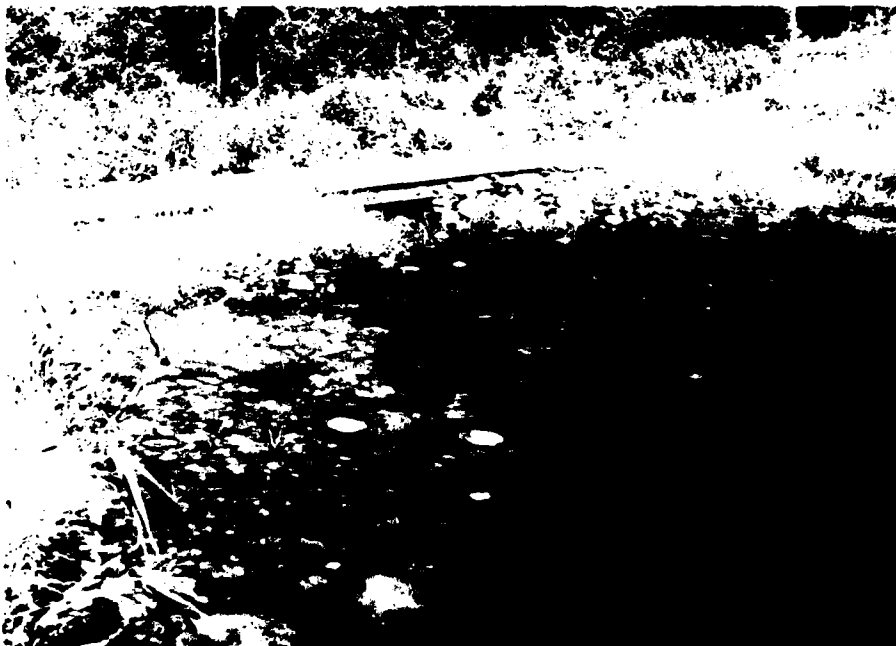
The 50 foot wide emergency spillway is an earth excavation on the left abutment. A 2 foot wide concrete wall extends across the spillway as shown in Photo No. 10. The approach channel to the spillway, shown in Photo No. 9 is paved with riprap. The channel downstream of the concrete wall is paved with large riprap shown in Photos No. 16 & 17. Small brush is growing in the spillway. Photo No. 16 shows an area on the left slope of the emergency spillway discharge channel which was eroded during the flood of 1973. The Photo shows the displaced riprap due to this erosion.

PHOTO NO. 9 - View of emergency spillway crest from shoreline upstream of left abutment.

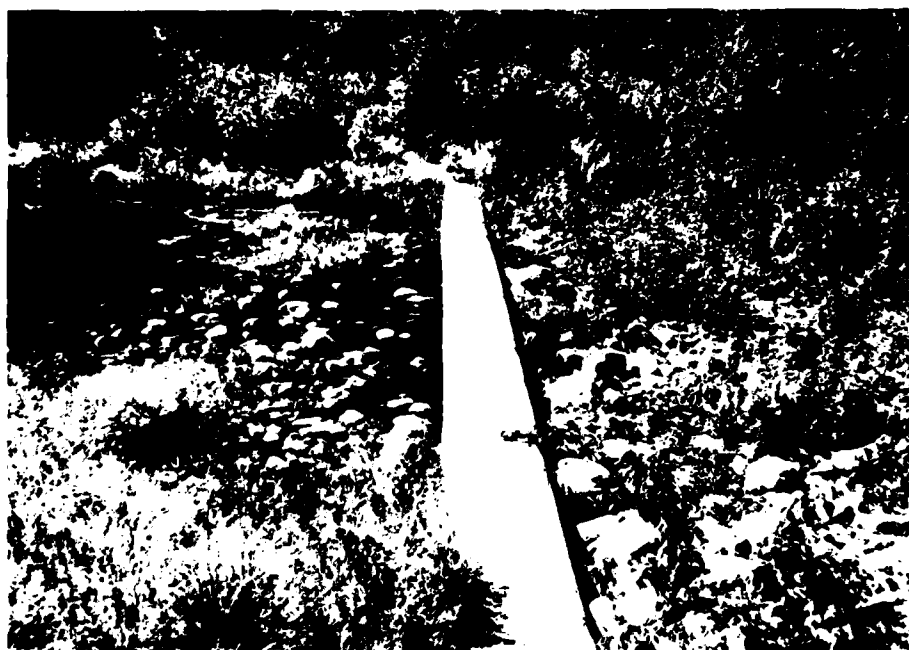
PHOTO NO. 11 - Emergency spillway crest as viewed from right
end of spillway.

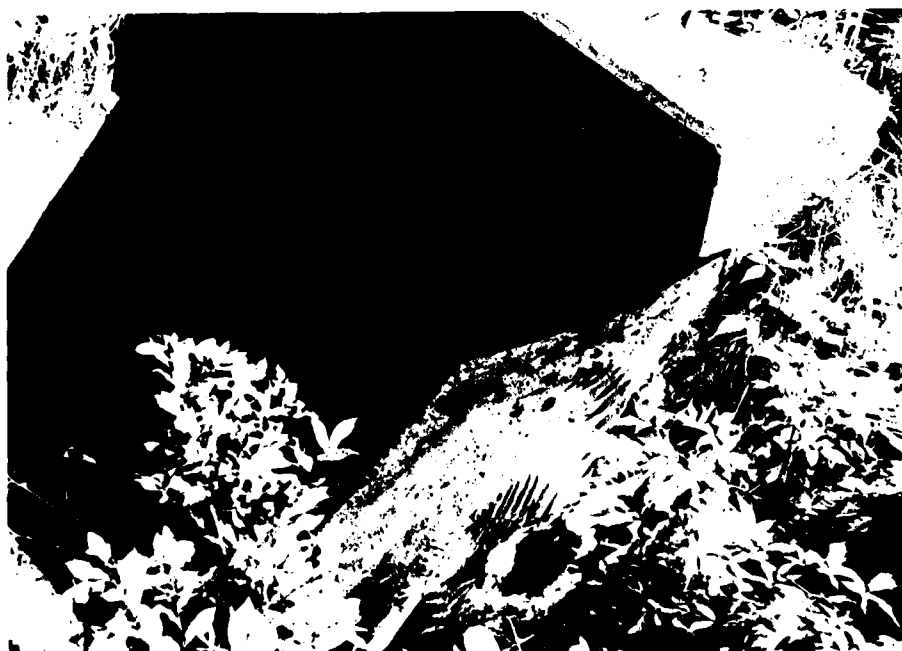
PHOTO NO. 15 - Detail of outlet structure.
