NATIONAL PROGRAM FOR INSPECTION OF NON-FEDERAL DAMS  
WINDSOR UPPER DAM (VT.) (U) CORPS OF ENGINEERS WALTHAM  
MA NEW ENGLAND DIV SEP 78

WINDSOR UPPER DAM VT 00013

SEPT 1978

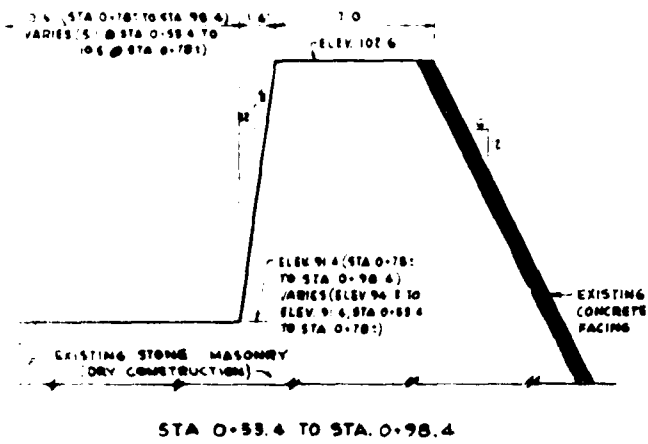
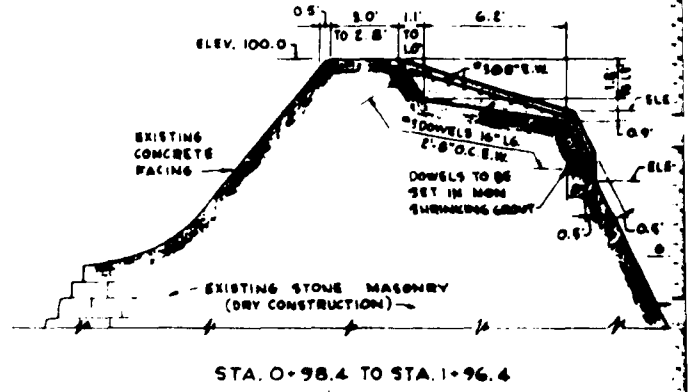
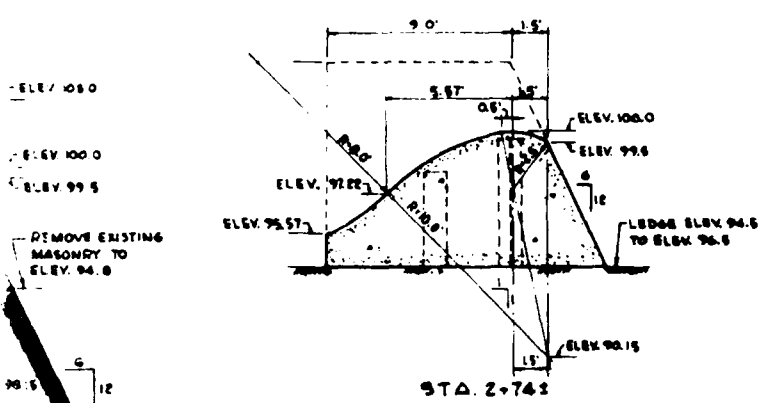
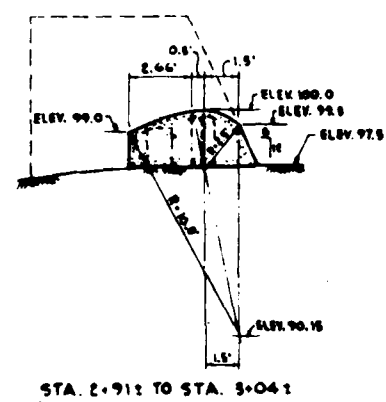
CROSS SECTIONS  
SCALE: 1/4" = 1'-0"

THIS WORK WAS NOT INCLUDED IN THE MODIFICATIONS MADE  
TO THE WINDSOR UPPER DAM IN 1961.

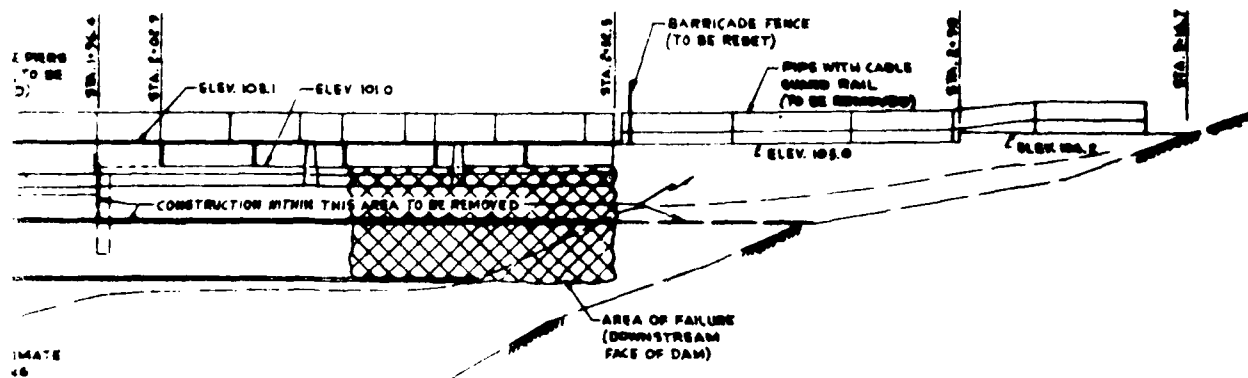
APPROXIMATE LEDGE  
(TAKEN FROM SKETCH BY CENTRAL  
VERMONT PUBLIC SERVICE CORP.  
DATED 11-22-90, SHOWING LEDGE  
ON DOWNSTREAM FACE OF DAM)

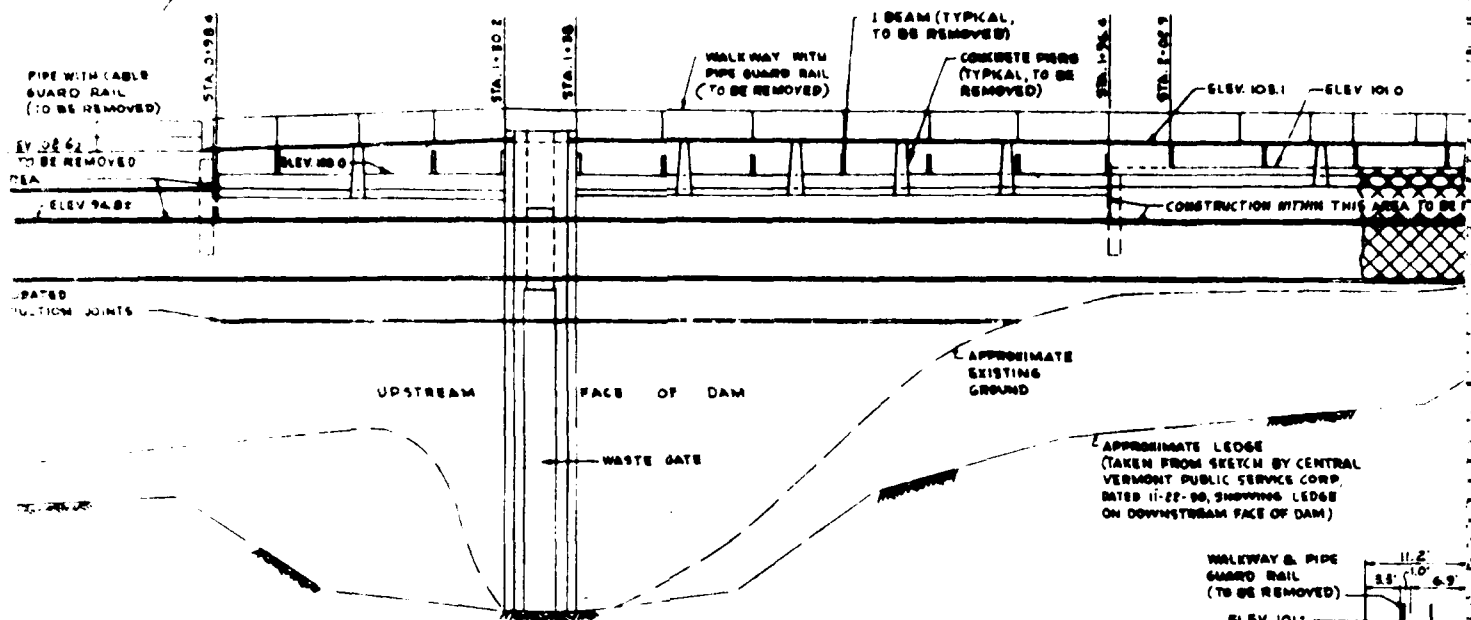
ELEVATION OF UPSTREAM FACE OF DAM  
SCALE: 1" = 10'

- (a) The concrete on the upstream face, piers and crest of the dam is in very poor condition (see photographs 1, 2 and 4).
- (b) The concrete in the primary spillway chute is in fairly good condition, except for the end walls (see photograph 3).
- (c) A section, 15 feet high by 20 feet deep and two to three feet thick, has fallen from the downstream face of the easterly portion of the dam (see photographs 3 and 6).
- (d) The size and condition of the waste gate in the center of the dam and the penstock gate near the left abutment were not determinable. The

- (a) No water should be impounded by the structure in its present state.
- (b) At the point of the existing failure near the east auxiliary spillway, all rock and concrete masonry should be removed from the bottom of the failure to the top of dam for the width of the gap. This will permit the spring runoff to flow freely through the gap, and greatly reduce the hazard of structural failure resulting from water impounded by the limited capacity of the gated outlets.

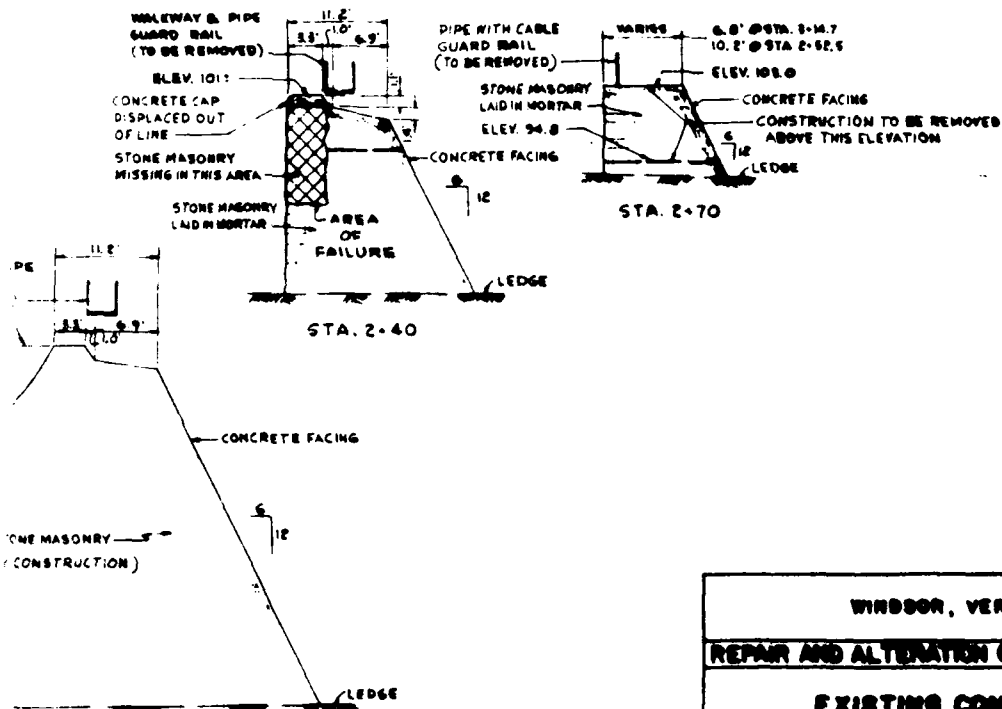
WINDSOR, VERMONT			
REPAIR AND ALTERATION OF MILL POND DAM			
EXISTING CONDITIONS AND DEMOLITION			
SCALE AS NOTED		APRIL, 1981	
FAY SPOFFORD & THORNDIKE INC ENGINEERS BOSTON MASS			
DESIGNED BY J.C.P.	IN CHARGE J.C.P.	CHECKED BY EW-7	DATE 3
APPROVED F. M. Cahaly			
SHEET NO. 3 OF 3

APPROXIMATE LEDGE  
TAKEN FROM SKETCH BY CENTRAL  
VERMONT PUBLIC SERVICE CORP.  
DATED 11-22-80, SHOWING LEDGE  
ON DOWNSTREAM FACE OF DAM

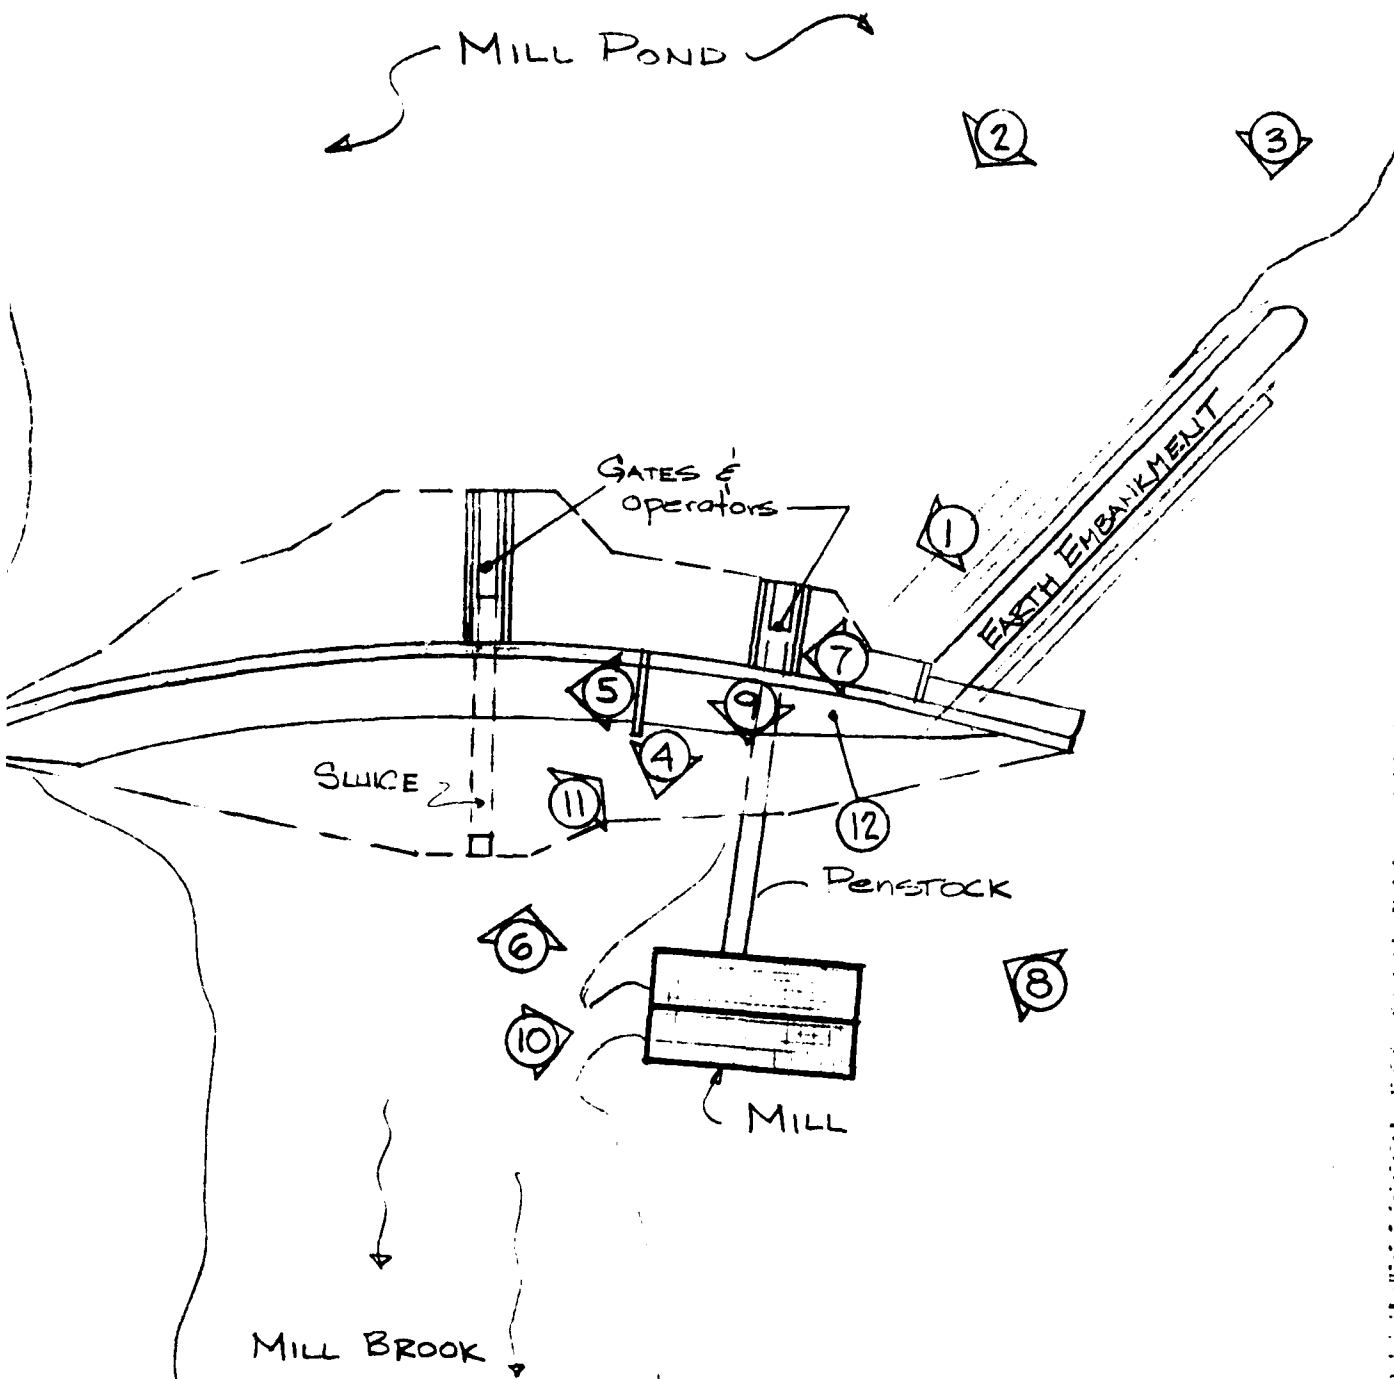
PHOTO INDEX

- FIG. 1 Upstream face of dam as viewed from left abutment.
- FIG. 2 Windsor Upper Dam as viewed from upstream.
- FIG. 3 Grass-covered embankment and lawn at left abutment.
- FIG. 4 Downstream as viewed from top of dam.
- FIG. 5 Longitudinal view of spillway.
- FIG. 6 Downstream face of dam.  
(Note discontinuity of white water along the spillway).
- FIG. 7 Operators for penstock and sluice gates.  
(Penstock operator in foreground).
- FIG. 8 Main spillway and auxiliary spillways as viewed from downstream.  
(Note vegetation on downstream face).
- FIG. 9 Penstock (breached area has been repaired) to mill downstream.
- FIG. 10 Outlet from mill downstream from dam.
- FIG. 11 Downstream face at left abutment.  
(Note void near concrete cap).
- FIG. 12 Detail view of granite masonry construction.

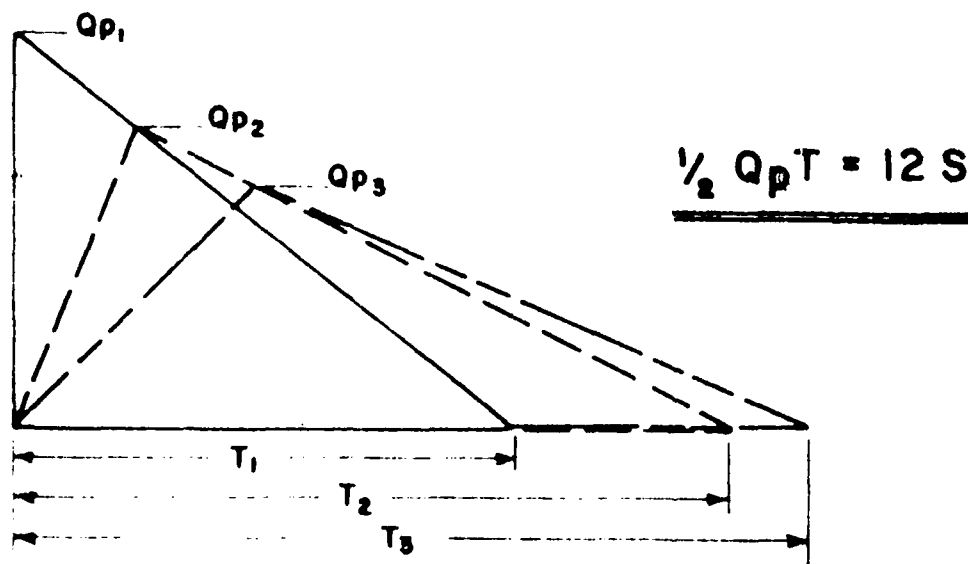
# "RULE OF THUMB" GUIDANCE FOR ESTIMATING DOWNSTREAM DAM FAILURE HYDROGRAPHS

Reservoir Stage at time of failure: 107.3' local datum  
= 645 ACRES-Feet

Spillway  $Q$  just prior to failure = 16,600 cfs  
(= 355.4' msl @ Union St.)

$\therefore$  failure wave = 13' tall
