# DOLE RESERVOIR DAM & DIKE

NH 00143 & NH 00483

## PHASE I INSPECTION REPORT NATIONAL DAM INSPECTION PROGRAM

MARCH 1980

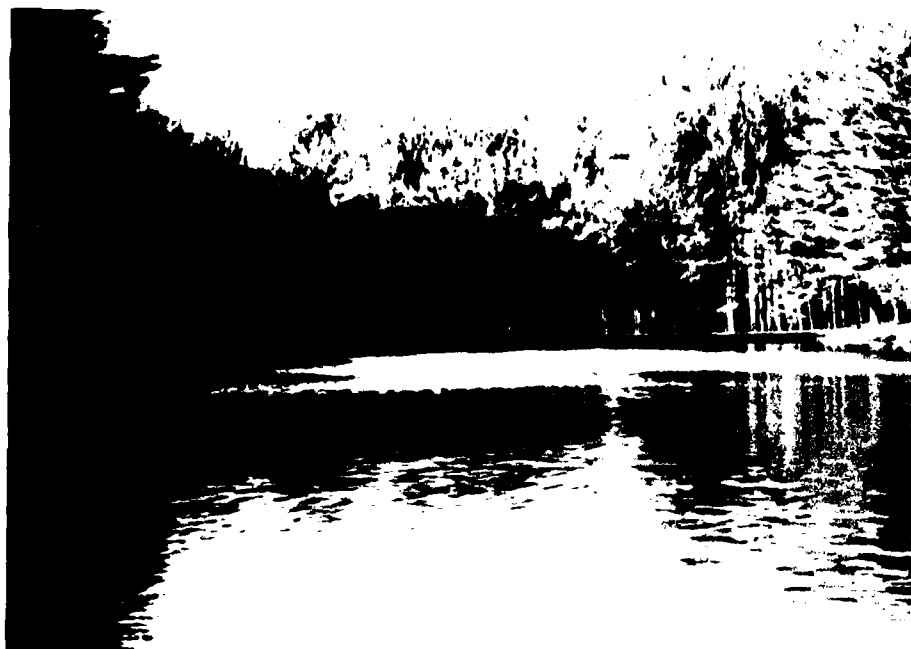
c. Appurtenant Structures. There is an earth dike at the northwest end of the reservoir (see Photo No. 12). It is about 8.7 feet high, 170 feet long, and 9 feet wide at the crest.

Photo No. 12 - General view of dike from reservoir.

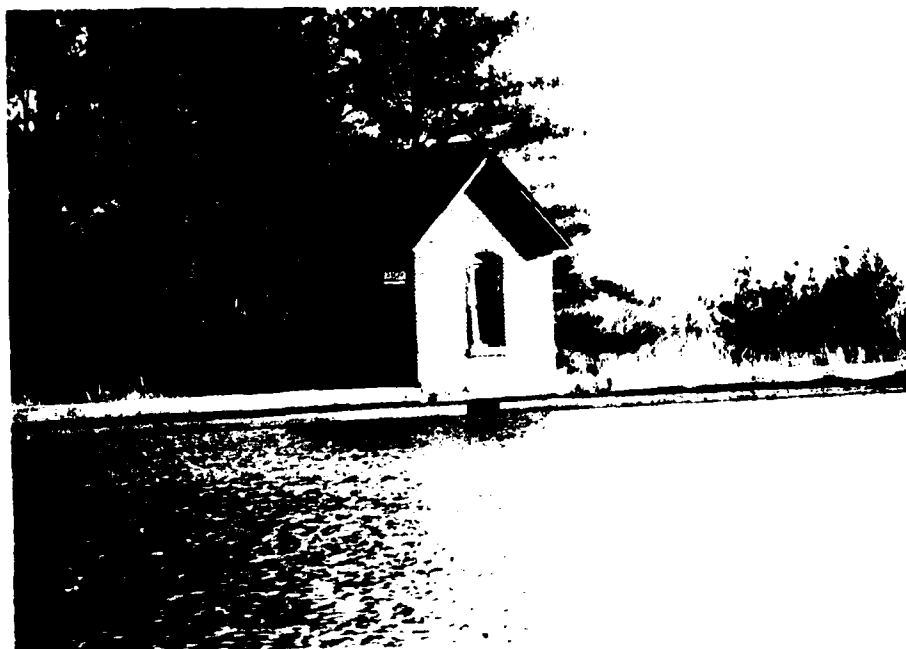
Photo No. 6 - View of gatehouse from left  
shoreline.

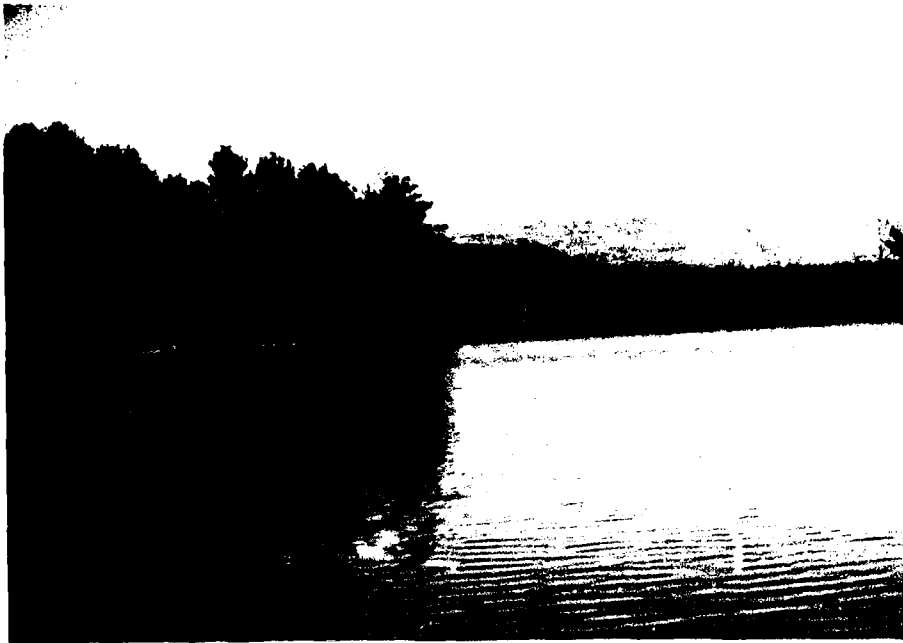
Photo No. 1 - General view of center section of  
dam from reservoir
