MERRIMACK RIVER BASIN  
STERLING, MASSACHUSETTS

HYCREST FARM POND DAM  
MA 00673

PHASE I INSPECTION REPORT  
NATIONAL DAM INSPECTION PROGRAM

FEBRUARY 1979

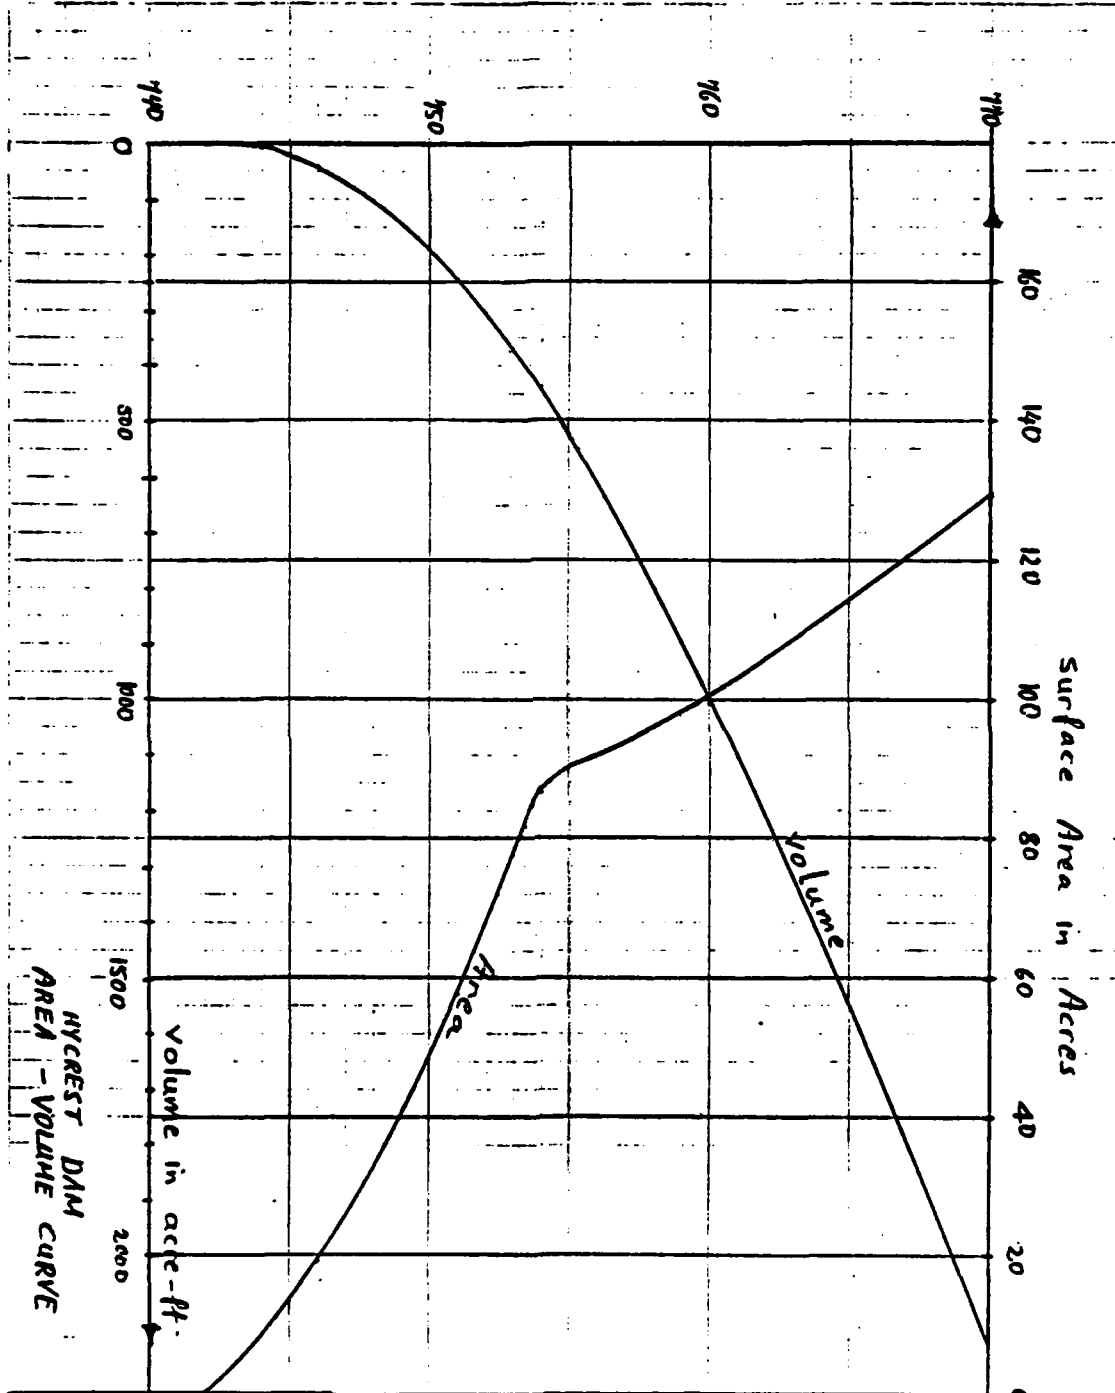
HYCREST DAM  
AREA - VOLUME CURVE

$$\text{Surcharge} : 135 \text{ acre-ft} \rightarrow 3.6'' \approx 3.5'' \text{ o.k.}$$

Conclusion: Dam would be overtopped by about 0.2-ft of water if the existing flash boards are all left in place.
