NATIONAL PROGRAM FOR INSPECTION OF NON-FEDERAL DAMS  
SPRAGUE UPPER RESERVOIR (U) CORPS OF ENGINEERS WALTHAM  
MA NEW ENGLAND DIV JUN 79

*SPRAGUE UPPER RESERVOIR DAM*  
DOCUMENT IDENTIFICATION  
*JUNE 1979*  
*R103105*

SPRAGUE UPPER RESERVOIR DAM RI 03105

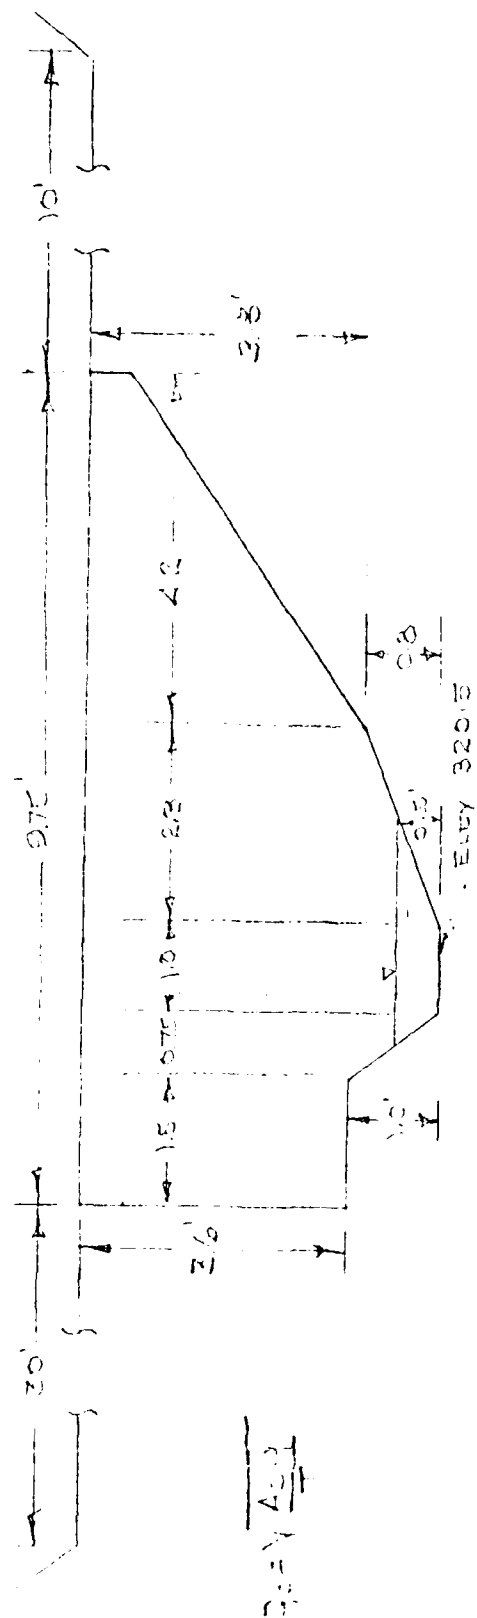
FIGURE 2

e. Test Flood Analysis. Reservoir area and capacity curves and tables, for use in flood routings, are shown on Fig. 2, Sheet D-5 and Sheet D-6, Appendix D. For determining surface areas and surcharge capacities, planimetered areas were taken from contours delineated on USGS 2,000 ft. per in. quadrangle sheets.

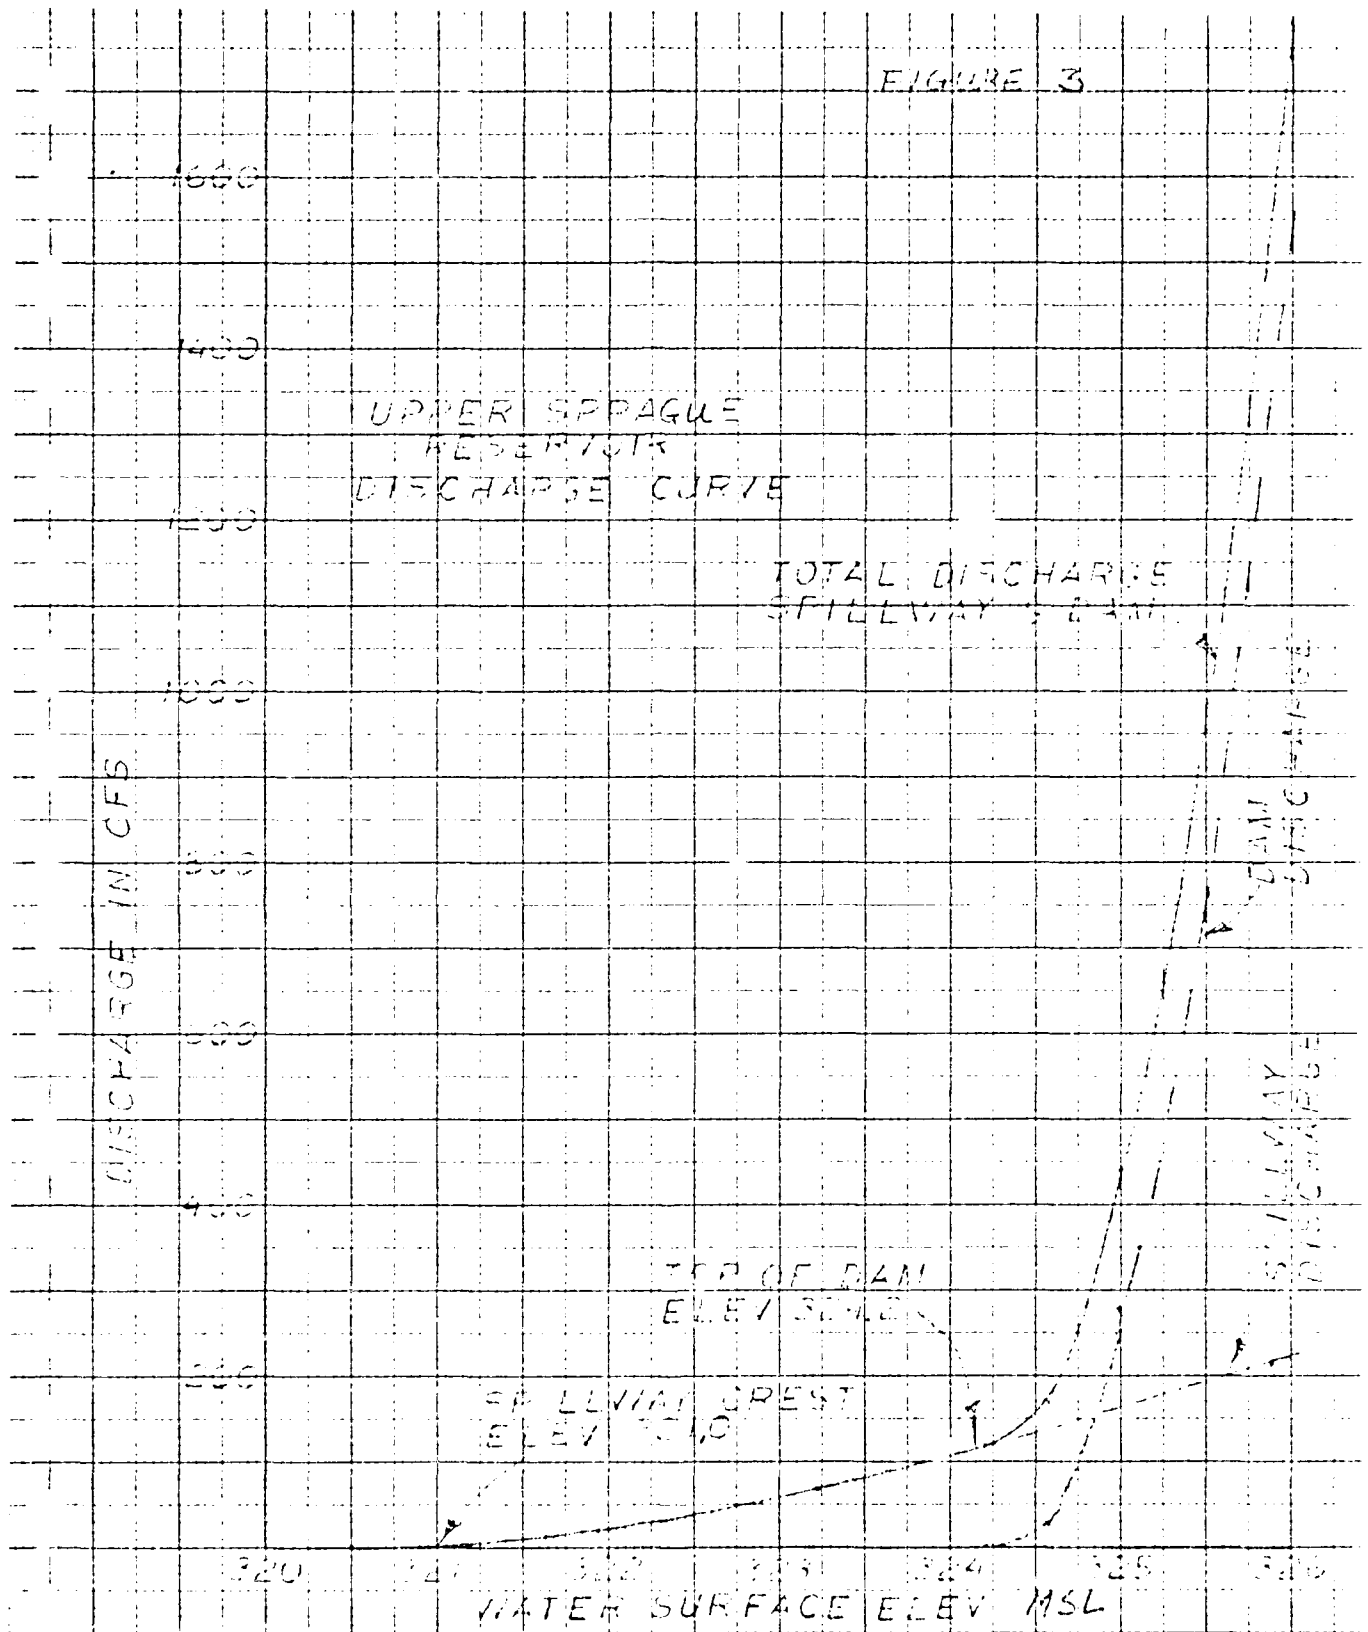
FIGURE 3

Discharge tables and curves for the spillway and for over the top of the dam are shown on Sheets D-7, D-8 and D-9 and Fig. 3 Sheet D-10, Appendix D.
