CONNECTICUT RIVER BASIN  
WHITINGHAM

LAKE SADAWGA  
VT00012

PHASE I INSPECTION REPORT  
NATIONAL DAM INSPECTION PROGRAM

AUGUST 1978

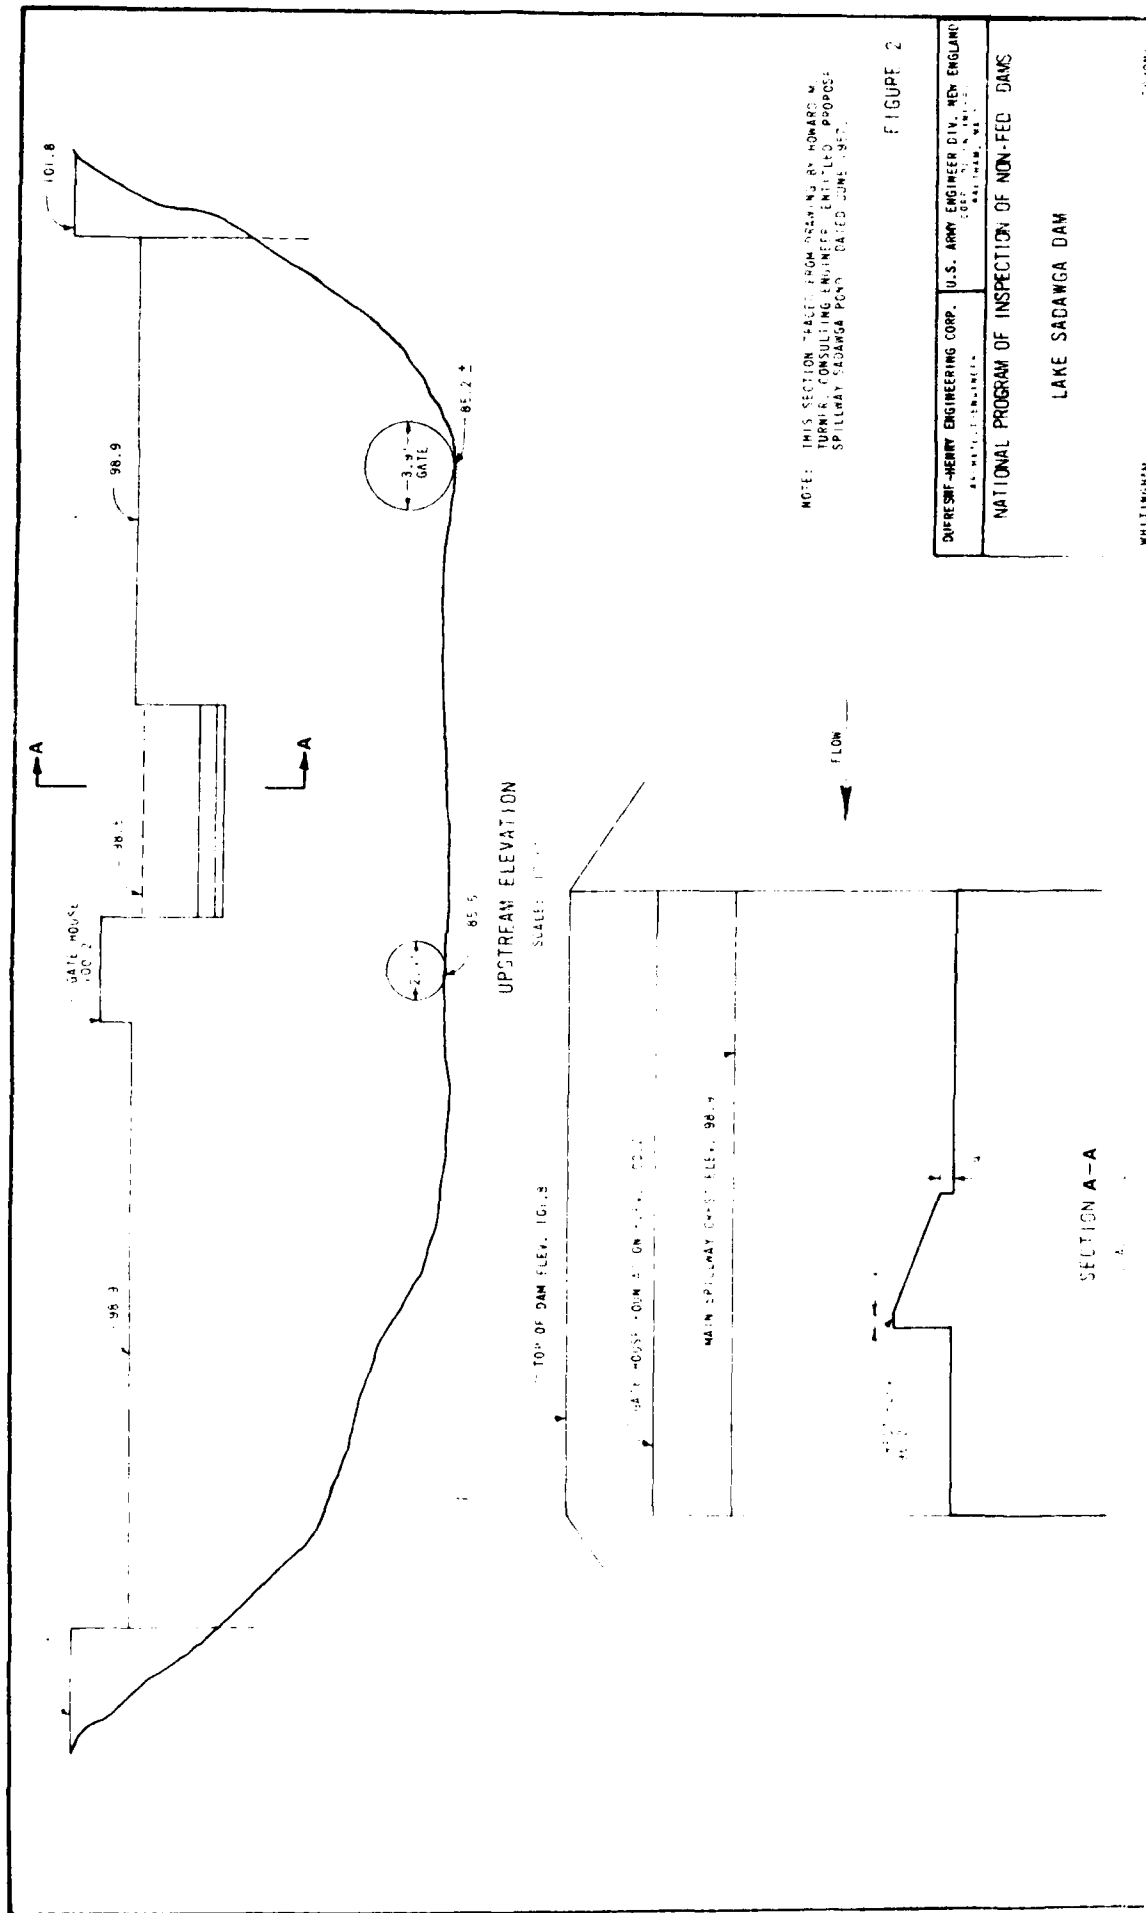
FIGURE 2

NOTE: THIS SECTION TRACED FROM DRAWING BY HOWARD W. TURNER, CONSULTING ENGINEER, ENTITLED, PROPOSED SPILLWAY SADAWAGA POND, DATED JUNE 1967.

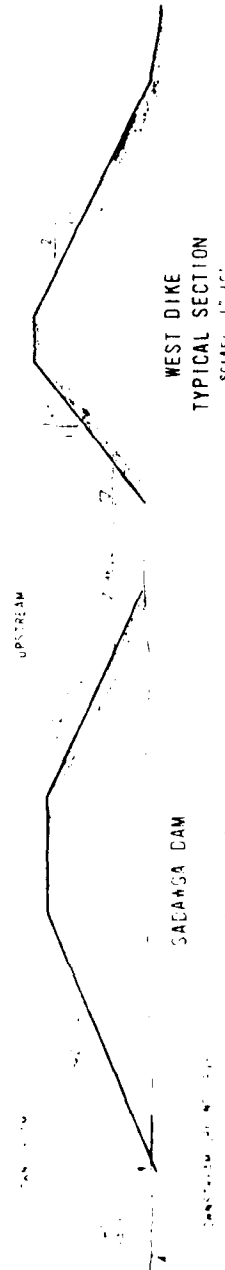
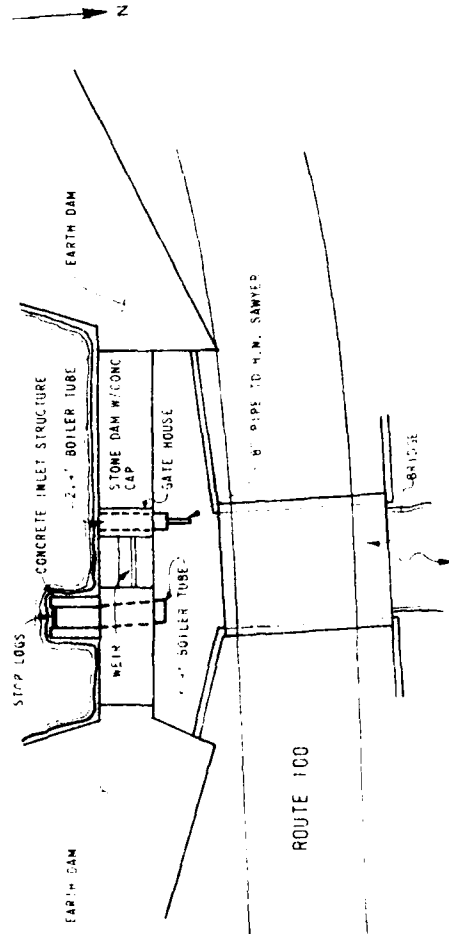
FIGURE 1

Figure 1 shows an approximate cross section, which was taken at a location about 73 feet right of the right spillway training wall. The freeboard is nearly 6 feet and the lake is quite shallow at this location. There is a head of only 2.6 feet across the embankment. The head is several feet high growing from the riprap.
