268 CONNECTICUT RIVER BASIN AD-A156 CLAREMONT, NEW HAMPSHIRE CLAREMONT PAPER COMPANY DAM NH 00139 STATE NO 47.06 PHASE I INSPECTION REPORT NATIONAL DAM INSPECTION PROGRAM JUL 0 8 1985 FILE COPY G DEPARTMENT OF THE ARMY **NEW ENGLAND DIVISION, CORPS OF ENGINEERS** WALTHAM, MASS. 02154 A TUTTE a talease; Approvi FEBRUARY 1979 Dist 85 06 12 013

NATIONAL DAM INSPECTION PROGRAM PHASE I INSPECTION REPORT

Identification No.:NH00139Name of Dam:Claremont Paper Company DamCity:ClaremontCounty and State:Sullivan County, New HampshireRiver:Sugar RiverDate of Inspection:November 21, 1978

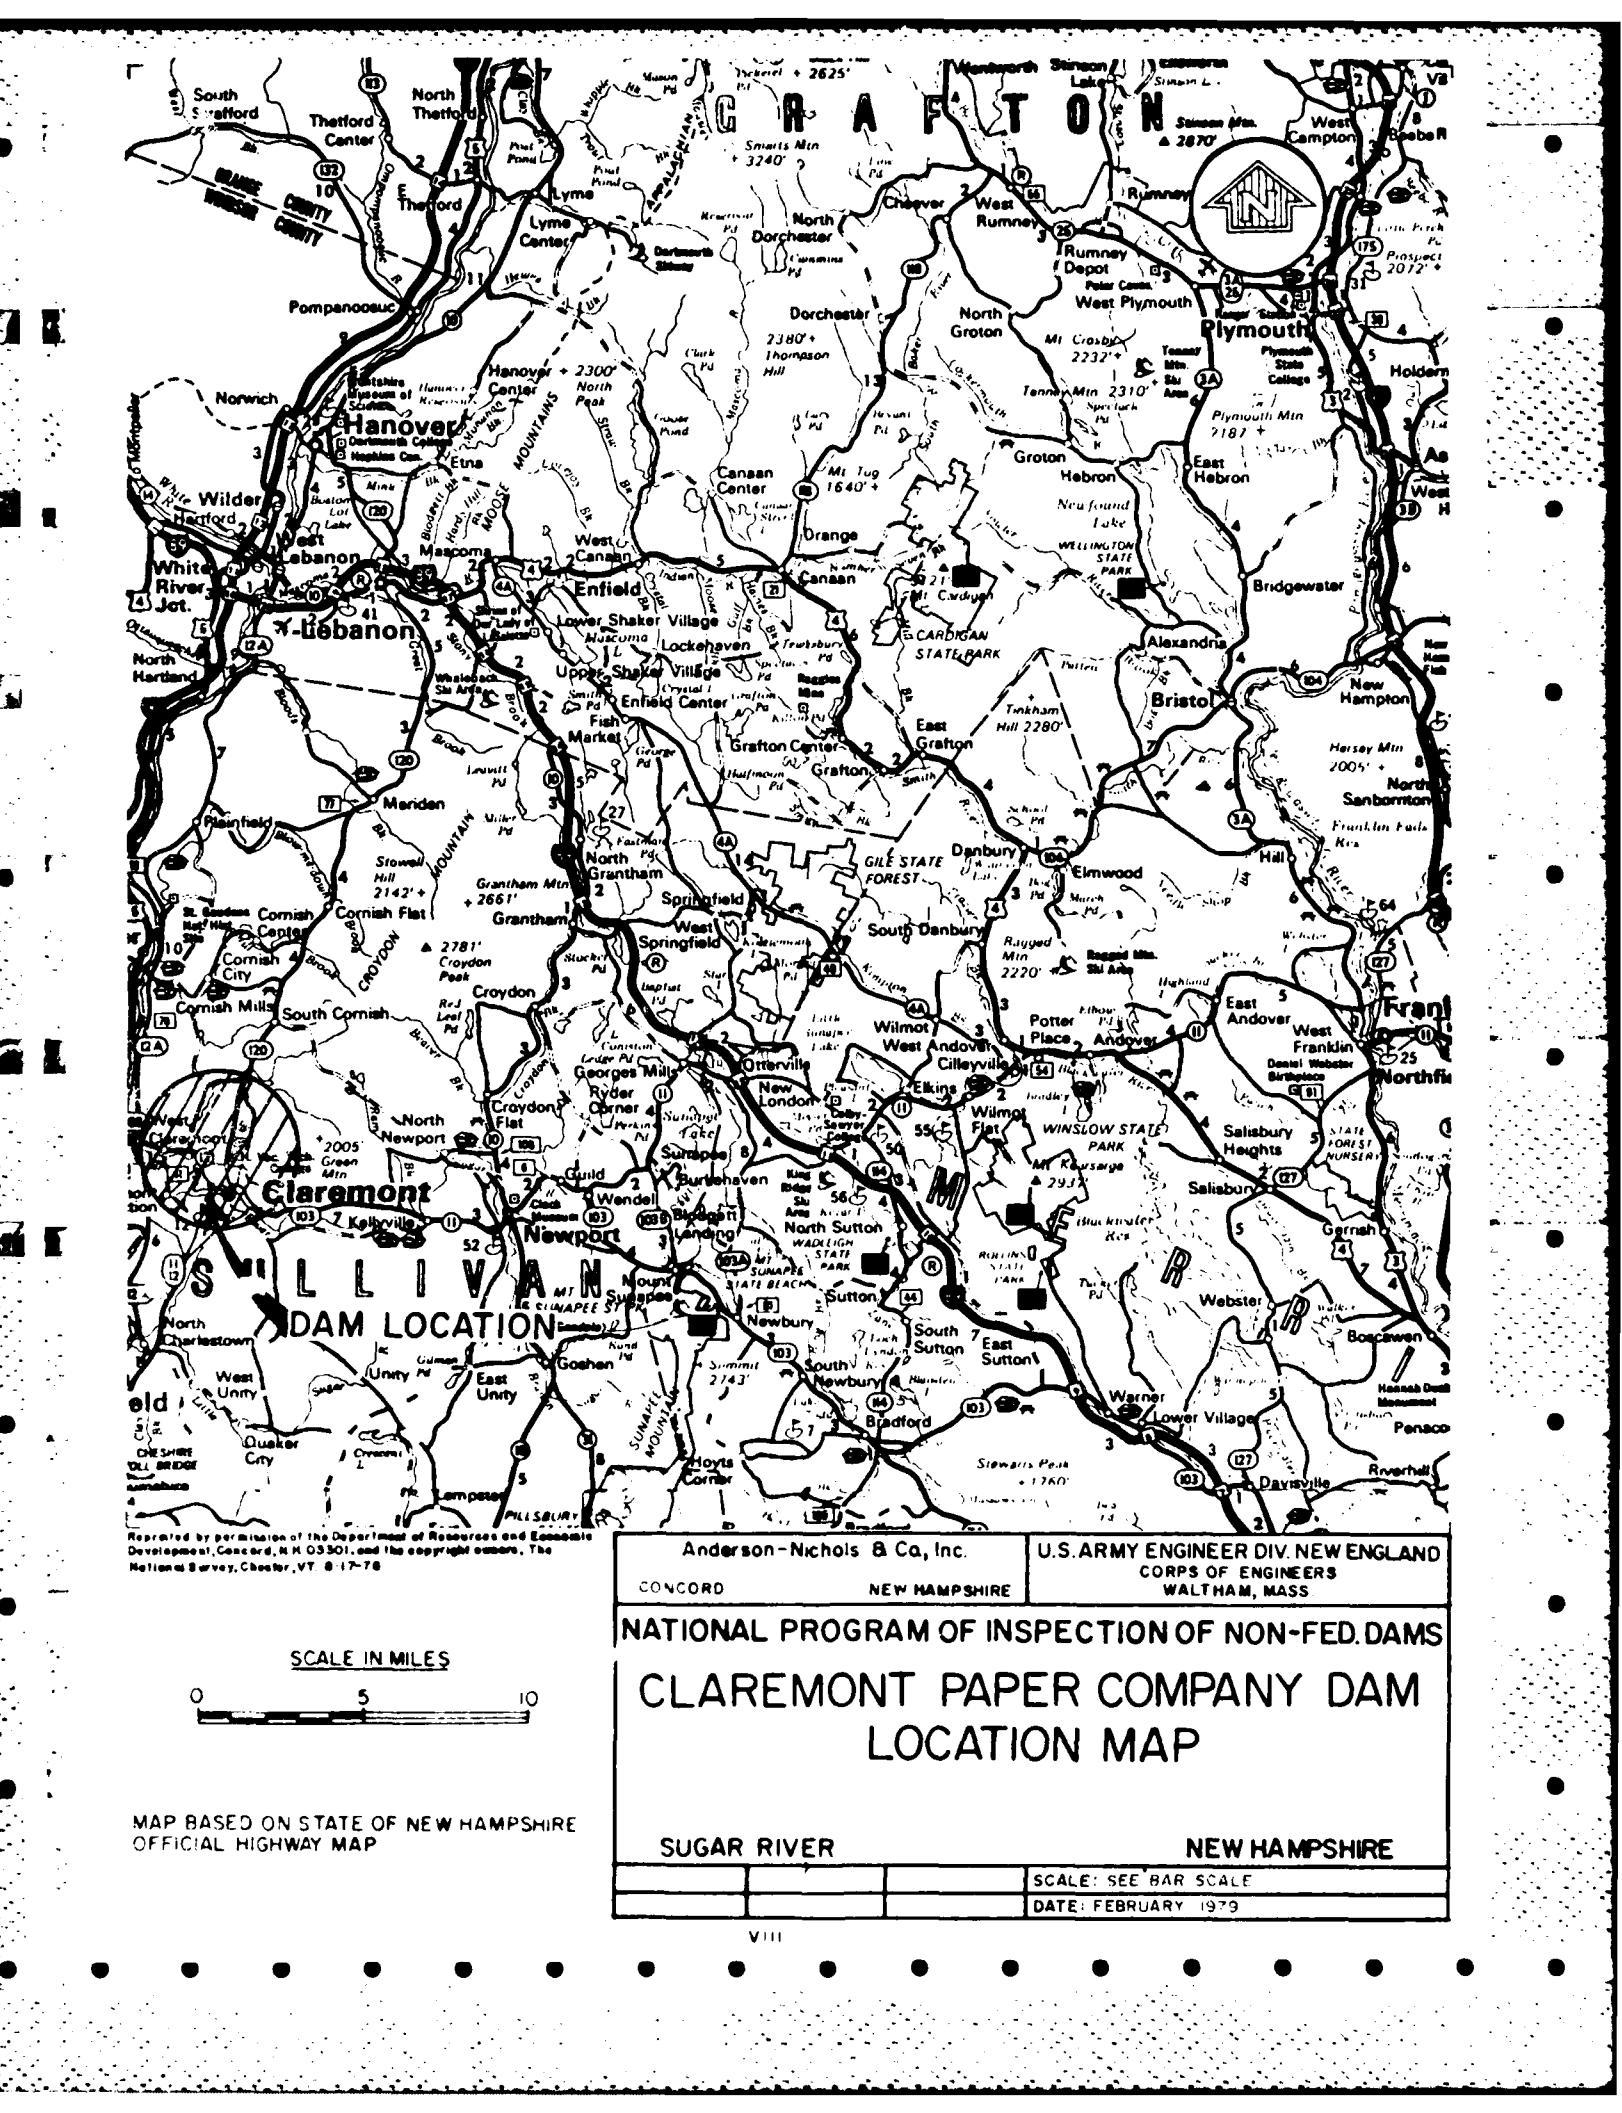
Figure 1 - Overview of the Claremont Paper Company Dam.
