## RYEGATE PAPER COMPANY DAM NH 00014

# PHASE I INSPECTION REPORT NATIONAL DAM INSPECTION PROGRAM

DEPARTMENT OF THE ARMY NEW ENGLAND DIVISION, CORPS OF ENGINEERS WALTHAM, MASS. 02154

JUNE 1979

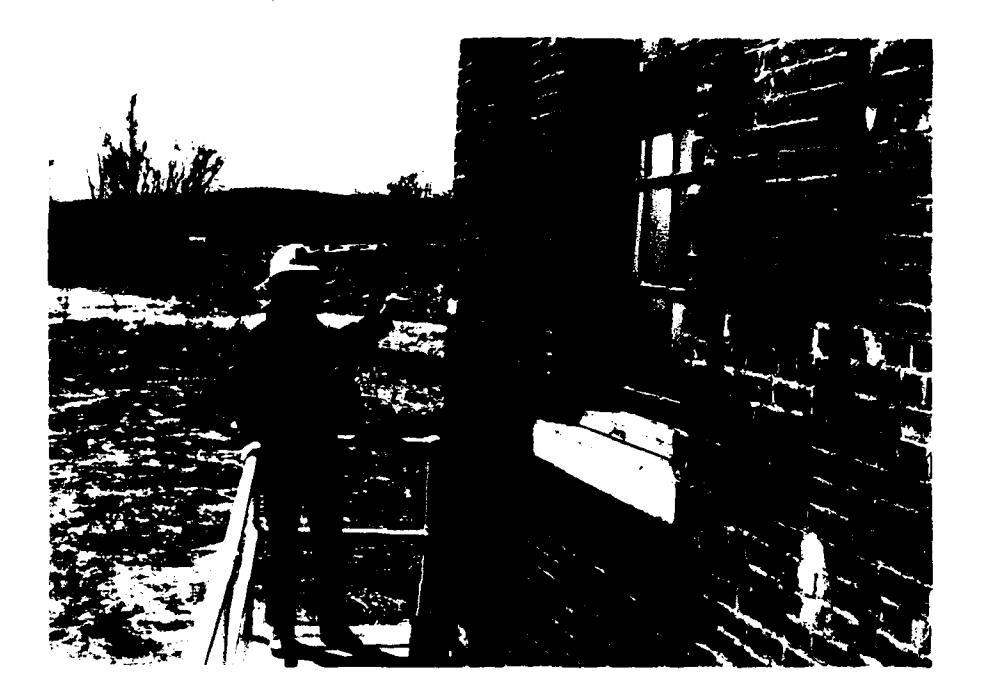
C-7

e. <u>Downstream Channel</u>. The valley downstream of the dam as far as Woodsville, N.H. has generally steep high sides. Trees are growing on the banks of the river, but the river itself is wide and unobstructed immediately downstream of the dam. (See Appendix C-Figure 7.) Woodsville, New Hampshire and Wells River, Vermont are located about 4½ miles downstream of the dam. A group of 14 houses and the National Guard Armory are located in the floodplain of the Connecticut River in Woodsville; a group of 7 houses is located in the floodplain in Wells River. A U.S.G.S. gaging station is located near these houses on the Vermont side of the Connecticut River.

Figure 13 - Looking at the downstream channel from the west abutment.
