LOCHMERE DAM

NH 00015

PHASE I INSPECTION REPORT
NATIONAL DAM INSPECTION PROGRAM

NOVEMBER 1978

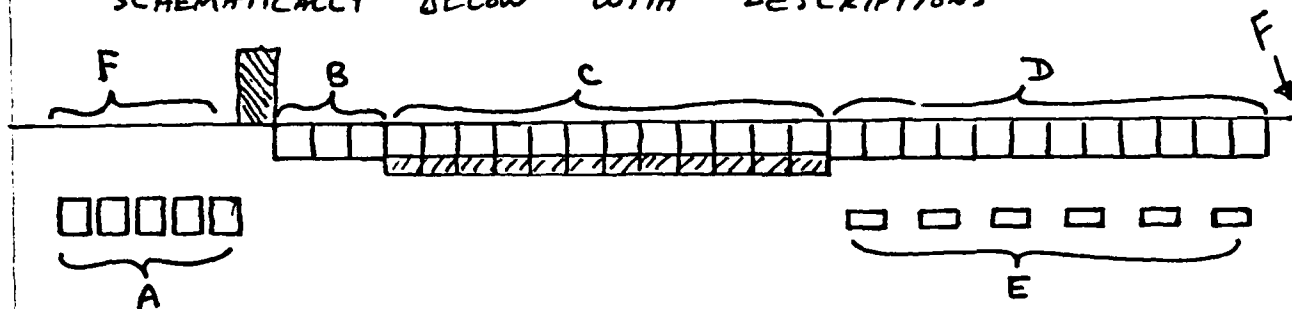
THE LOCHMERE DAM CONSISTS 5 TYPES OR LOCATIONS OF DISCHARGE POINTS, EXCLUDING OVERTOPPING OF THE DAM OR OVERBANKS. THEY ARE SHOWN SCHEMATICALLY BELOW WITH DESCRIPTIONS

A: FIVE DEEP SLUICE GATES. INVERT ELEVATION = 471.3*
MAX. OPENING OF EACH GATE = 6' X 6'.

B: THREE BAY SPILLWAY. INVERT ELEVATION = 481.3 MSL
THREE OPENINGS OF 5' 6".
OGEE SECTION.
