HEAD WORKS DAM -
OSSIPPEE LAKE
NH 00328

BERRY BAY DAM -
OSSIPPEE LAKE
NH 00329

PHASE I INSPECTION REPORT
NATIONAL DAM INSPECTION PROGRAM

NOVEMBER 1978

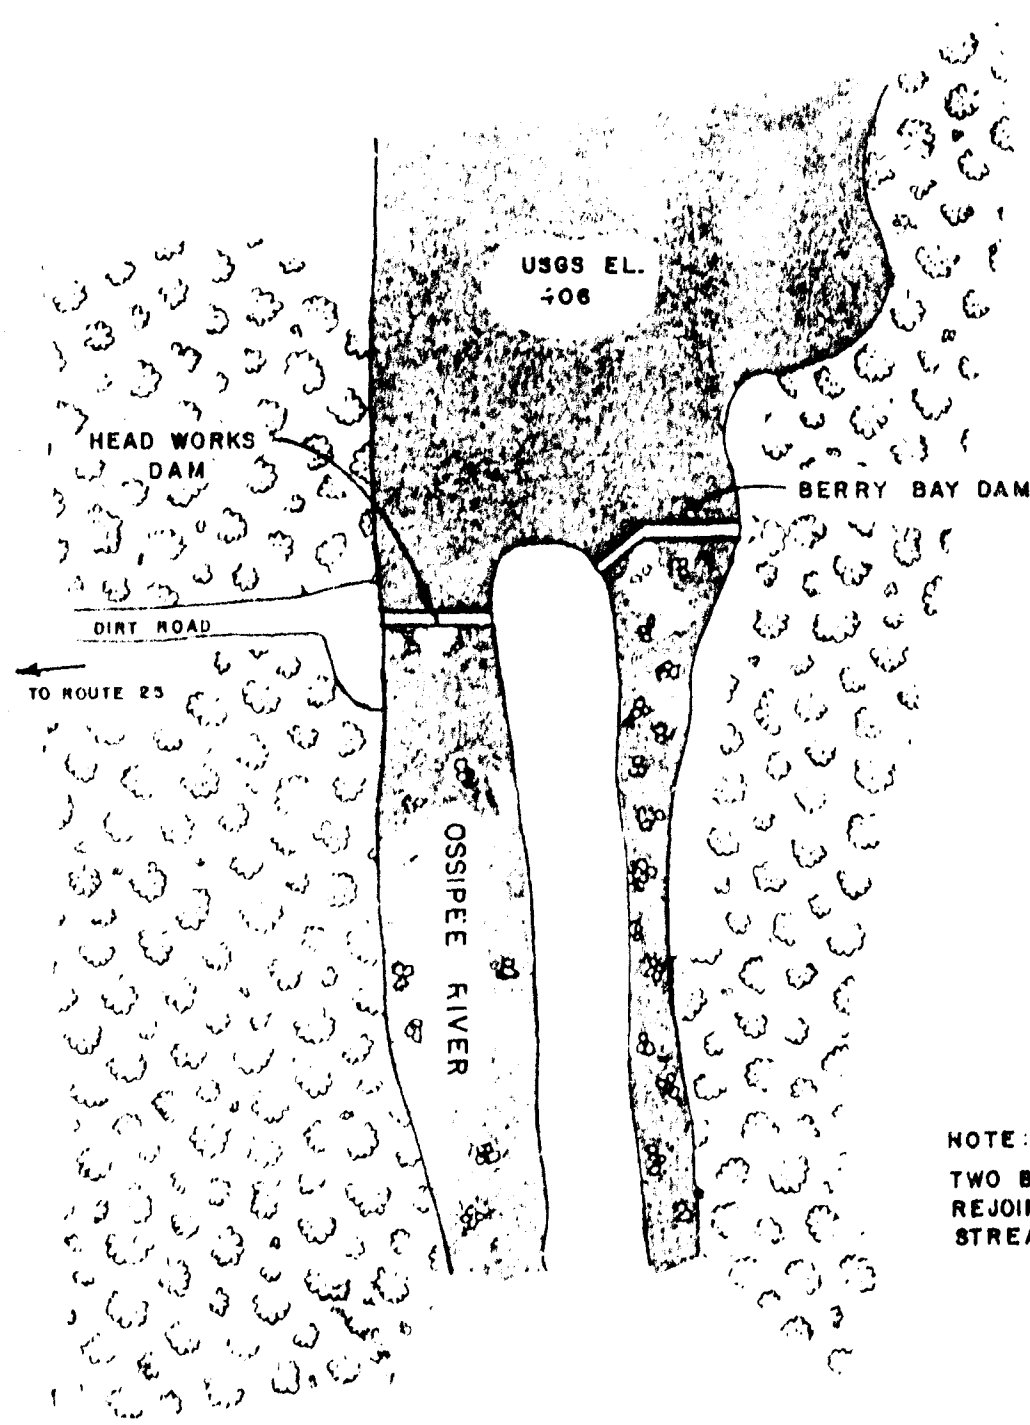
FIG. 1

The engineering works creating Ossipee Lake and three smaller neighboring bays consist of two independent structures located at the same point in the river, but separated by a small island (Figure 1). The first of these structures, locally known as the Head Works Dam, is basically a 33 foot long, concrete gravity structure with concrete cutoff walls at both abutments (Figures 2 through 4). The top of the dam is approximately 12 feet above the stream bed. Five sluice gates, each approximately 4 feet by 6 feet, control the structure's discharge; three of the five gates are electrically operated. A gatehouse spans the entire dam.

The downstream reaches of these structures consist of 1000 feet of two relatively steep, narrow channels which abruptly widen at the confluence of the channels (Fig. 1). These features would tend to contain and then attenuate any flood wave. For this reason and since there is very little development downstream of the dams for at least 3 miles, a hazard potential classification of LOW is assigned.
