WHITE'S POND DAM

NH 00106

PHASE I INSPECTION REPORT
NATIONAL DAM INSPECTION PROGRAM

AUGUST 1978

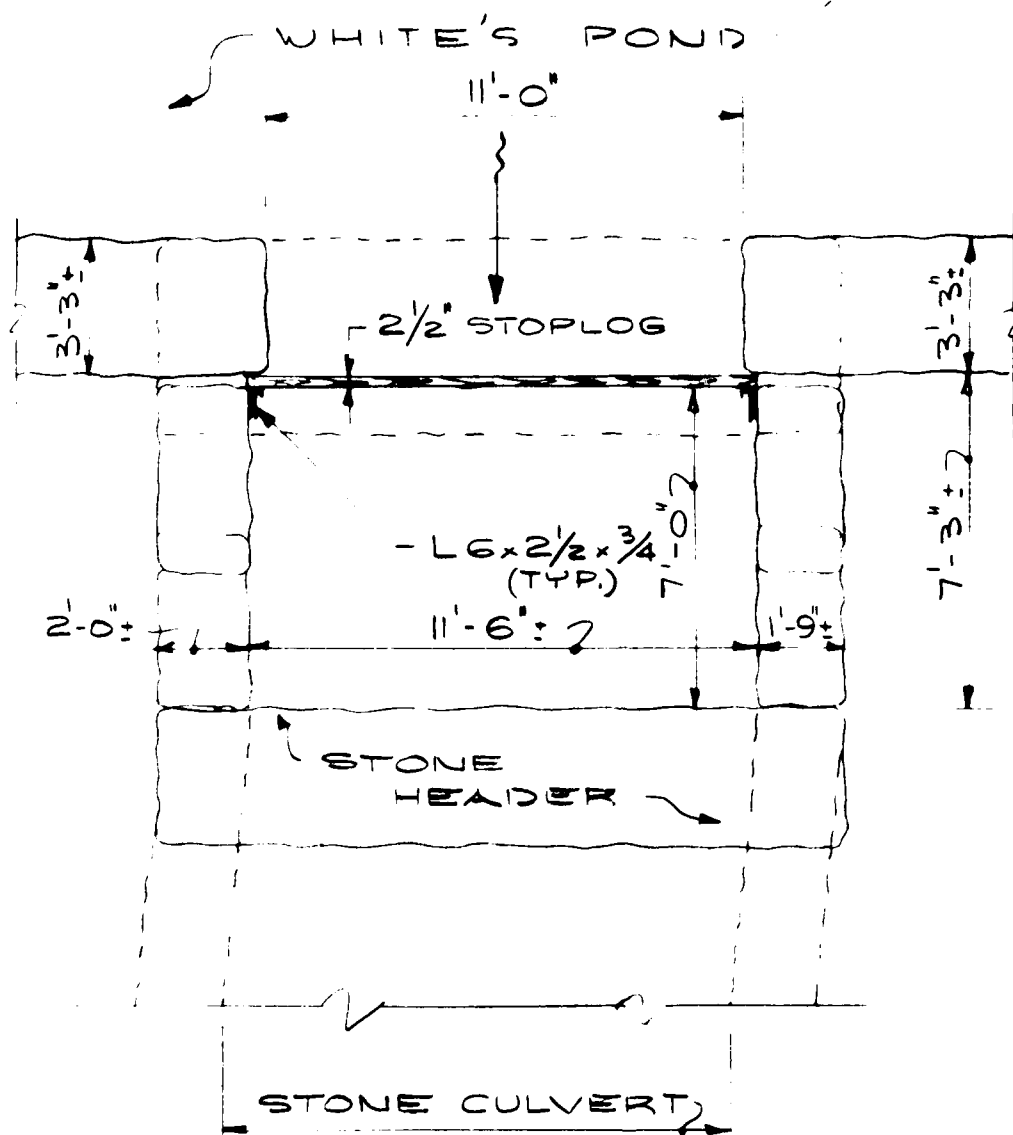
FIG. 4

The spillway structure consists of squared stone granite masonry with unmortared chinking stones (Figures 3, 4, and 5). The spillway is 11.5 feet long by 3.3 feet wide with a 10 foot vertical drop between the spillway sill and the flume invert. A nominal 3 inch by 21 inch timber stop-log is set on top of the spillway and secured by means of restraining angles bolted to the sidewalls of the adjacent flume. The invert of the spillway is 3.7 feet below the top of the granite block facing of the dam. It was observed that continuous seepage is permeating through the second joint coursing of the granite dam facing adjacent to both sides of the spillway; the second capstone joint being below pond level (Photo Nos. 2 and 3).
