MERRIMACK RIVER BASIN  
WOODSTOCK, NEW HAMPSHIRE

MIRROR LAKE DAM  
N.H. 00317

PHASE I INSPECTION REPORT  
NATIONAL DAM INSPECTION PROGRAM

AUGUST 1980

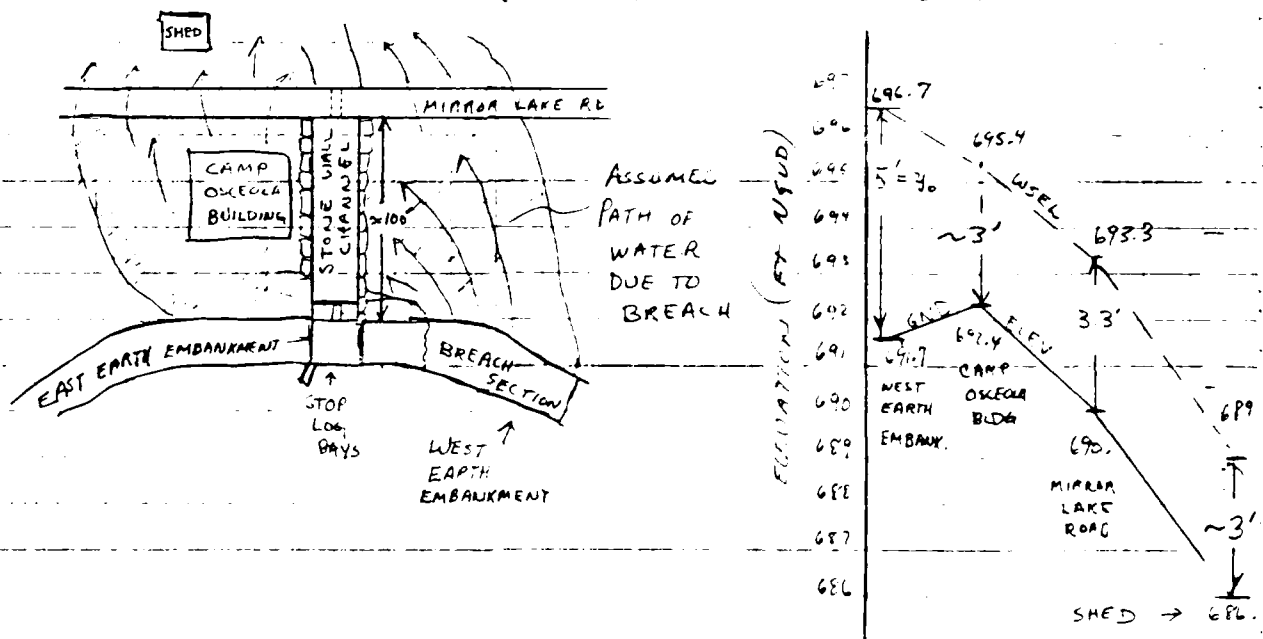
IN ADDITION TO THE ROAD BEING FLOODED IT IS ALSO VERY LIKELY THAT THE CAMP OSCEOLA BUILDING LOCATED 2/3 OF THE ROAD AND THE UNINHABITED SHED LOCATED 1/3 OF THE ROAD WOULD ALSO BE INUNDATED BY ABOUT 3 FEET. THIS NUMBER WAS ARRIVED AT AFTER EXAMINATION OF THE RELATIVE POSITION AND ELEVATION OF THESE BUILDINGS WITH RESPECT TO THE BREACHED SECTION AND MIRROR LAKE ROAD (CROSS SECTION #1).

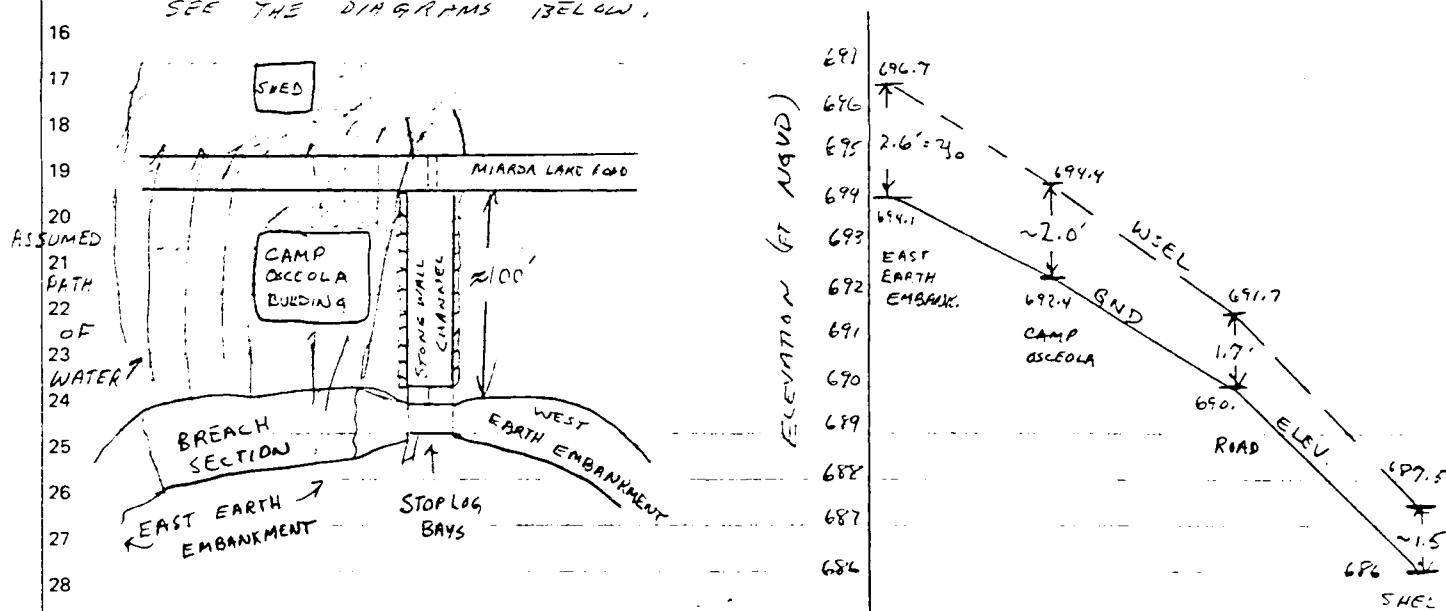
A BREACH OF THE EAST EARTH EMBANKMENT WOULD CAUSE  
MIRROR LAKE ROAD TO BE OVERTOPPED BY ABOUT 1.7 FT.

IN ADDITION, THE CAMP OSCEOLA BUILDING AND THE  
UNINHABITED SHED LOCATED DIRECTLY IN THE PATH OF  
THE BREACH DISCHARGE WERE ASSUMED TO BE INUNDATED BY  
2.0 and 1.5 FT RESPECTIVELY. THESE FIGURES WERE  
ARRIVED AT AFTER EXAMINATION OF THE RELATIVE POSITIONS AND  
ELEVATIONS OF THESE TWO STRUCTURES WITH RESPECT TO  
THE BREACH SECTION AND MIRROR LAKE ROAD (CROSS SECTION #1)  
SEE THE DIAGRAMS BELOW.
