MERRIMACK RIVER BASIN  
WILTON, NEW HAMPSHIRE

SOUHEGAN RIVER WATERSHED  
DAM NO. 10A

PHASE I INSPECTION REPORT  
NATIONAL DAM INSPECTION PROGRAM

AUGUST 1979

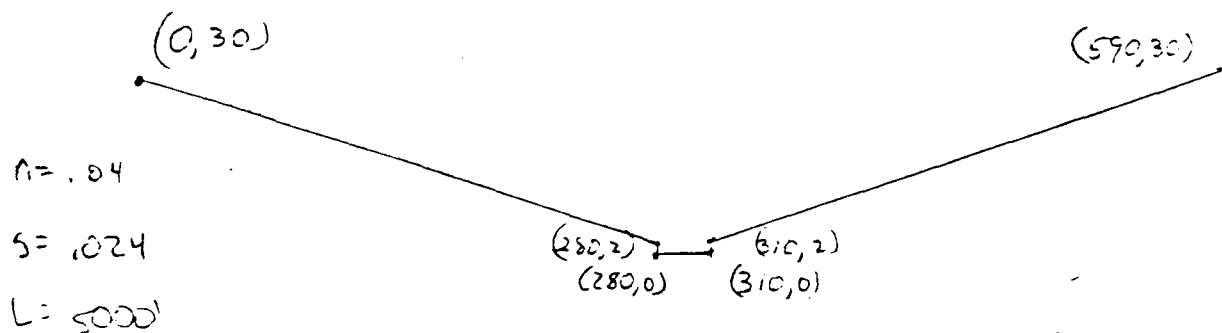
The channel just downstream of S.R.W. Dam #10A is represented by this typical cross-section. (field notes & U.S.G.S. quad):

A Normal Flow vs. depth relationship for this channel is given on p 11. At 5300 cfs of flow, the depth would be 6.6 ft.

$$Y_0 = 849 - (793 + 6.6) = 49.4 \text{ ft.}$$

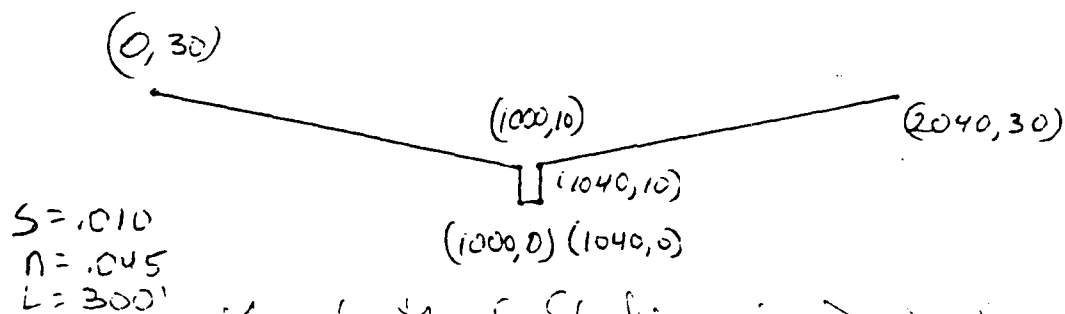
The village of Davisville (Location 1, map on p. 8) consists of about 3 residences and one mill. These buildings are grouped around a small pond on Mill Brook. Under dam failure conditions, this would approximate the cross-section at Davisville (from field notes & U.S. G.S. Quads):

The depth of flooding at Davisville is estimated by a stage-Normal discharge relationship for this cross-section (p. 14). Due to its short length this reach would provide negligible attenuation due to storage. The houses and mill have first floor elevations about 10 feet above the stream bed. The pre-failure outflow of 5,300 cfs would generate

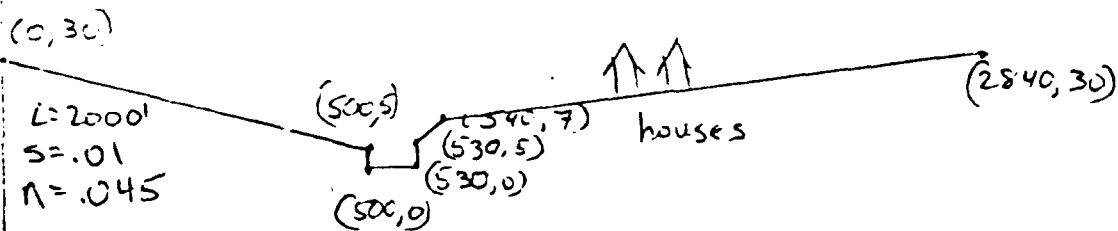
The next damage center downstream of Davisville is a group of 2 houses, 13 and fourteen feet above the streambed, 2000 ft. down Mill Brook from the village. The cross section in this reach is taken from field notes and a U.S.G.S. quad:

The Stage-Normal Discharge Relationship for this reach is given on p. 16, and the attenuation due to storage in  
 it is calculated on p. 17.

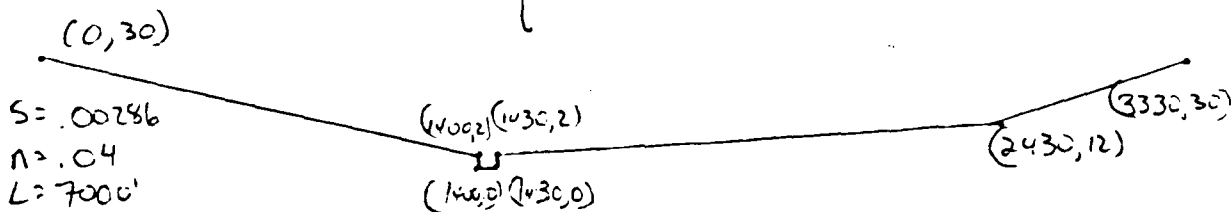
Mill Brook then flows about 7000 feet to Old Wilton Reservoir. Most of this reach is in a broad flood plain, with the brook meandering through. There are two houses near the downstream end of this reach. The following typical cross-section is taken from a U.S.G.S. quad sheet:

The Stage-Normal Discharge Relationship for this reach is given on p. 17. The pre-failure outflow of 5300 cfs would produce a stage of about 6.2 ft. The attenuation due to storage in this reach is calculated on p. 20. The attenuated discharge at the end of this reach is 39,100 cfs, which produces a stage of 11.4 ft. This stage would <sup>D-19</sup>not threaten the houses nearby.

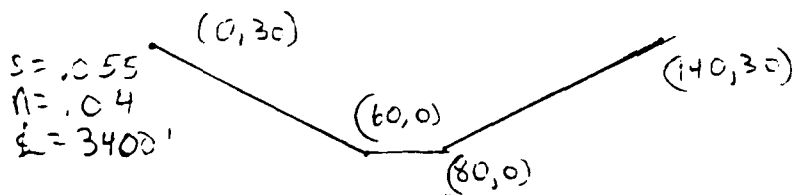
Downstream of old Wilton Reservoir, Mill Brook joins Stockwell Brook, and proceeds 3700 ft. to flow into Stony Brook. The first 3400 feet of this stretch are represented by this cross-section, determined from field notes and a U.S.G.S. quad sheet:

This reach is quite steep, with the stream confined to a narrow gorge. The pre-failure flow of 5300 cfs would increase slightly due to inflow from Stockwell Brook. We will assume this inflow as 7000 cfs. The combined pre-failure flow of 6300 cfs would cause 7.3 ft. of flow in the channel, as shown on the Normal Flow Relationship given on p. 22. The attenuation due to storage in this reach is calculated on p. 23.

The attenuated dam failure flow at the end of this reach is 38,000 cfs, which would yield a stage of 12.7 ft. There are no structures on this reach.

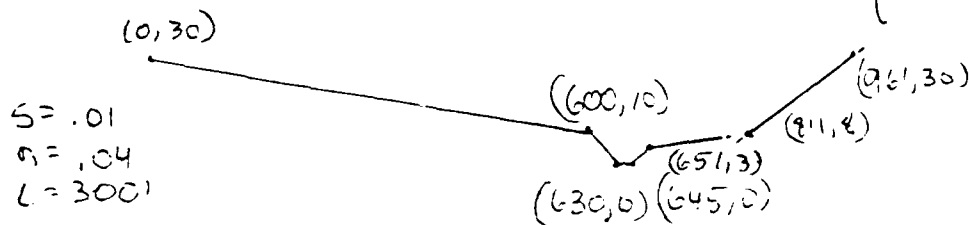
About 300' upstream of the confluence with Stony Brook, Mill Brook leaves the gorge and flattens out considerably. This reach has one trailer about eight feet above the streambed and one house under construction about 15 feet above the streambed. The following typical cross-section of the reach is based on field notes and a U.S.G.S. quad:

A Stage-Normal Discharge Relationship for this reach is given on p. 25. The pre-failure outflow of 6300 cfs would cause a stage of about 9.6 feet, which would create 1-2 feet of flooding at the trailer. The peak dam failure outflow would increase the stage to about 17.5 ft, which would create 9.5 ft. of flooding at the trailer, and 2.5 ft. at the house. This sudden rise could present a threat of loss of life in this area.

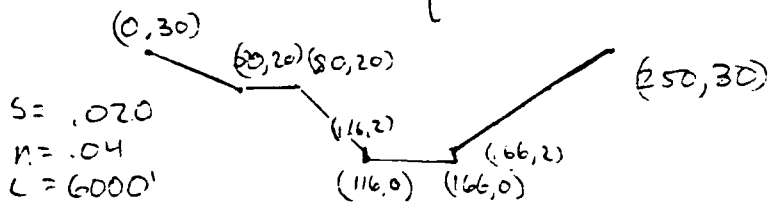
The following typical cross-section is based on field notes and U.S.G.S. maps:

The Stage-Normal Discharge relationship for this reach is given on p. 27. The pre-failure flow of 6300 cfs would be augmented by inflow from Stony Brook. This inflow is assumed to be 2000 cfs. The combined flow of 8300 cfs would yield 8 ft. of flow. The attenuation due to storage in this reach is calculated on p. 28. The attenuated peak flow at Wilton is 35,700 cfs, which yields a stage of 17 ft.

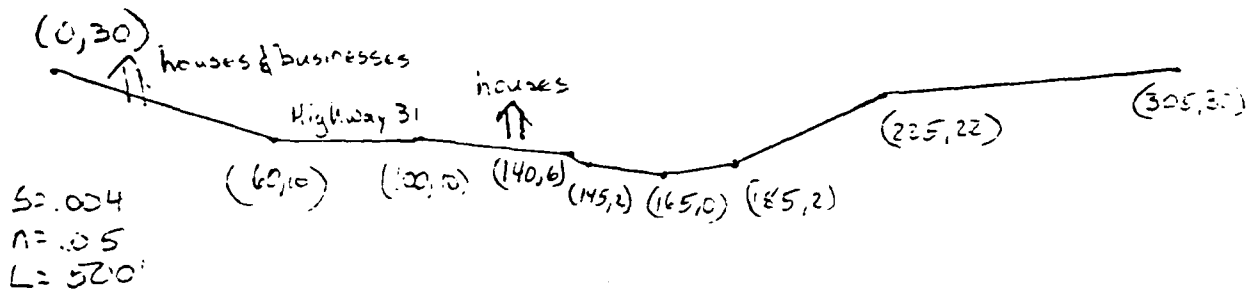
The Stage-Normal Discharge Relationship for this reach is given on p. 30. Attenuation in this short reach would be negligible. The pre-failure outflow of 8,300 cfs would create a stage of 14.3 ft, which would cause <sup>severe</sup> flooding problems at the houses and businesses on the bank. (This flow compares to the F.I.S. 500 year flow of 8100 cfs on Stony Brook). The dam failure flow of 35,700 cfs would yield a stage of 25.5 feet, which would cause extreme and dangerous flooding of all the houses and businesses between Highway 31 and the brook.
