OLIVERIAN DAM

NH-00268

PHASE I INSPECTION REPORT  
NATIONAL DAM INSPECTION PROGRAM

MAY 1979

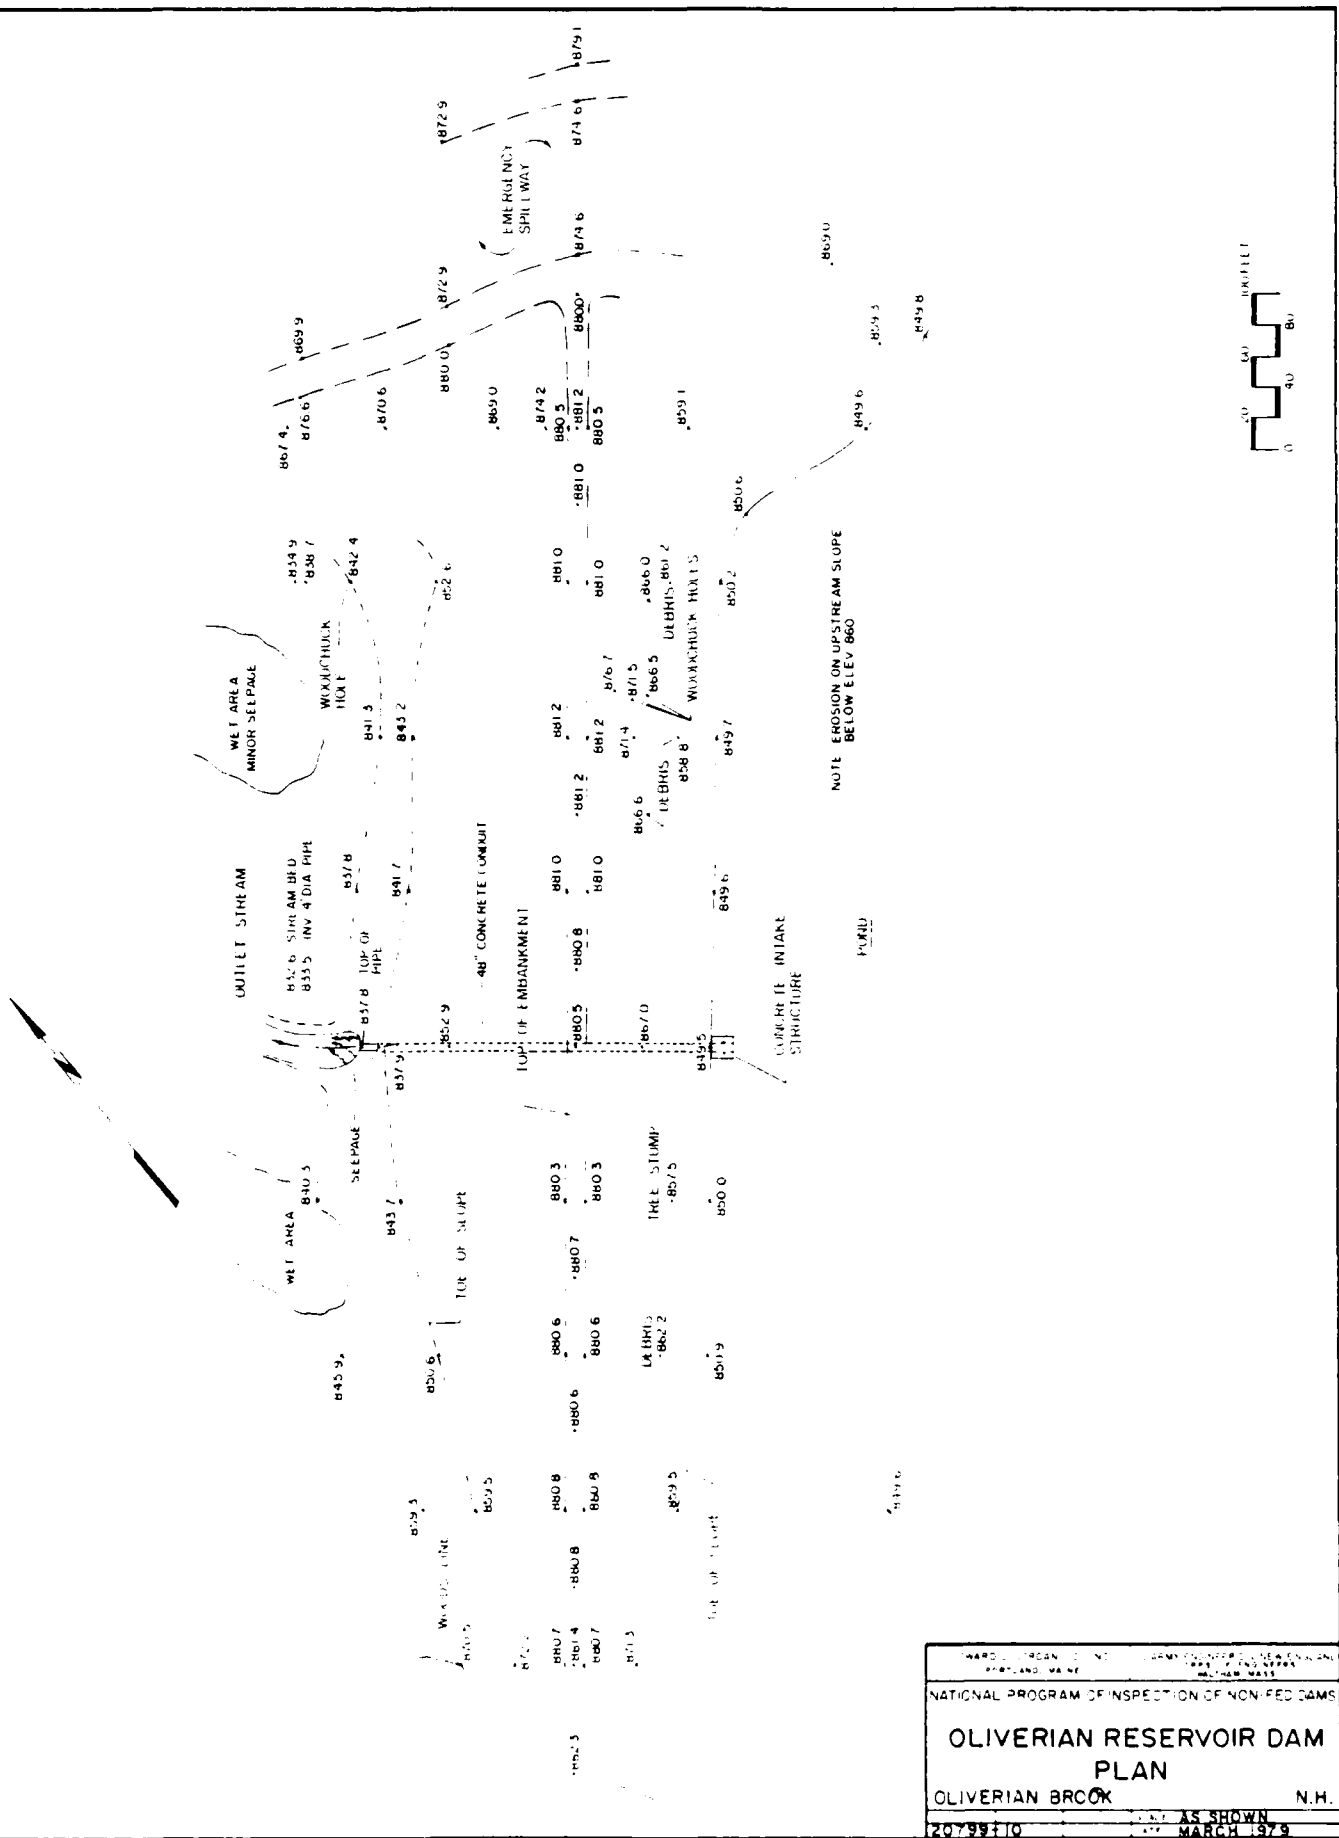
III. The following sketch shows a plan of the Oliverian Dam with notes added based on the visual inspection. Also, following are reproductions of selected drawings from the "as-built" drawings of the dam.
