MERRIMACK RIVER BASIN  
NASHUA, NEW HAMPSHIRE

MINE FALLS DAM

PHASE I INSPECTION REPORT  
NATIONAL DAM INSPECTION PROGRAM

MARCH 1979

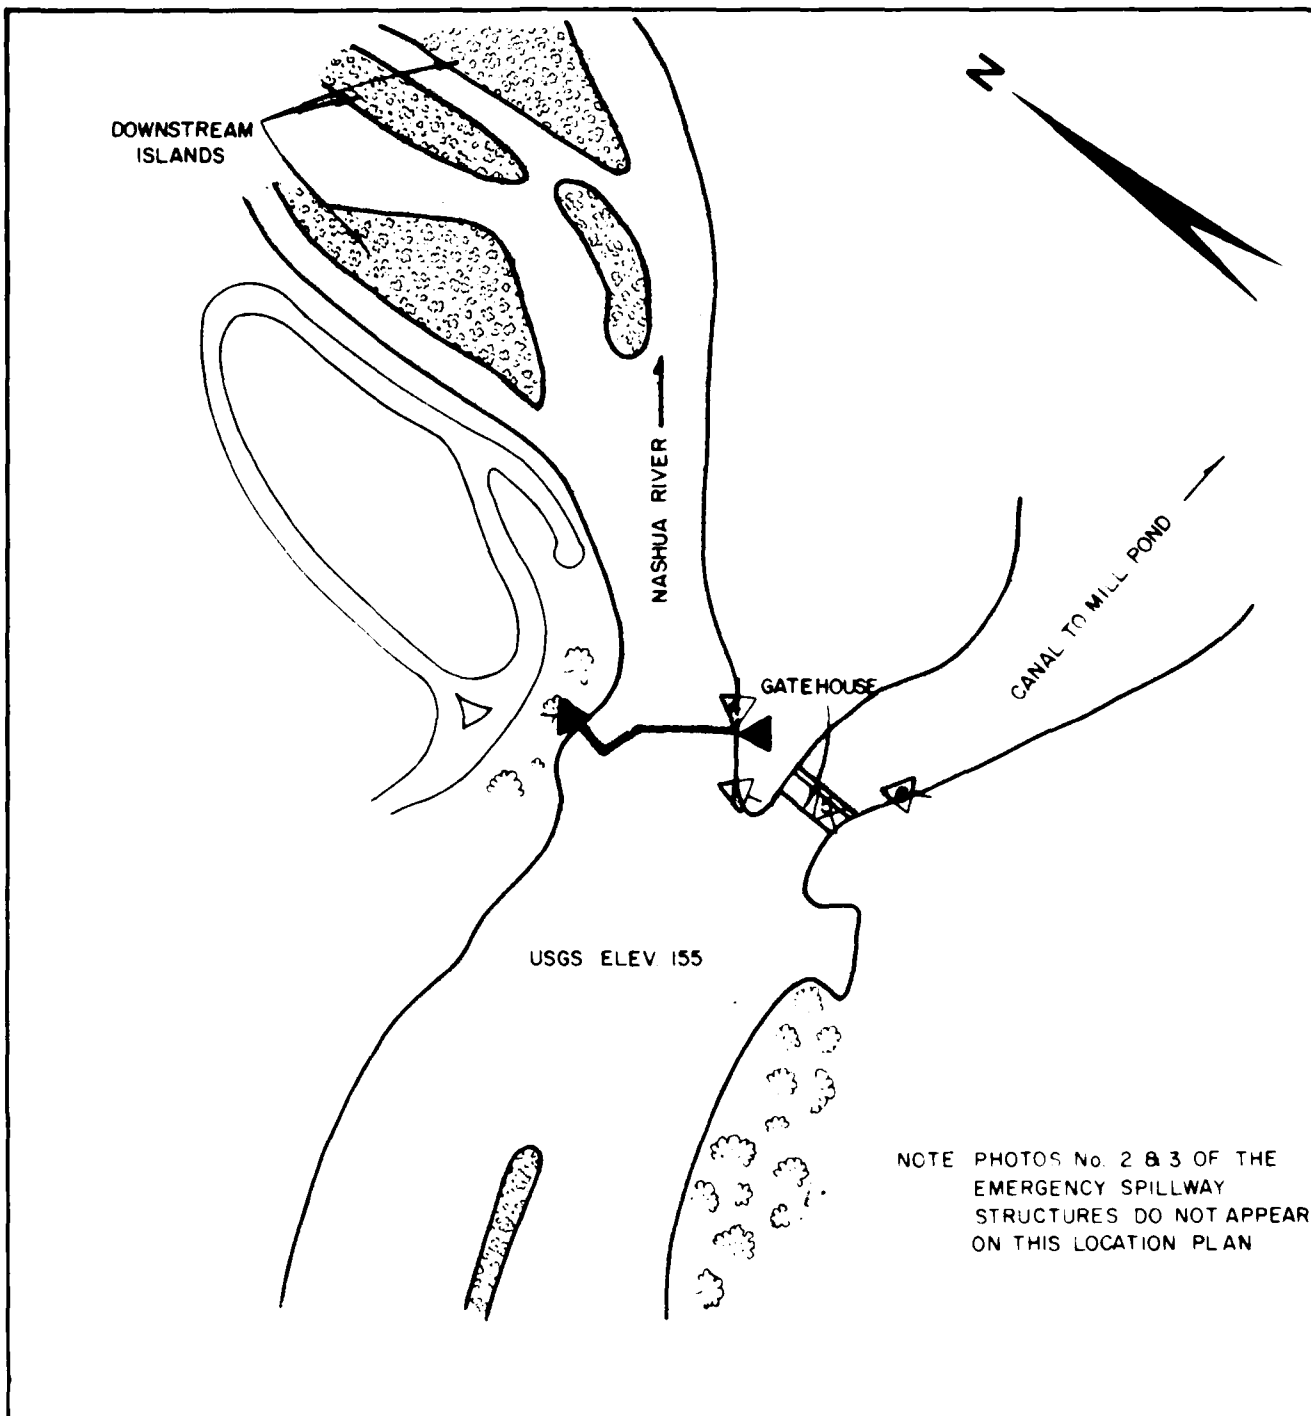
GOLDBERG, ZOINO, DUNNICLIFF & ASSOC., INC. GEOTECHNICAL CONSULTANTS NEWTON UPPER FALLS, MASS		U.S. ARMY ENGINEER DIV NEW ENGLAND CORPS OF ENGINEERS WALTHAM, MASS	
NATIONAL PROGRAM OF INSPECTION OF NON-FED. DAMS			
SITE PLAN			
MINE FALLS DAM		NEW HAMPSHIRE	
		SCALE 1" = 200'	
		DATE NOVEMBER 1978
