CONNECTICUT RIVER BASIN  
PITTSBURG, NEW HAMPSHIRE

**FIRST CONNECTICUT LAKE DAM****NH 00186****NHWRB 194.02**

**PHASE I INSPECTION REPORT**  
**NATIONAL DAM INSPECTION PROGRAM**

MAY 1979

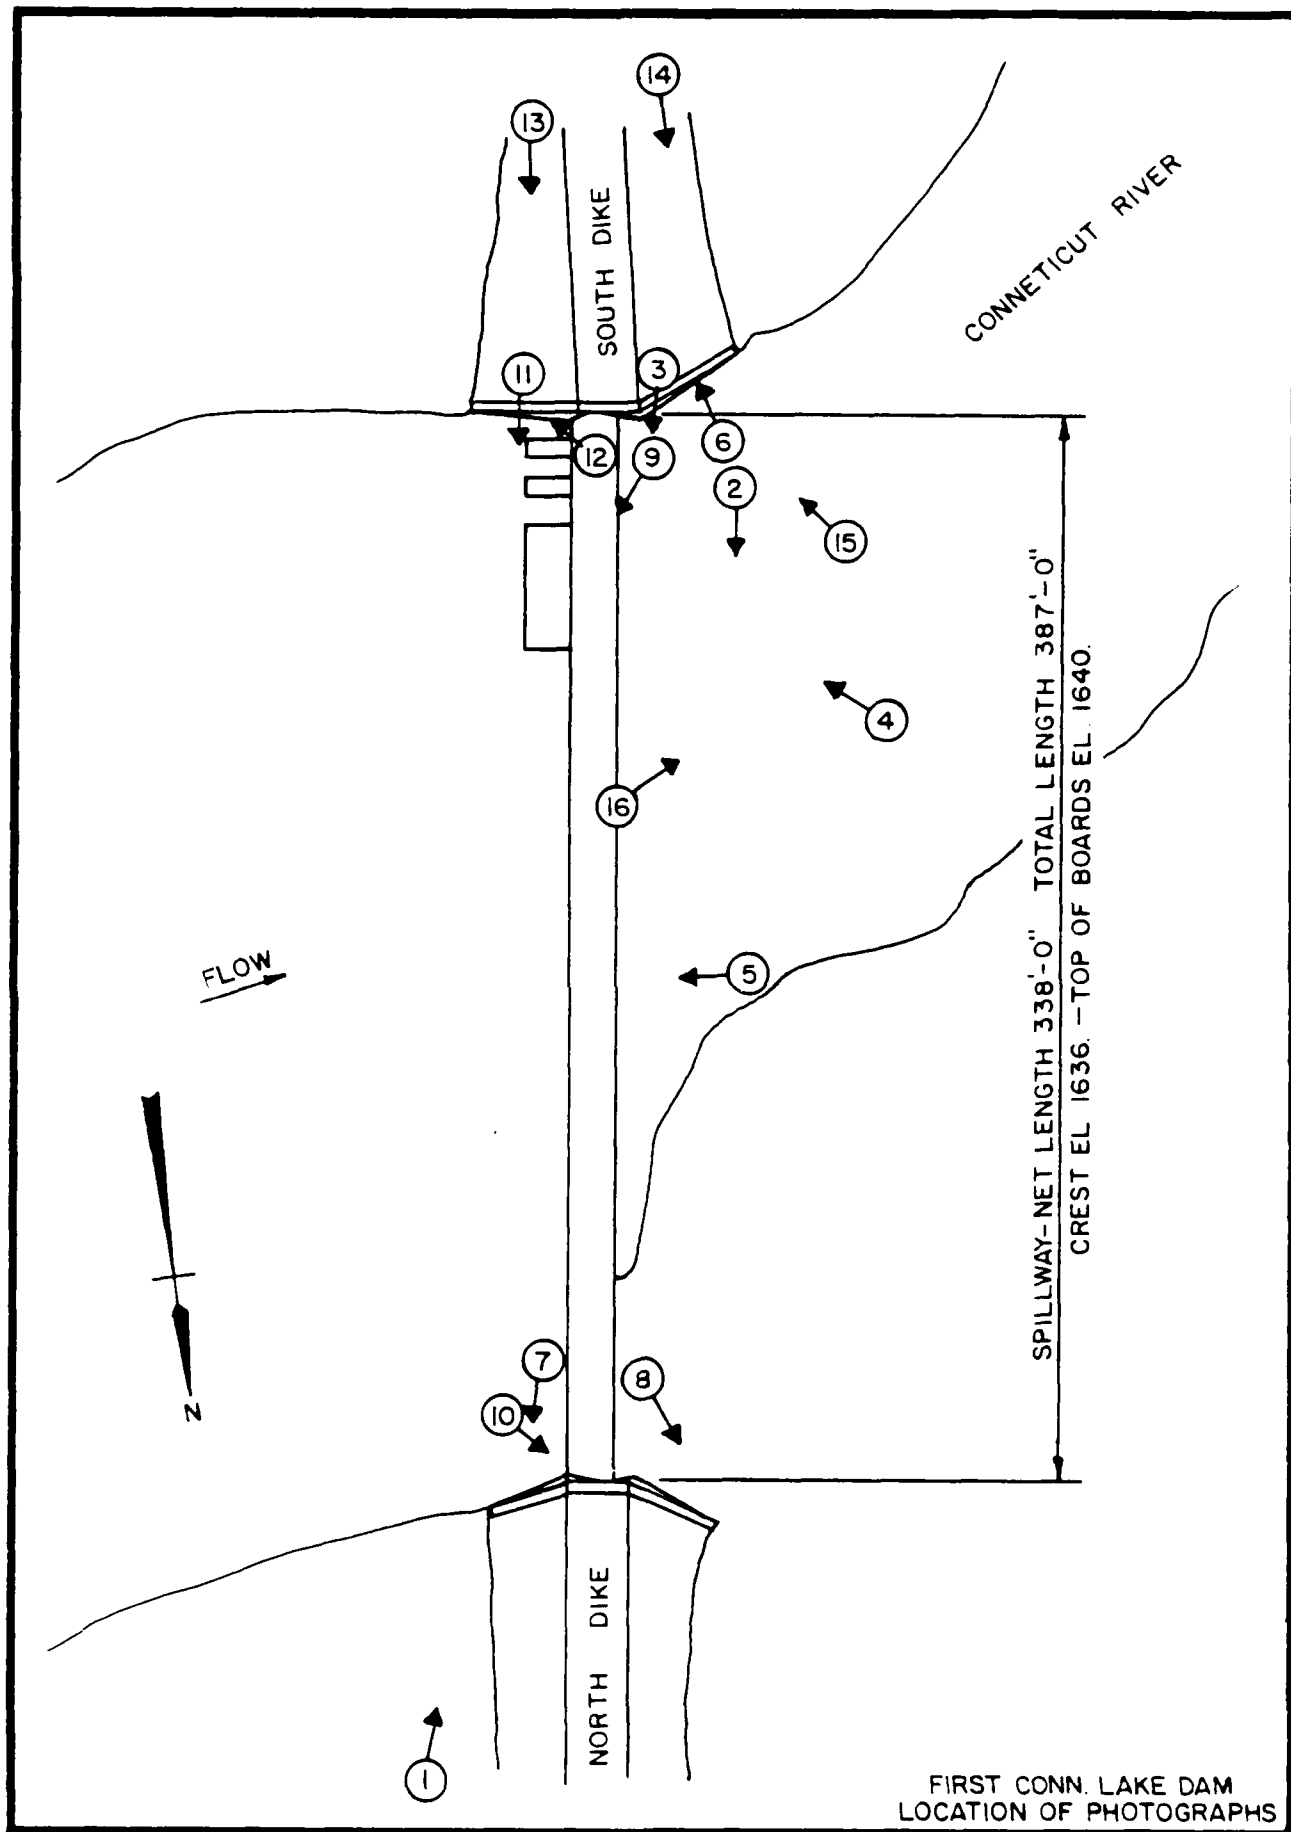
FIRST CONN. LAKE DAM  
LOCATION OF PHOTOGRAPHS

| <u>No.</u> | <u>Negative No.</u> | <u>Page</u> |
|---|---|---|
| 15. Erosion of south bank downstream.<br>On the left: south abutment above,<br>retaining wall below. | 9-36A | C-11 |
| 16. Downstream channel is Connecticut<br>River, looking from the footbridge. | 10-3 | C-11 |
