MERRIMACK RIVER BASIN
NEW DURHAM, NEW HAMPSHIRE

MERRYMEETING LAKE DAM
NH 00342

PHASE I INSPECTION REPORT
NATIONAL DAM INSPECTION PROGRAM

OCTOBER 1978
85 06 27 027

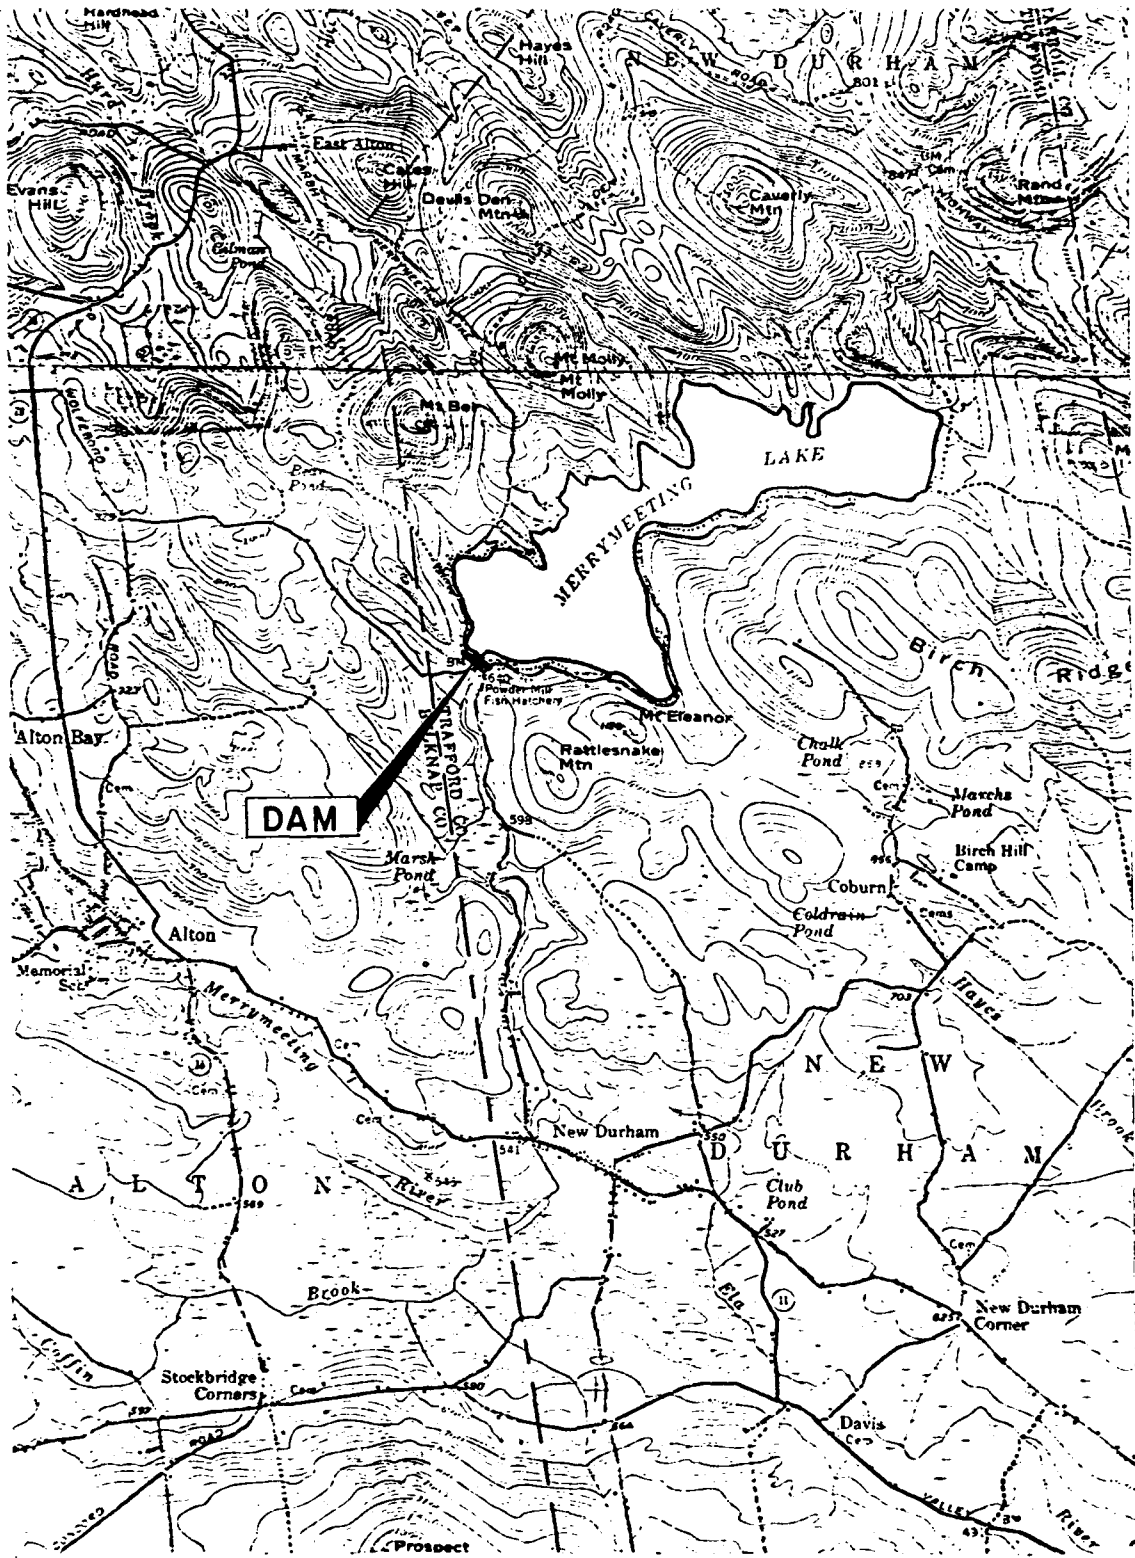
MERRYMEETING LAKE DAM

View of the dam from the downstream side. The low level outlet gate house is in the center. The zone of seepage is demarcated by the end of the cut grass area and the swamp-type vegetation below it.

It is recommended that the owner, within 12 months after receipt of this Phase I Report, acquire basic engineering data that would allow the proper assessment of the seriousness of the observed seepage and its effect on the stability of embankment's toe slope.
