MERRIMACK RIVER BASIN  
WILTON, NEW HAMPSHIRE

HILLSBOROUGH MILLS DAM

PHASE I INSPECTION REPORT  
NATIONAL DAM INSPECTION PROGRAM

APRIL 1979

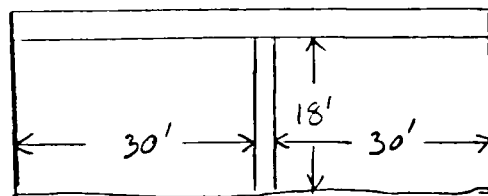
Railroad Bridge  $\frac{1}{2}$  mile d/s of dam

$$\begin{aligned} \text{Flow area at depth of } 16.8' \\ = 60 \times 16.8 = 1008' ^2 \end{aligned}$$

$$\begin{aligned} \text{Flow area of natural channel at depth of } 16.8' \\ \approx 1070' ^2 \end{aligned}$$

Bridge represents little constriction. Flow depth should not reach lower chord.

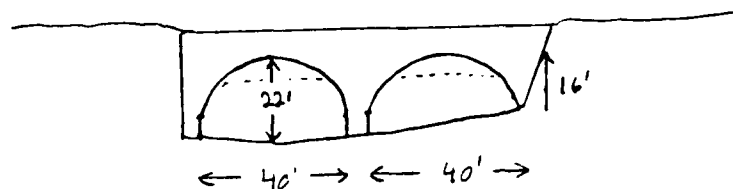
Highway Bridge 3000' d/s of dam

Flow area at depth of 16.8'  
 $\approx 33 \times 16.8 + 33 \times 14 = 1016' ^2$

Bridge represents little constriction. Flow depths should not reach top of opening
