SOUHEGAN RIVER WATERSHED  
DAM NO. 35

NH 00435  
NHWRB 175.21

PHASE I INSPECTION REPORT  
NATIONAL DAM INSPECTION PROGRAM

AUGUST 1979

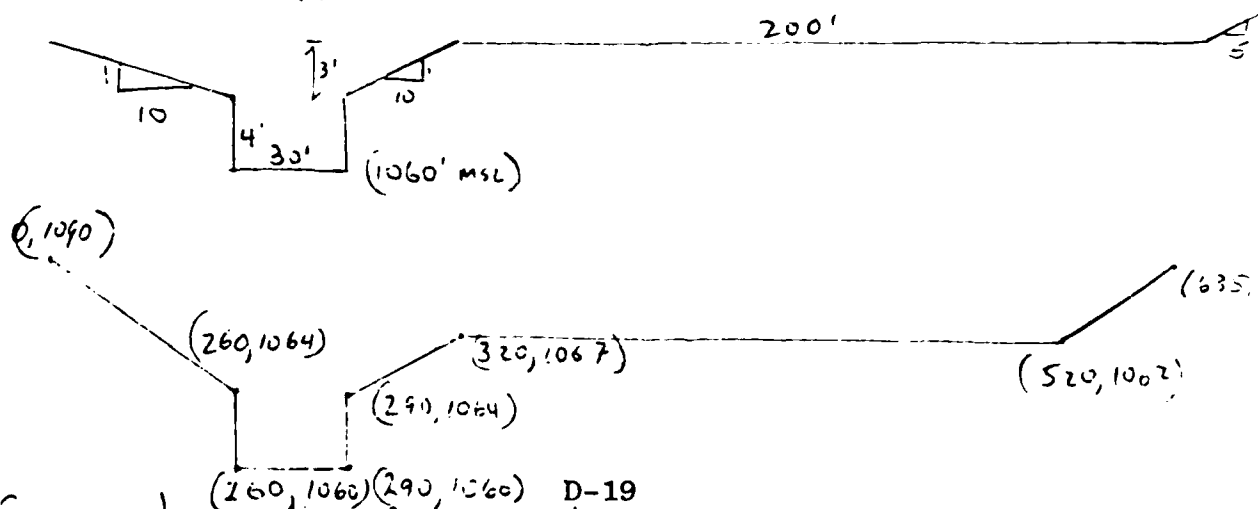
The channel just downstream of S.R.W. Dam #35 has approximately this cross-section (from field notes)

From sheet 4 of S.C.S. plans, D-19  
 $S = 1.0123$ ,  $n = 0.35$   
2.16 is a normal flow depth.

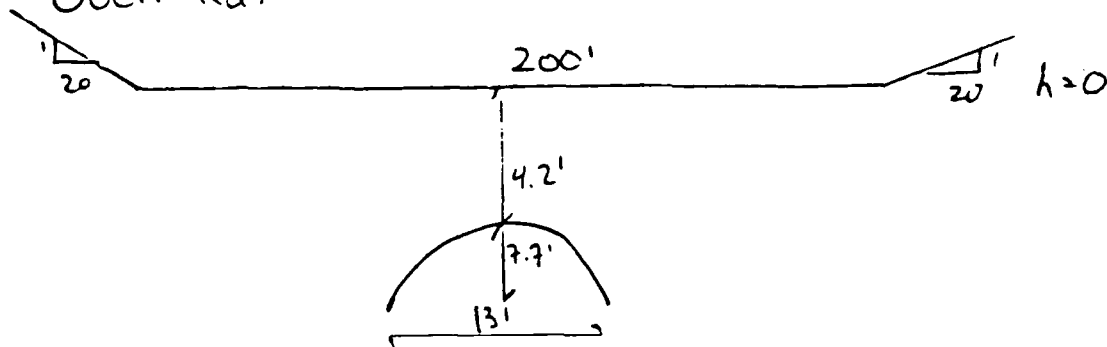
Goen Rd:

At high flows, the water level upstream of Goen Rd is controlled by the road embankment and culvert.

The flow through the culvert is estimated from FHWA Hydraulic Engineering Circular #5.

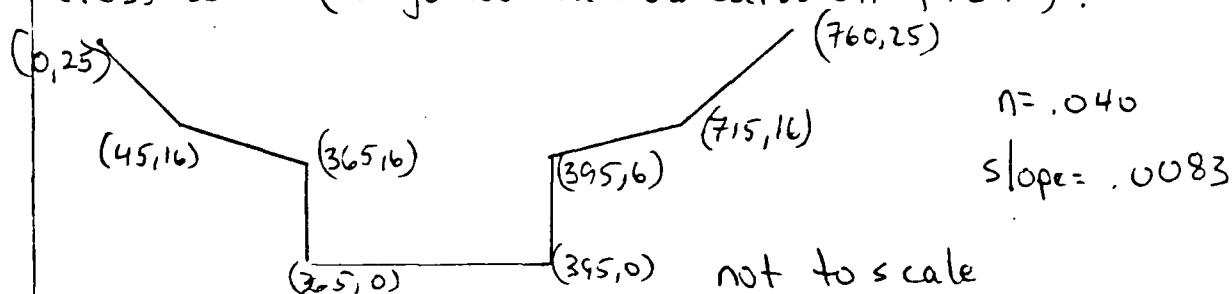
The next area of concern downstream of Smithville is a lumberyard about 3800 ft. downstream. The reach between Smithville and this lumber yard has this as a typical cross-section (Stage-Normal Flow curve on p. 24):

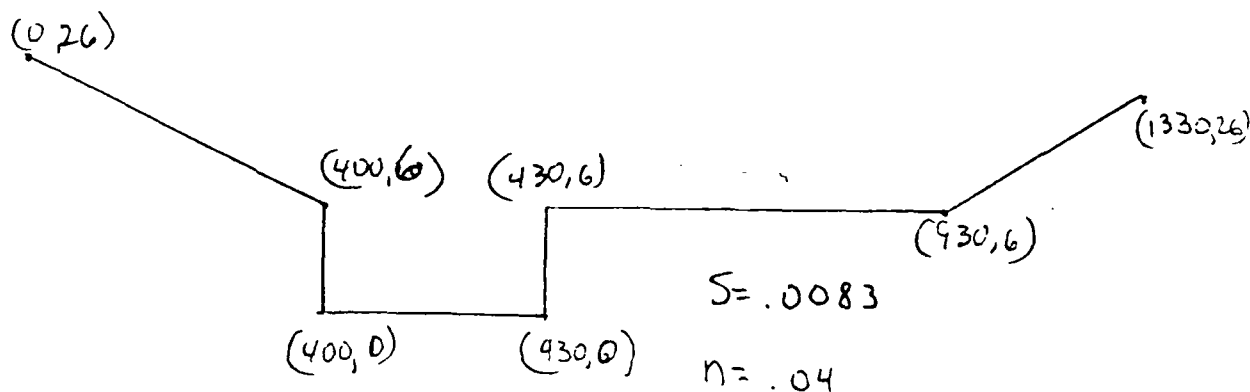
The next damage location downstream is Ashby Rd. Bridge, some 2800' downstream. The cross-section through this reach is approximately this:

The Stage - Normal Flow curve for this cross-section is given on p. 27. Although Ashby Rd. Bridge does provide a constriction to flow, it is unlikely to cause significant back water effects at the flows we are considering, which would probably cause major damage to or failure of the bridge.

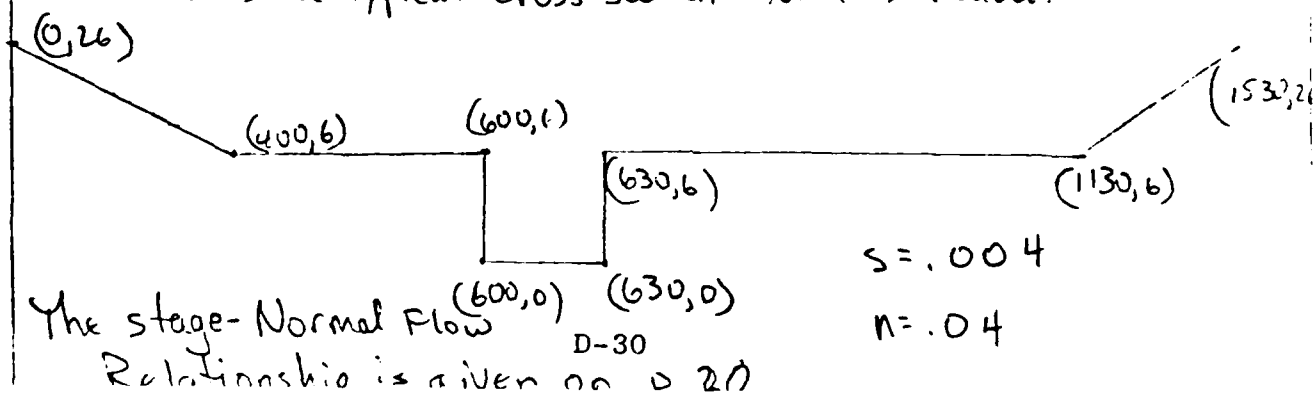
From the Ashby Rd. bridge, the stream proceeds about 3400' to the Souhegan River. The West Branch passes under River Rd. through two 6' c.m.p. culverts in this reach. At the flows we are considering, River Rd. would be seriously overtopped and probably washed out.

Here is a typical cross-section for this reach:
