SPOFFORD LAKE DAM

NH 00356

PHASE I INSPECTION REPORT  
NATIONAL DAM INSPECTION PROGRAM

NOVEMBER 1978

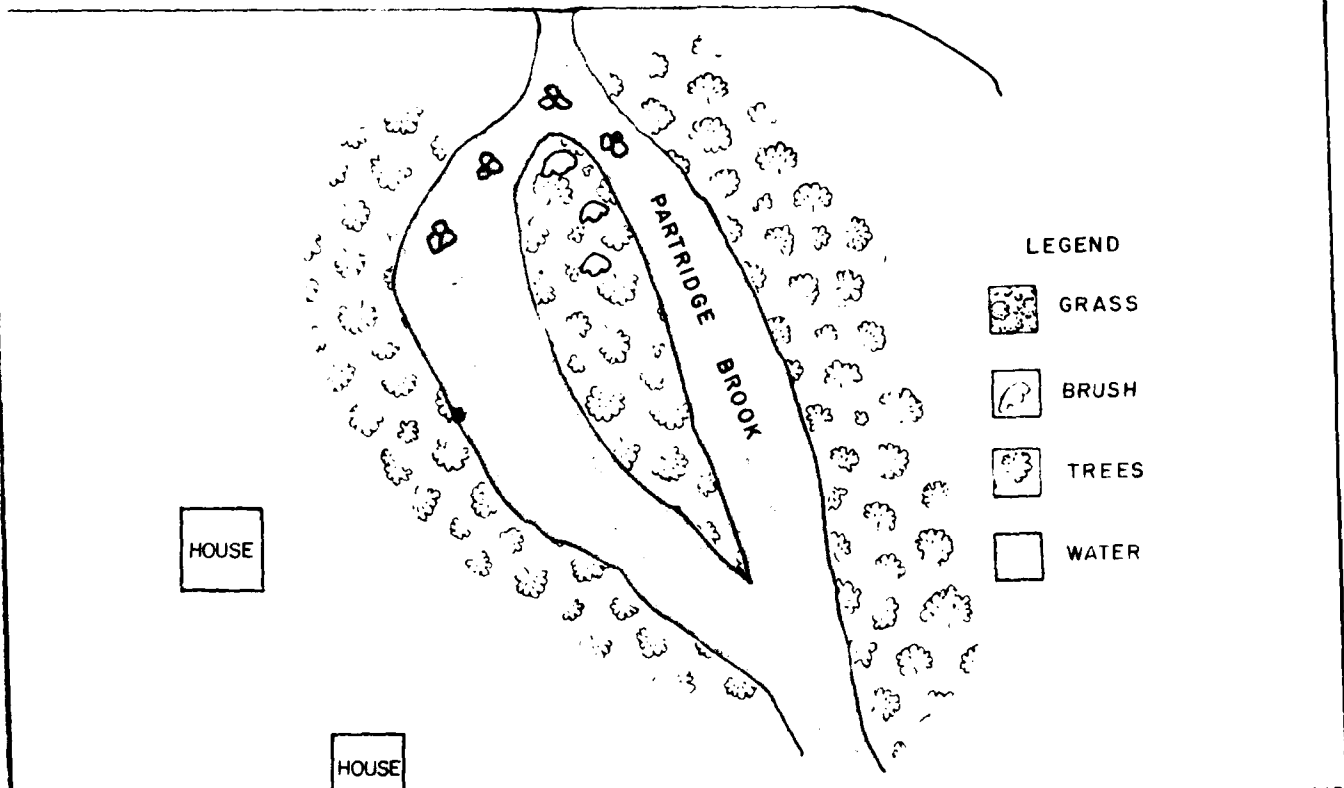
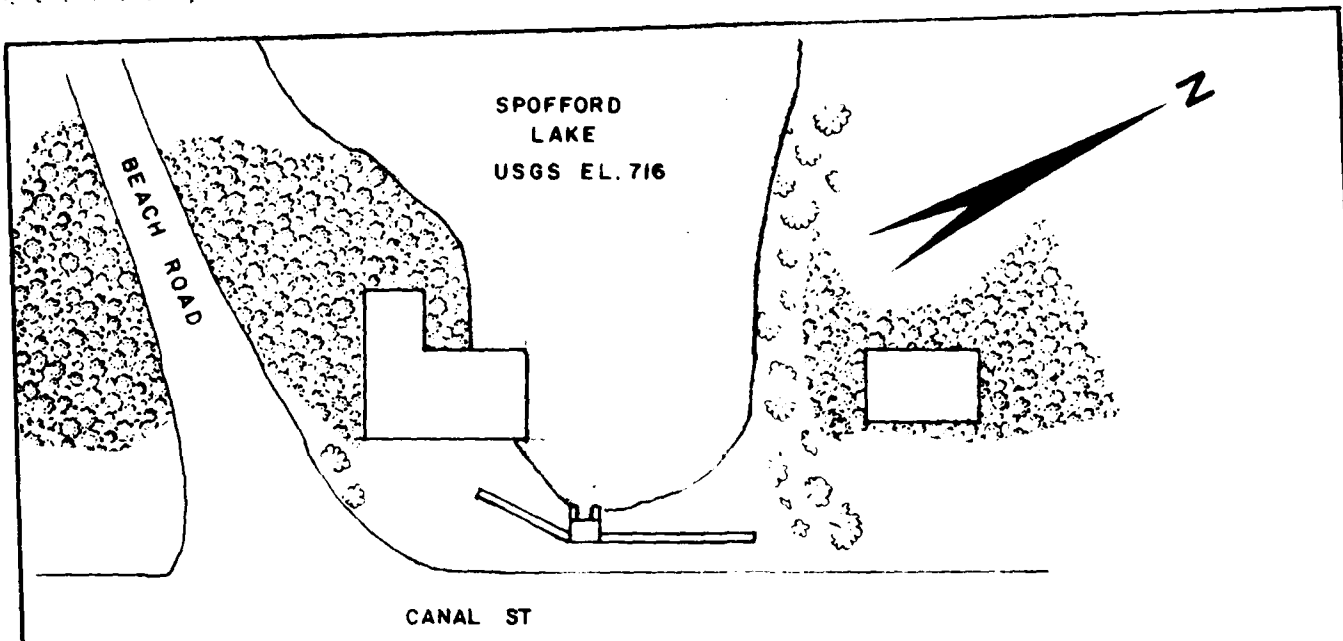
Spofford Lake Dam lies on Partridge Brook in the village of Spofford, NH. Canal Street runs directly over the dam and the site is easily reached via Routes 9 and 9A. The portion of the USGS Keene, NH quadrangle presented on page viii shows this locus. Figure 1 of Appendix B presents a site plan developed from historical records and the site visit.

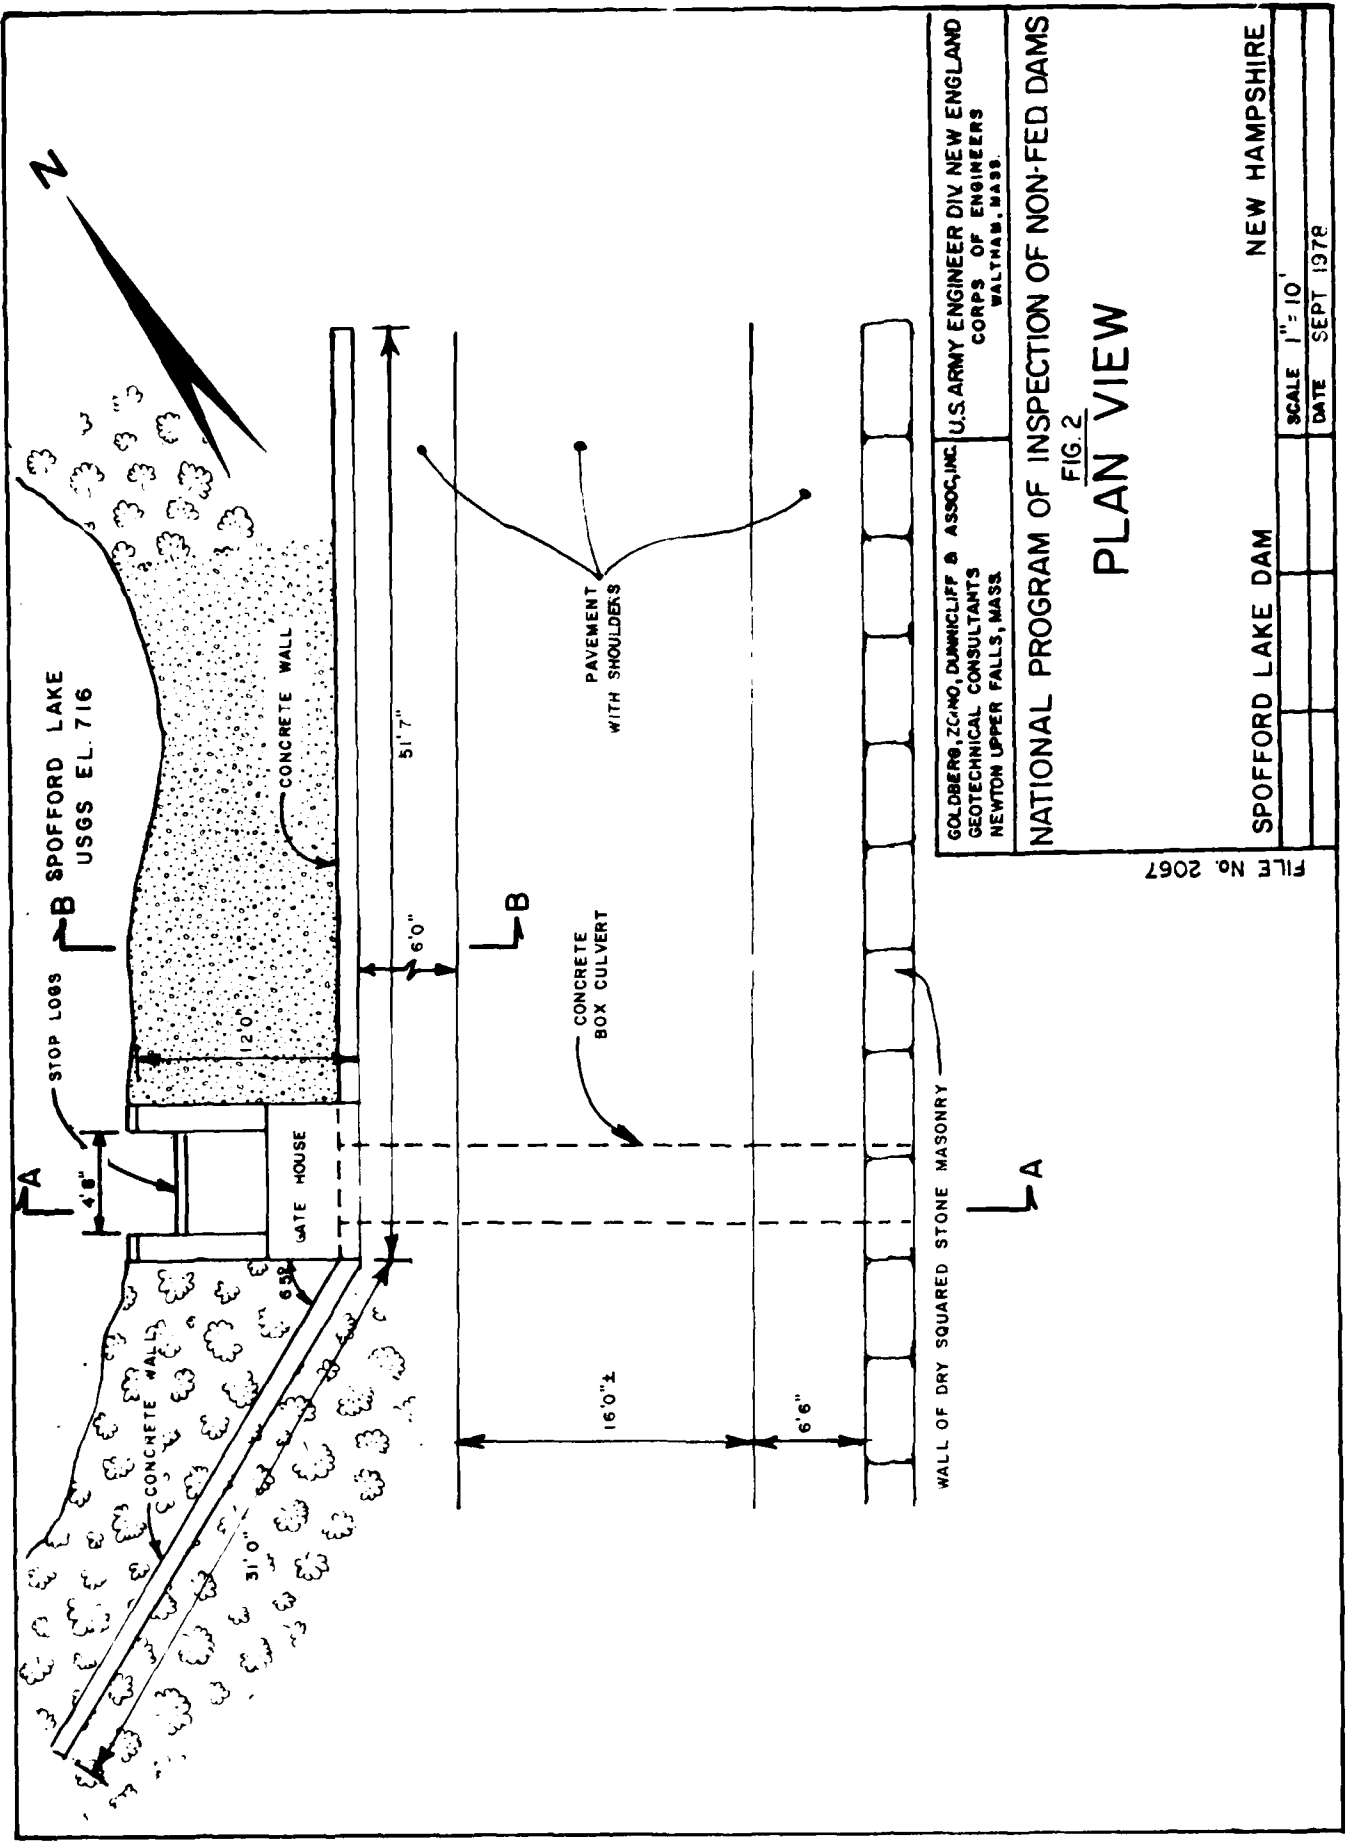
NATIONAL PROGRAM OF INSPECTION OF NON-FED DAMS  
 FIG. 2

The dam is basically an 83 foot long earth-filled masonry crib with a concrete wall serving as the upstream face and a squared stone masonry wall forming the downstream face (Figures 2, 4 and 5). A considerable quantity of loose gravel has been dumped in front of the upstream wall (Figure 5). The dam is approximately 28 feet wide and has a maximum height of almost 11 feet (Figure 4). Discharge at the dam is through a concrete culvert which is 4 feet wide by 3 feet 9 inches high at the upstream concrete wall and which decrease slightly in size as it passes under Canal Street. A steel sluice gate, still in place, but badly deteriorated, once controlled flow into the culvert. A 4 foot 9 inch wide stoplog weir, installed on the recommendation of the New Hampshire Water Resources Board in 1955, now performs this function. The dam has no functional spillway in its present configuration.
