CONNECTICUT RIVER BASIN
ROXBURY, NEW HAMPSHIRE

BABBIDGE RESERVOIR DAM

PHASE I INSPECTION REPORT
NATIONAL DAM INSPECTION PROGRAM

AUGUST 1981

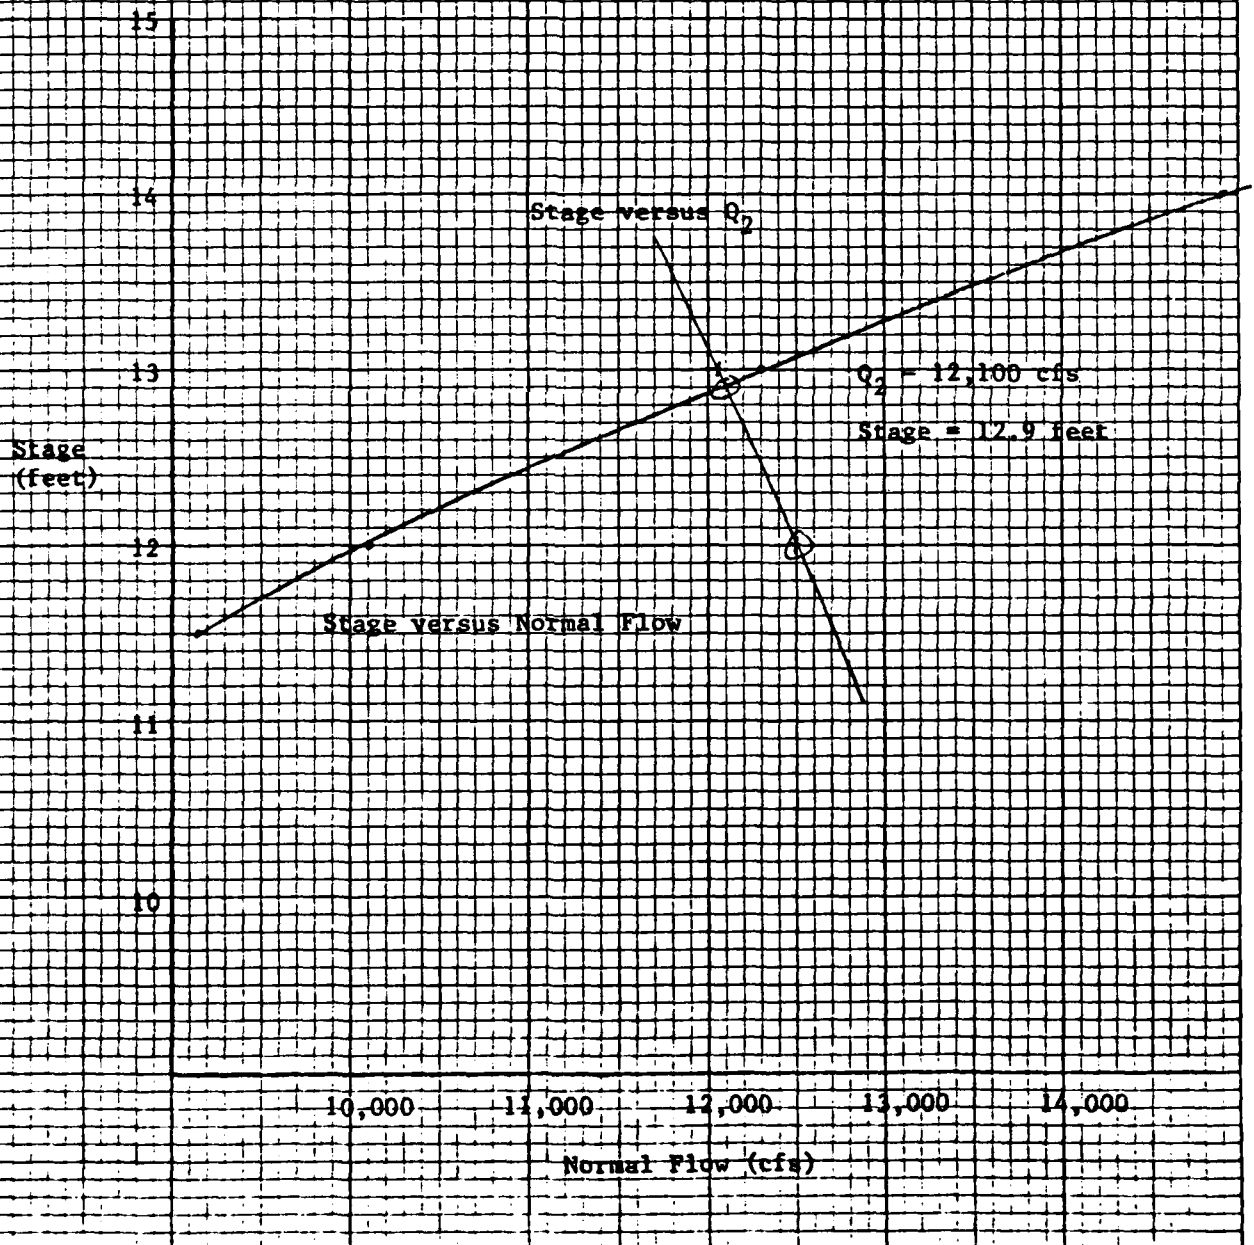
Reach on Otter Brook

dam failure flow gives approximately 16,800 cfs and a stage of about 14.7 feet at the upstream end of this reach. The flow area at the upstream end would be about 1348 square feet (1460 - 112). The attenuation due to stream storage is shown on the next page.

As shown in the calculations, the attenuated peak stage at the end of this reach is 12.9 feet above the streambed. Otter Brook then merges with Minnewawa Brook and the peak stage is further reduced. Although further damage is possible in the area of South Keene, it is expected that the wider channel of Otter Brook would reduce the peak stage enough so that the damage would be minor as compared to the damage potential at the junction of Roaring Brook and Otter Brook.
