MERRIMACK RIVER BASIN
PITTSFIELD, NEW HAMPSHIRE

BERRY POND DAM

NH 00105

PHASE I INSPECTION REPORT
NATIONAL DAM INSPECTION PROGRAM

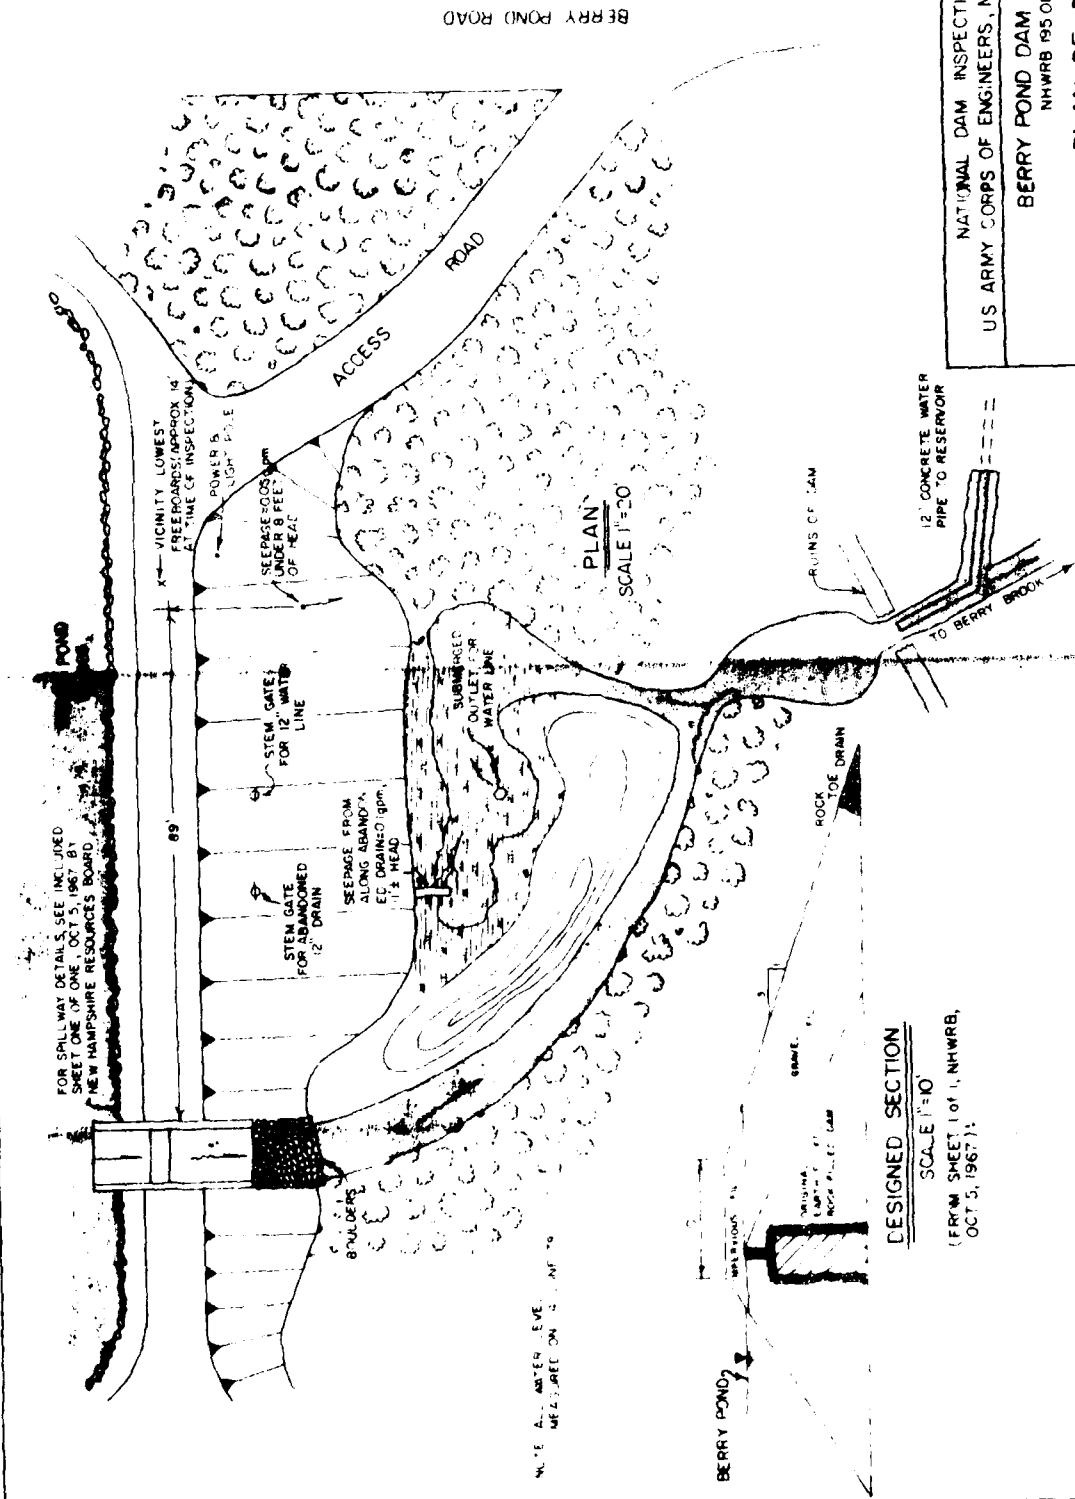
NATIONAL DAM INSPECTION PROGRAM
U.S. ARMY CORPS OF ENGINEERS, NEW ENGLAND DIVISION
BERRY POND DAM NH00105
NHWRB 195 01
PLAN OF DAM
JULY 1970 SCALE AS NOTED
FIG. 2

The dam is an earth embankment 185 feet long, 12 feet high with an 11 foot wide concrete spillway with stop-logs and spanning walkway as may be seen in Figure 2, Appendix B. The dam is built upon an earlier double rock wall, earth filled dam, now serving as a core. Three pipes originally penetrated the dam two of which are now non-operative. The third, an 8 inch water line with hand-operated stem valve in the downstream slope controls the yield of the pond, an average of 200,000 gallons per day being discharged to the outlet channel. Downstream, the flow is diverted from the natural water course into a 12 inch concrete pipe and canal, then into a distribution reservoir, with overflows going to White's Pond, then into the Suncook River downstream of Pittsfield center.
