WEBSTER DAM

NH 00378

PHASE I INSPECTION REPORT  
NATIONAL DAM INSPECTION PROGRAM

MARCH 1979

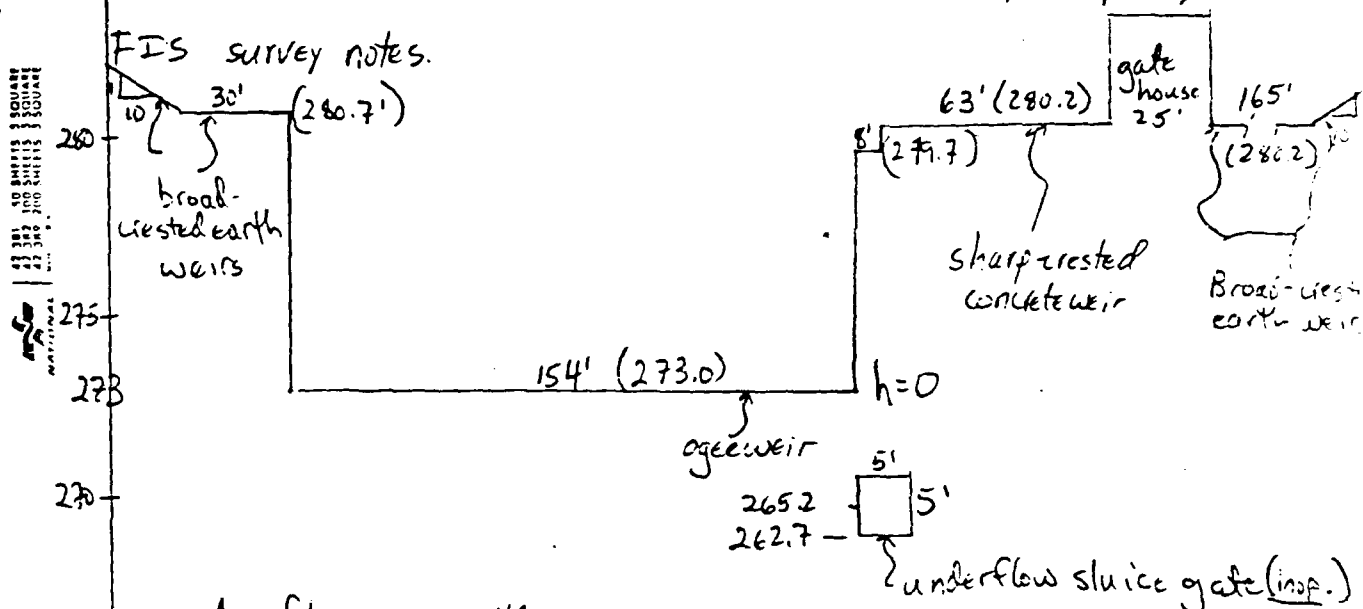
The information used to establish the cross-section at Webster Dam was determined from field notes, old plans, and Fico FIS survey notes.

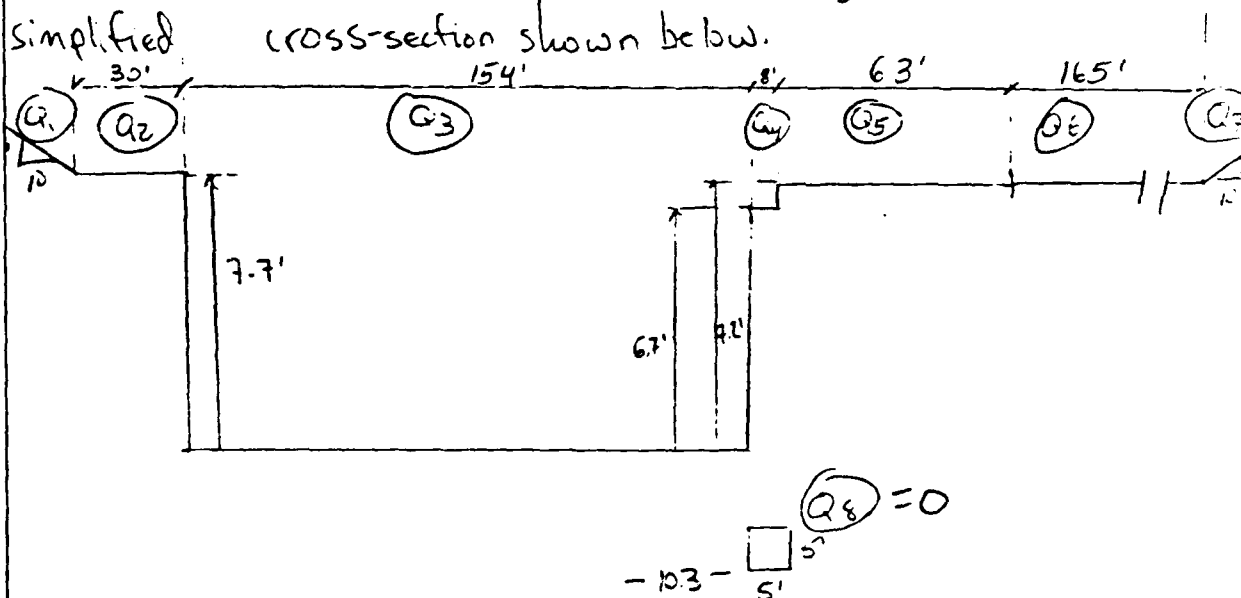
The flow over this cross-section is equivalent to that over the simplified cross-section shown below.

The canal gates controlled by the gate house to the right of the dam are inoperable. The 5' x 5' sluiceway under the dam is inoperable, and assumed to be closed.

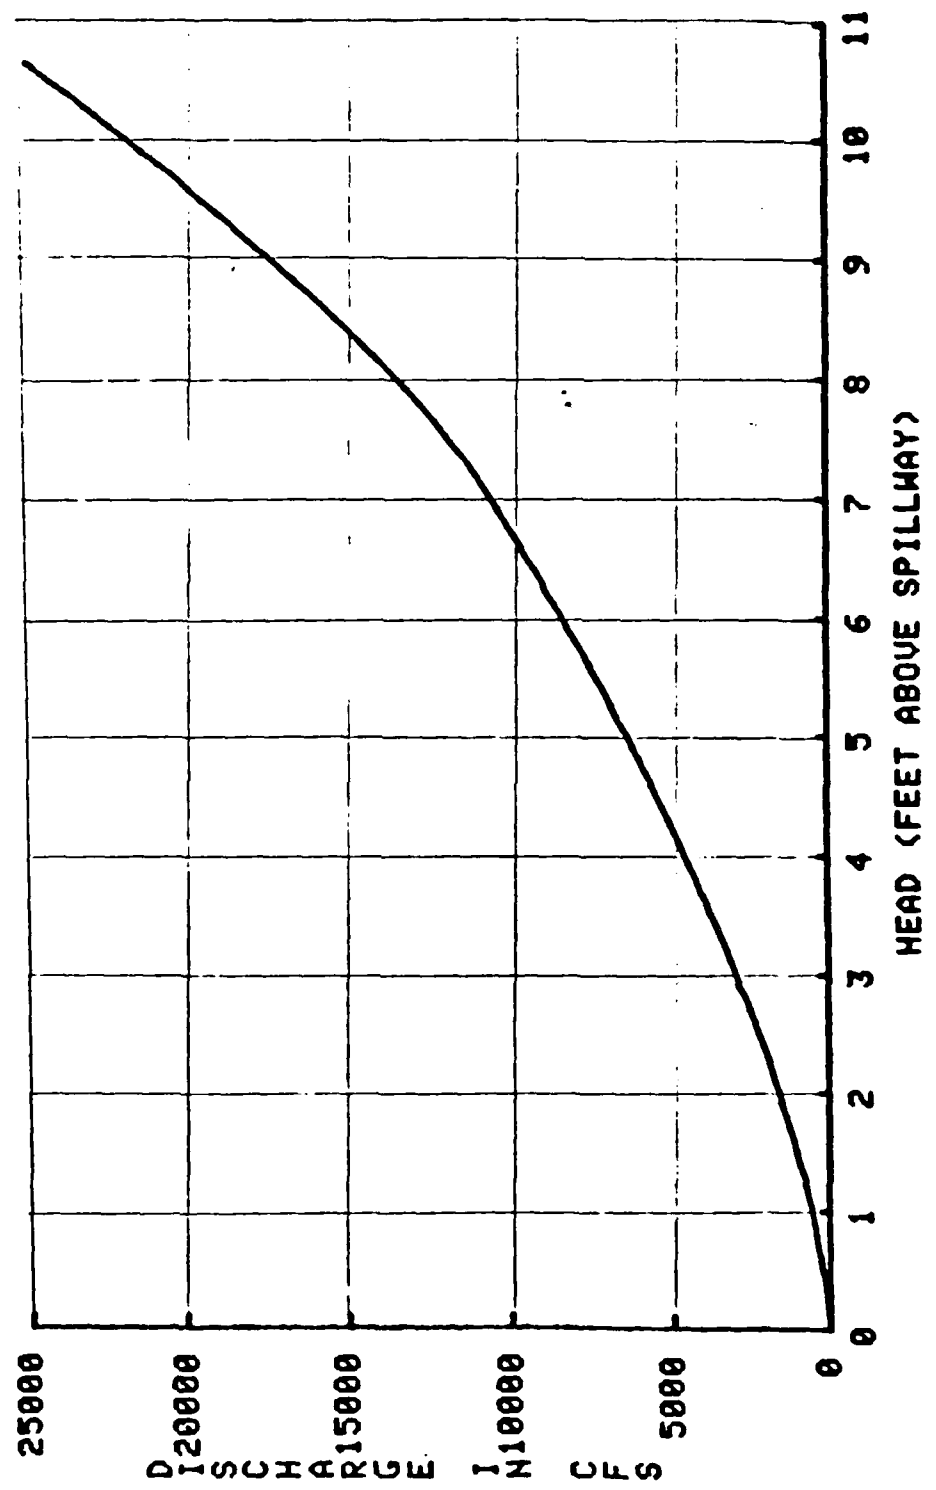
STAGE-DISCHARGE CURVE AT WEBSTER DAM

Assume that the dam fails when the water surface elevation reaches the crest on the right side, at  $h=7.2$  (elevation 280.2). From the stage-discharge curve, this would require a discharge of about 11,500 cfs.

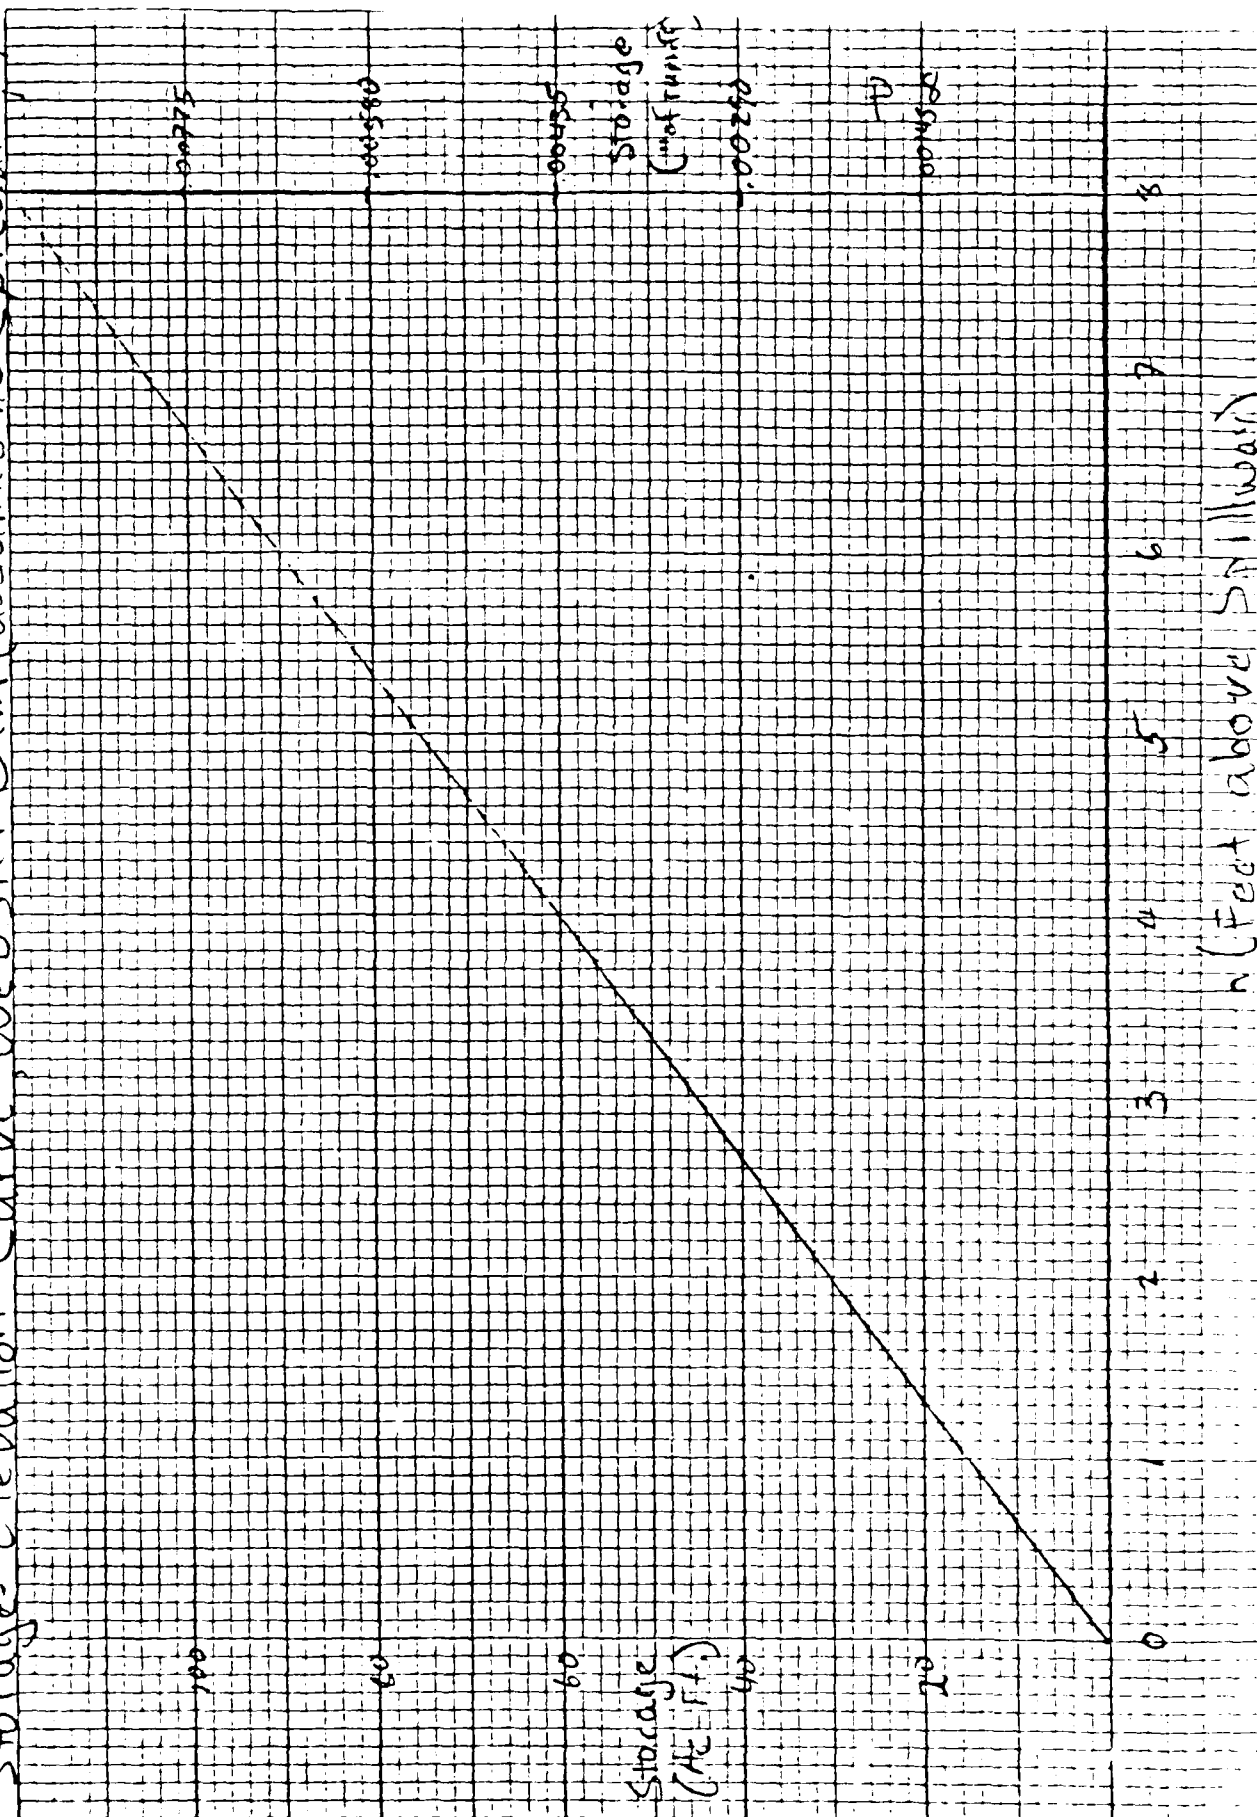
Storage-Elevation Curve, Webster Dam (Assumes no spreading)

The surface area of the pond created by Webster Dam is about 15 acres. The Storage elevation curve on p. 8 assumes no spreading as the pond rises.

1" of rise in the pond stores .00108 inches of rain

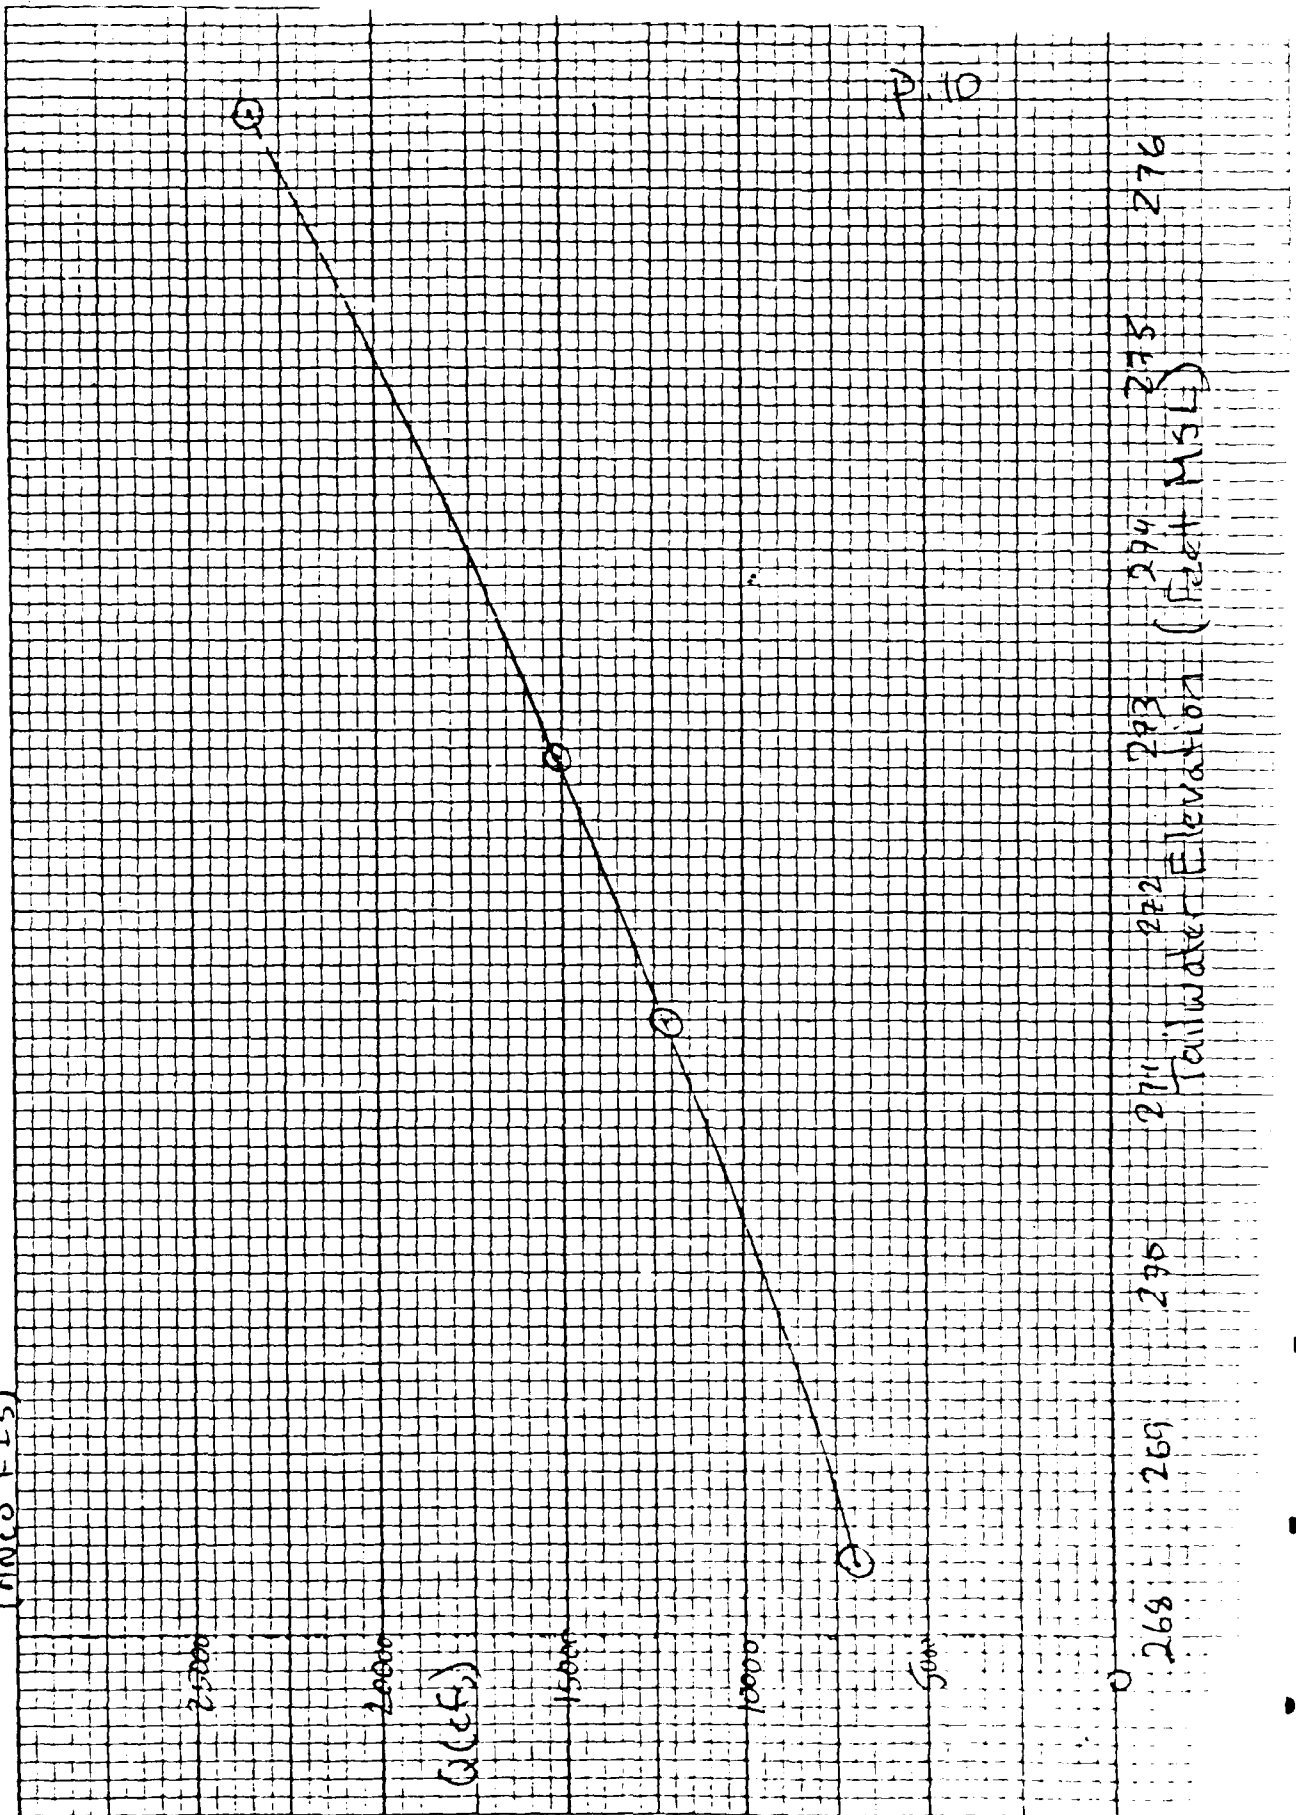
Discharge vs. tailwater elevation, Webster Dam (1 Foot downstream of dam)  
(ANCO FLS)

The sudden increase in outflow at failure would raise the tailwater 1.4', from 270.9 to 272.3'. There is no damage potential immediately downstream of the dam due to high banks and lack of development.

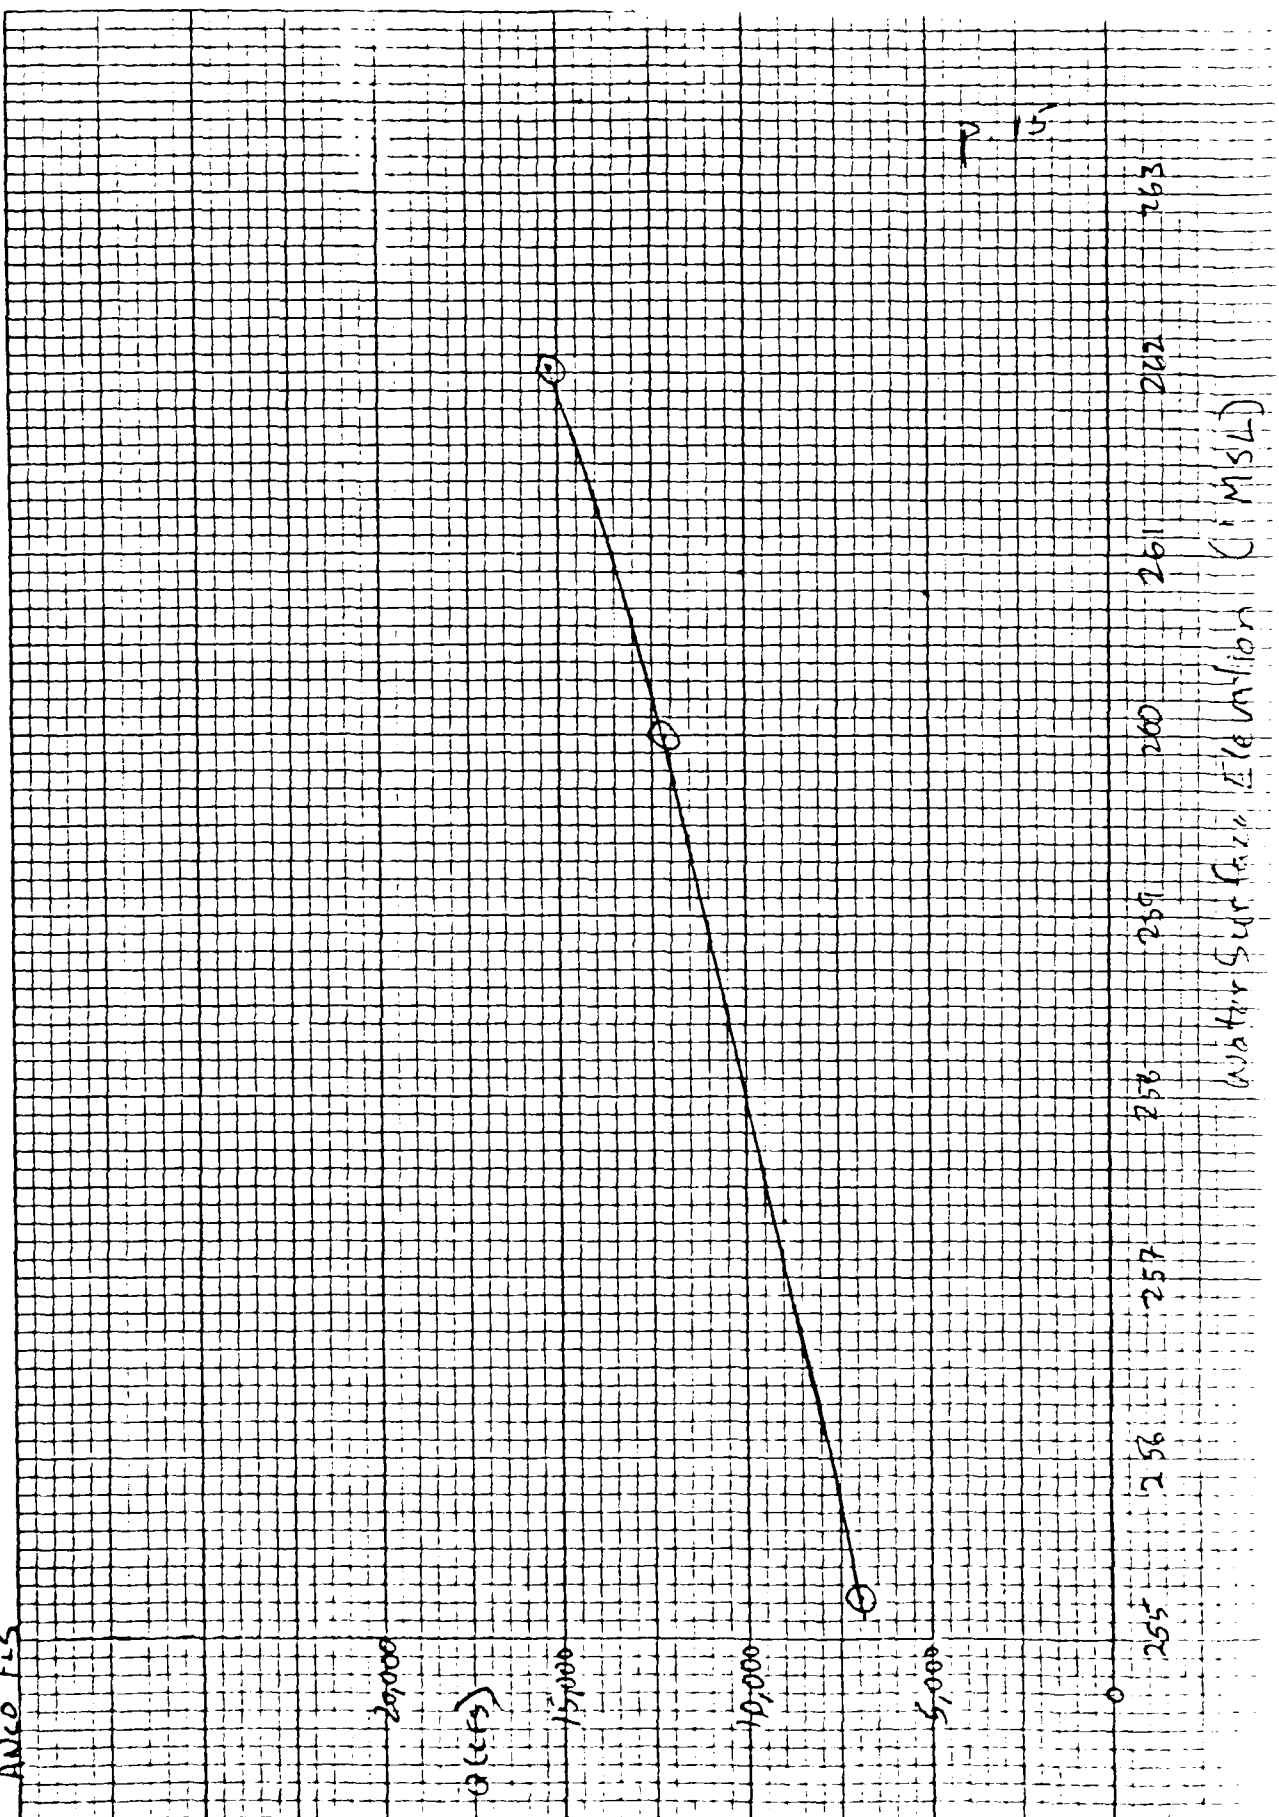
Discharge vs. Water Surface Elevation, Mill 1000' D.S. of Webster Dam  
 ALCO FIS

There is an old mill building about 1000' downstream of Webster Dam and about 400' upstream of the Main St. bridge. The Discharge-Elevation curve for the Suncook at this (from ANCO factory) is on p. 15. The factory is at elevation 255 (approximate).

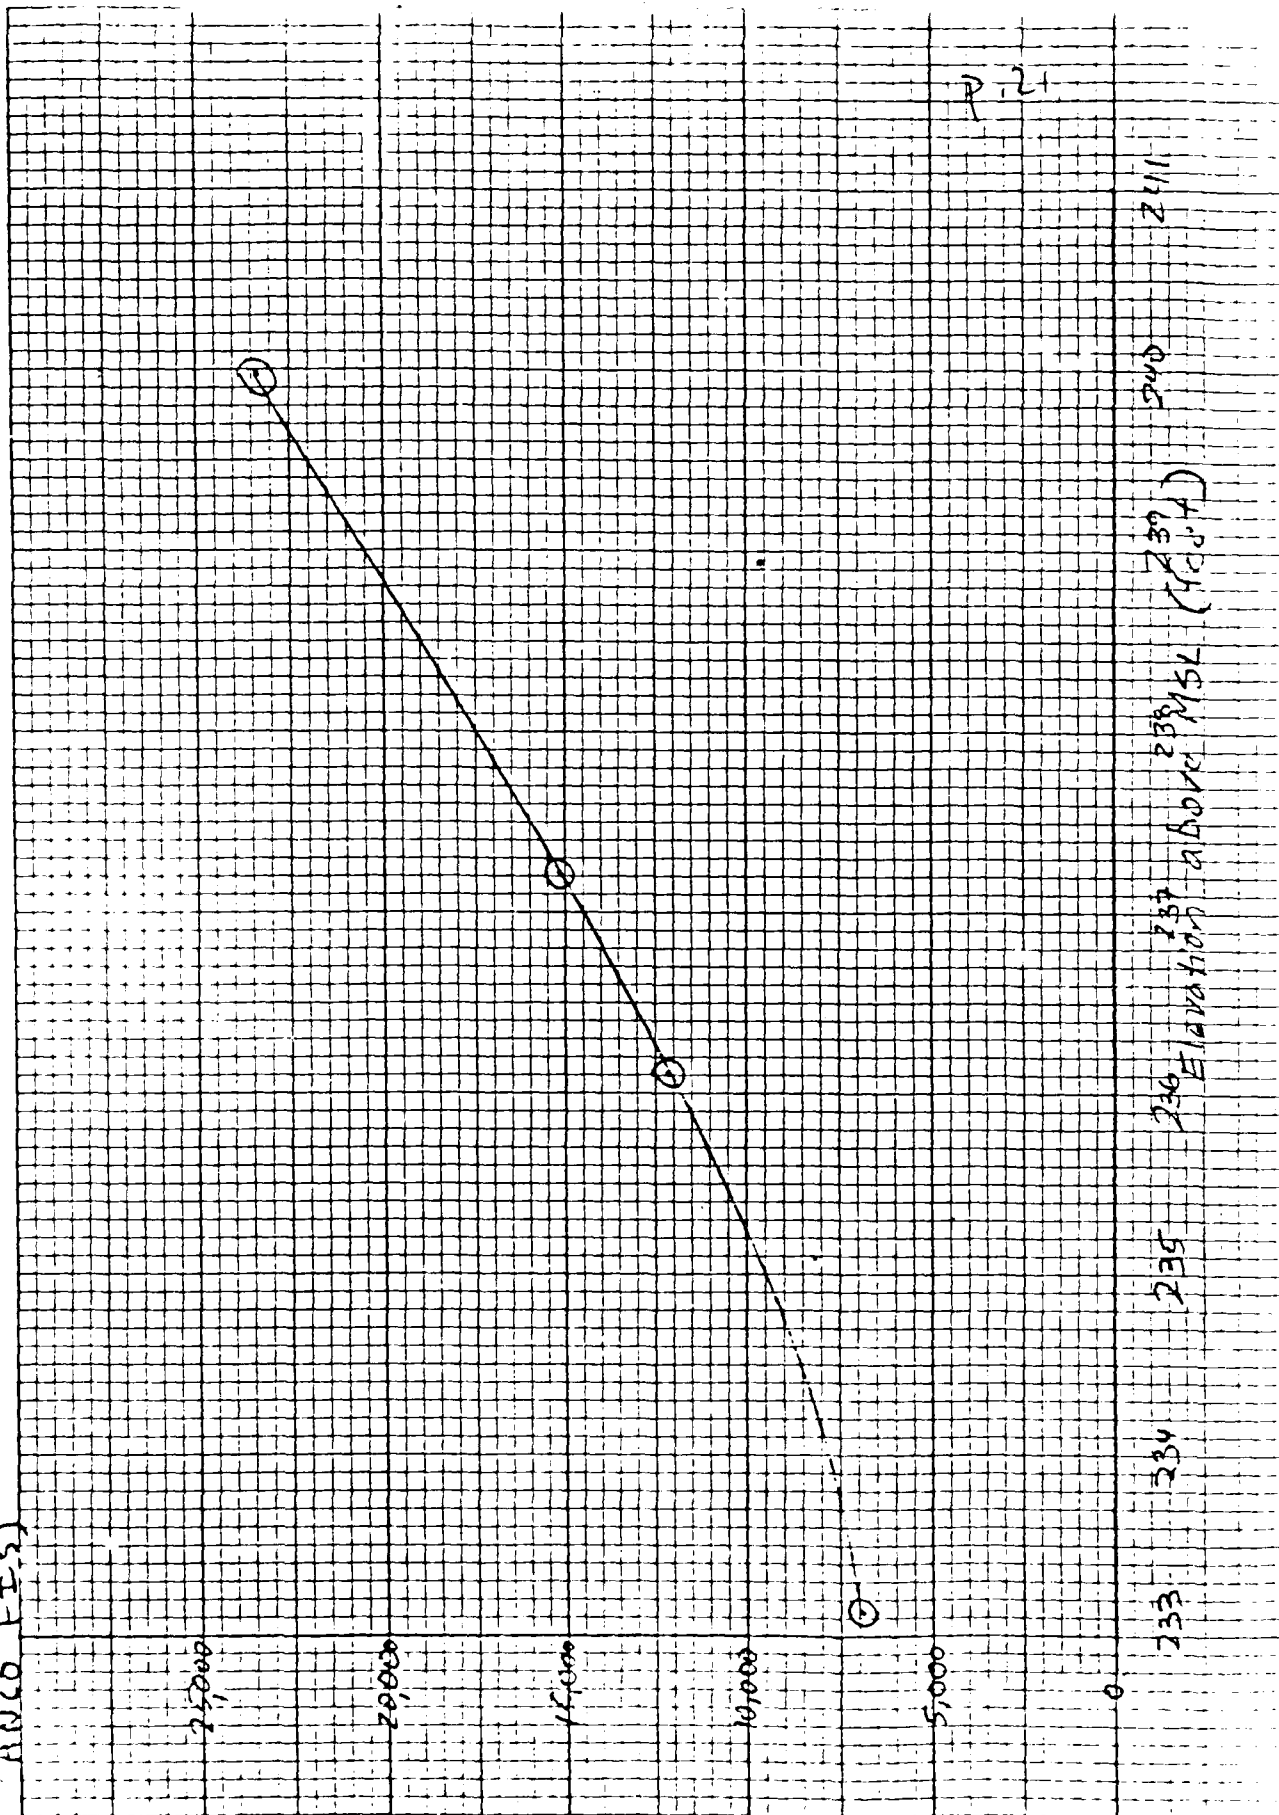
Discharge-Elevation Curve 650' downstream of Pembroke Dam  
ANCO F.I. 3

About 600' downstream of Pembroke Dam there are a number of homes on the north bank of the Suncook, at about elevation 239' above MSL. The discharge-elevation curve at this site is shown on p. 21

The pre-failure outflow of 11,100 cfs would create a water surface elevation of 235.7'. This would increase to 236.8' after failure with the flow of 14,000 cfs. Thus the flow would remain below the houses.
