**RICHELIEU RIVER BASIN
BELMONT VERMONT**

**STAR LAKE DAM
VT00010**

**PHASE I INSPECTION REPORT
NATIONAL DAM INSPECTION PROGRAM**

AUGUST 1978

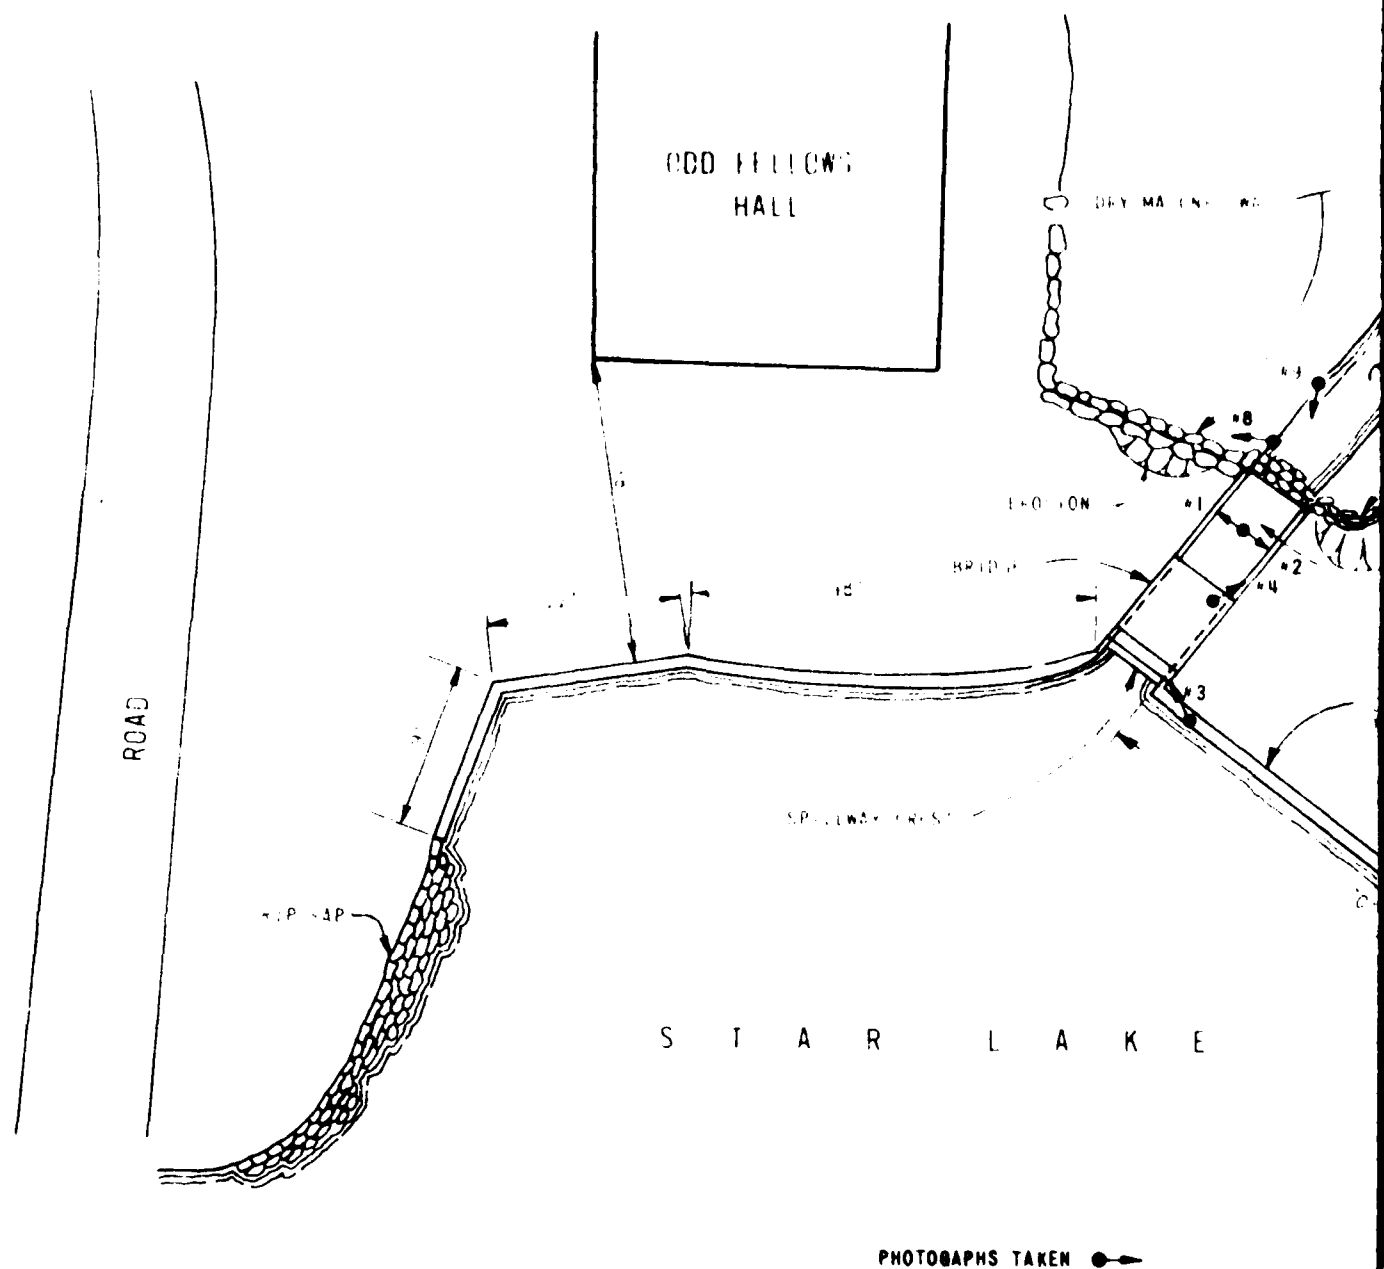
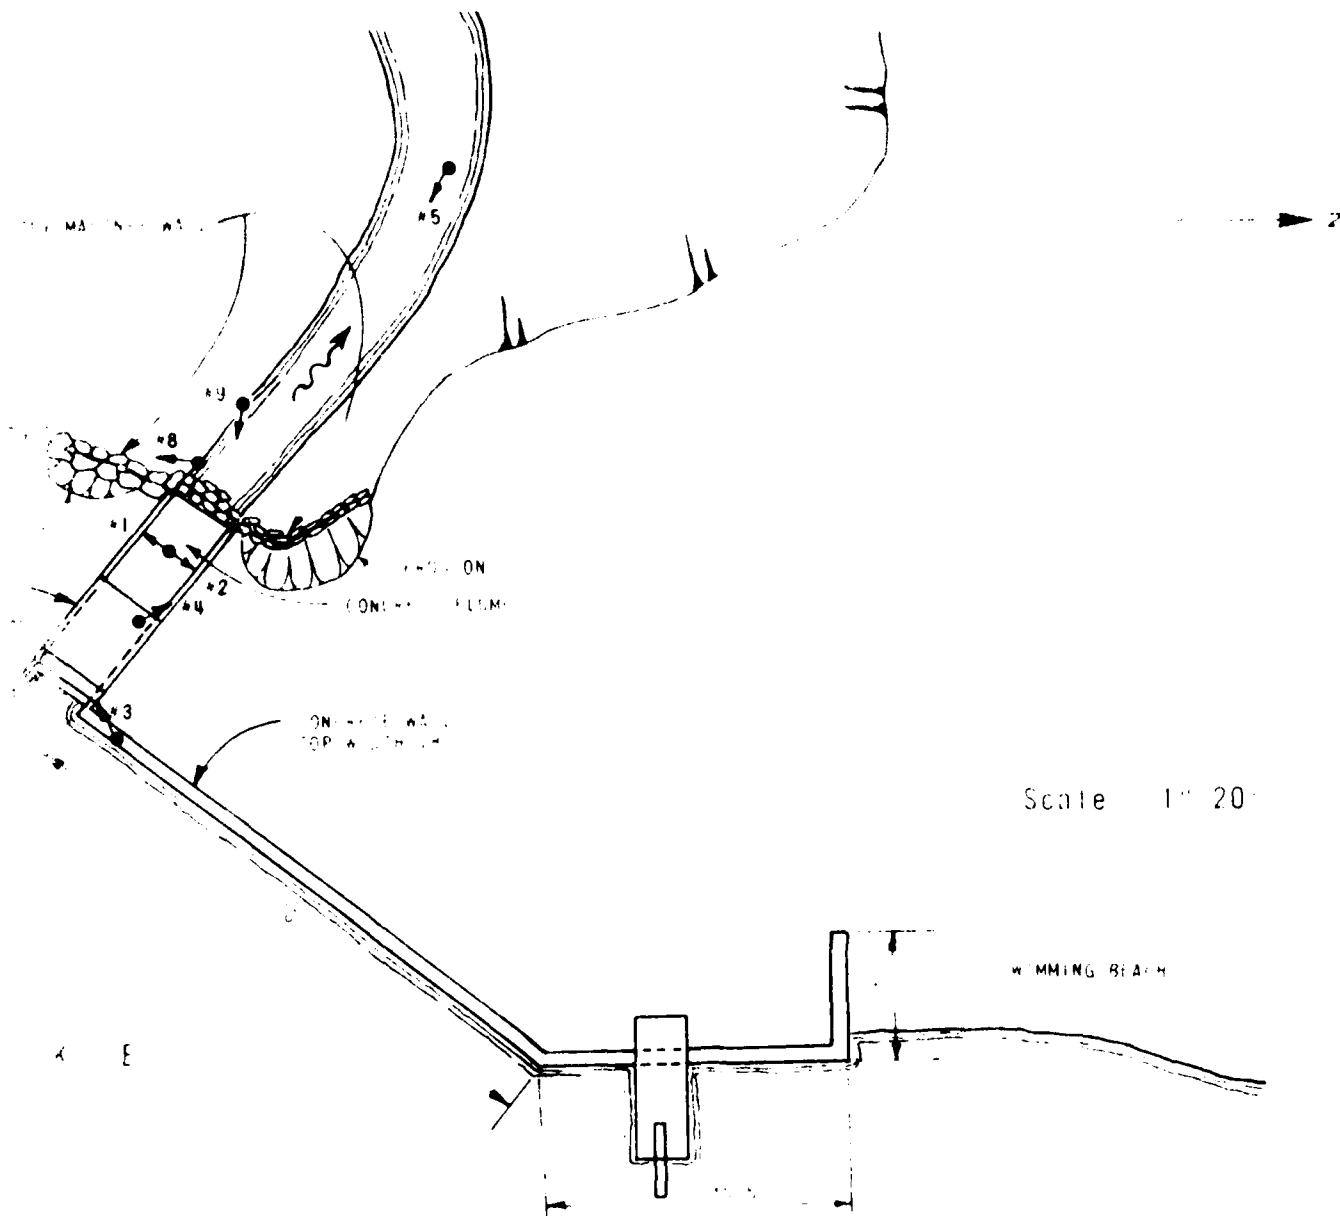
NOTE: PHOTOGRAPHS #6 AND #7 WERE TAKEN DOWNSTREAM (WESTERLY) FROM THIS SKETCH WHERE THE OUTLET STREAM PASSES UNDER THE ROADWAY IN BELMONT VILLAGE. NO. 6 IS AT INLET UNDER ROADWAY AND NO. 7 IS AT THE OUTLET
