COMMANDANT'S INTERNATIONAL TECHNICAL SERIES

Fire Aboard the M.S. SCANDINAVIAN SEA
on March 9, 1984
Technical Assessment

USCG CITS-85-1-1

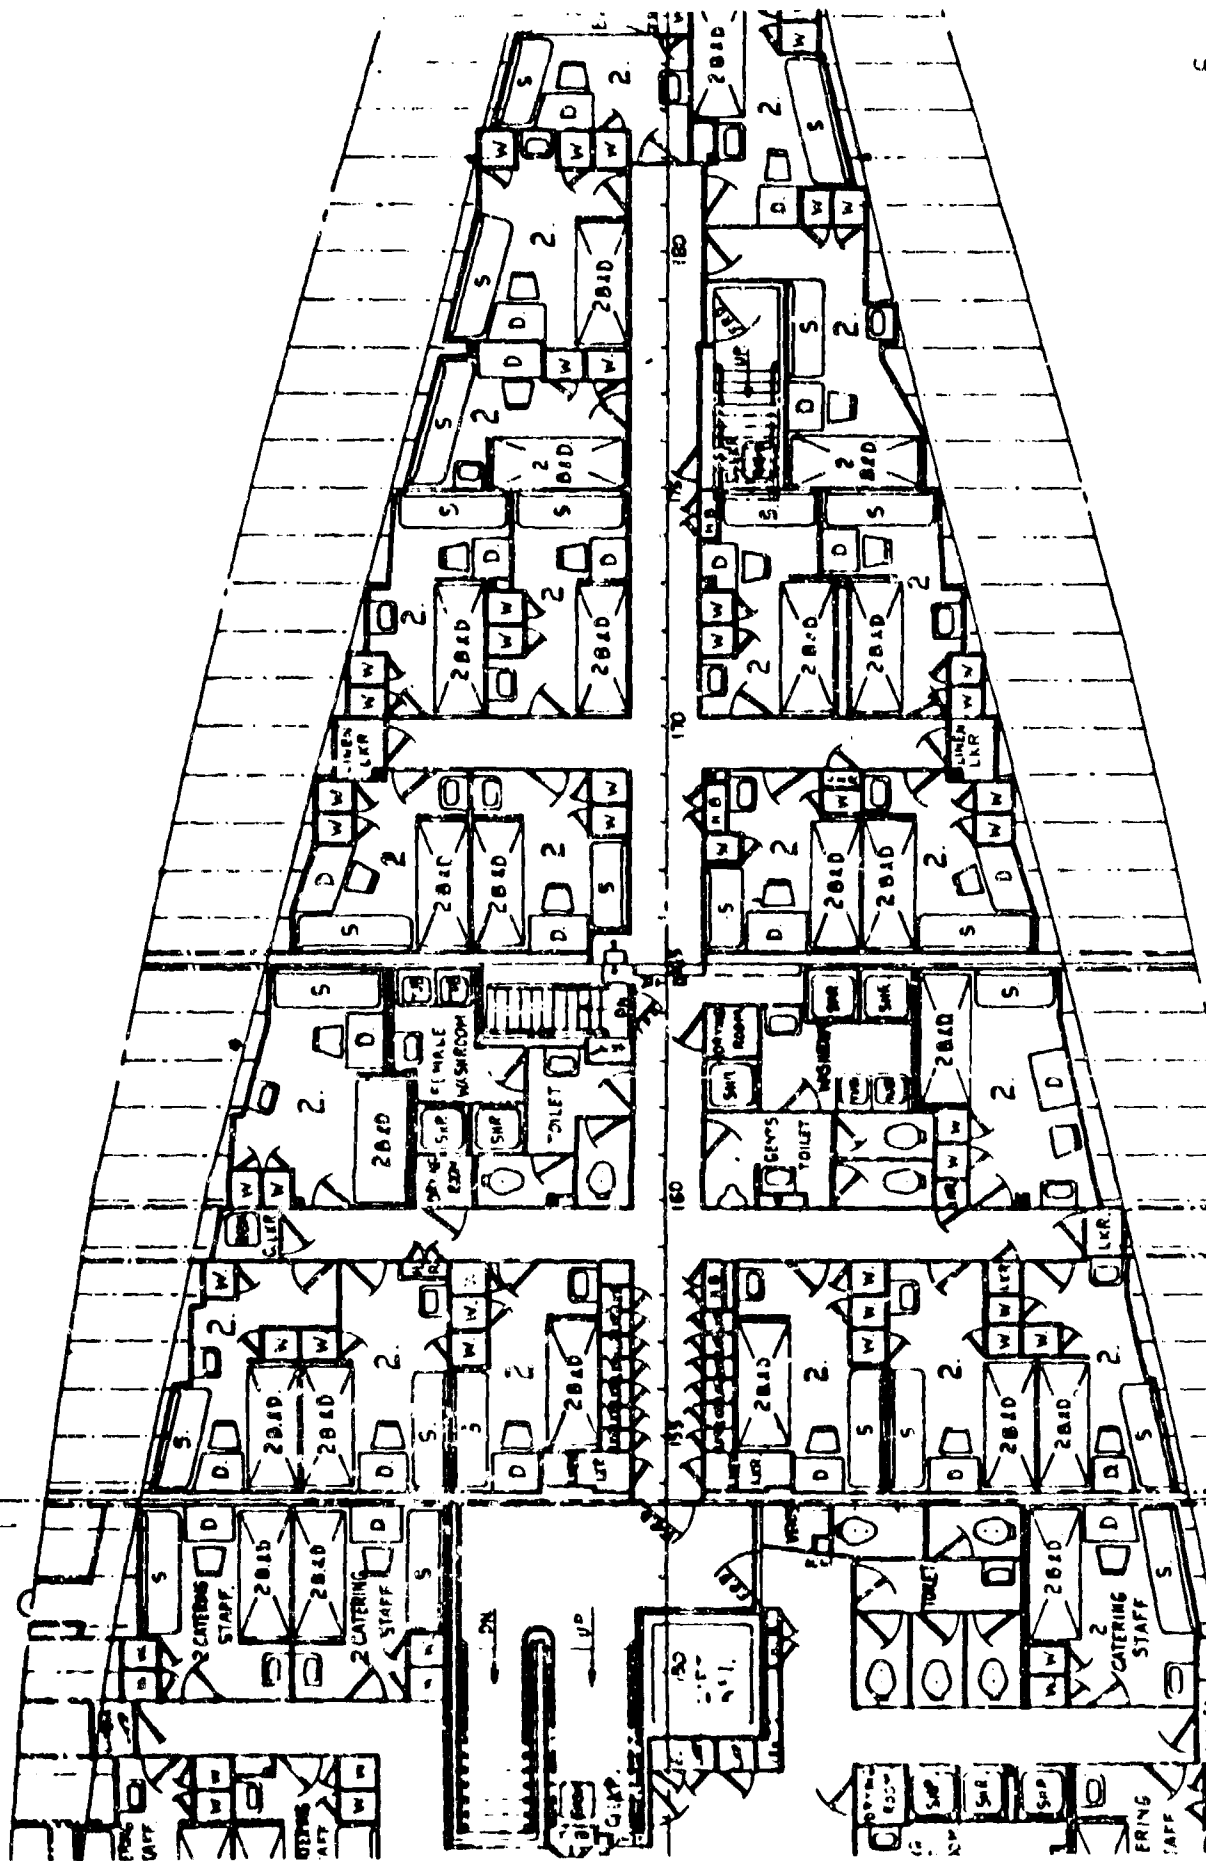
FIGURE 5
"A" DECK

For orientation purposes in the discussion of the investigation as to the cause of the fire, consult Figure 5. In addition, a larger diagram of the room of fire origin has been prepared that is close to scale and is shown in Figure 6. Descriptions of items in the room of origin are referenced to this drawing. This cabin is approximately 6'6" X 10'11".

Extensive fire damage occurred on "A" deck, the main deck, the upper deck and the lounge deck. These decks, forward of the fire door at frame 153 (see Figure 5), were eventually gutted in several areas. Some smoke and water damage also occurred aft of this position.

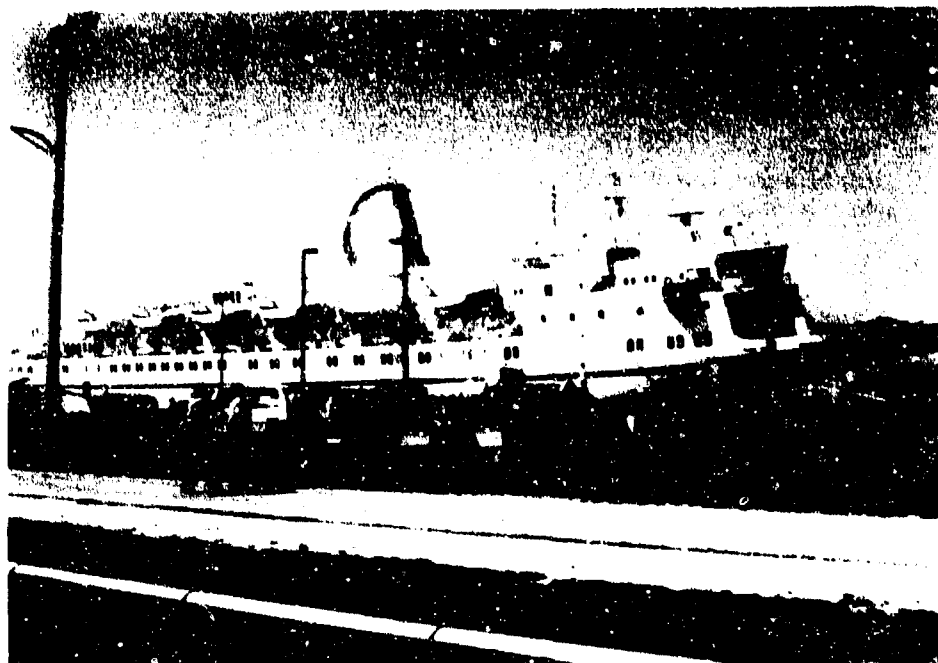
Photo 1 - SCANDINAVIAN SEA

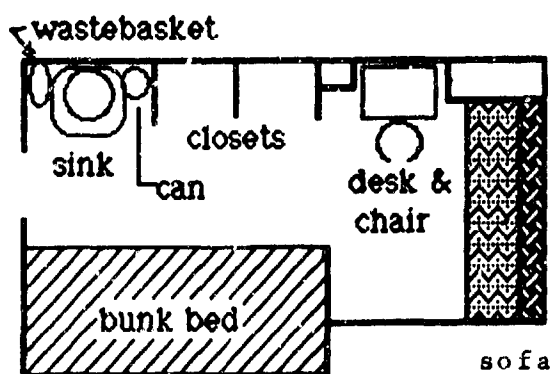
Figure 6 - Schematic of room 414

Photograph 7 is a view of the area under the sink in room 414. In the upper left corner of this photo is a wastebasket filled with debris and next to the broken partition (part of closet wall) is a metal one gallon can. The wastebasket and can are illustrated beneath the sink in Figure 6.

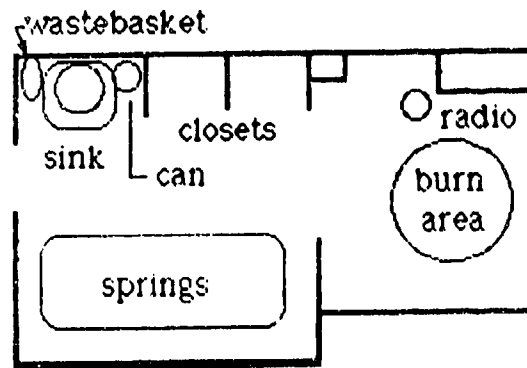
Figure 7 - Schematic of room 414

The remains of the radio (speaker frame) are shown in upper left part of Photograph 10 just above the water line. The approximate location of this radio relative to the desk is shown in Figure 7 below.
