REPORT
MRL-R-956

WELD REPAIR OF CRACKED DEFA
CANNON MOUNT FRAMES

J.C. Ritter, R.H. Phillips and B.F. Dixon

C Commonwealth of Australia
FEBRUARY, 1985

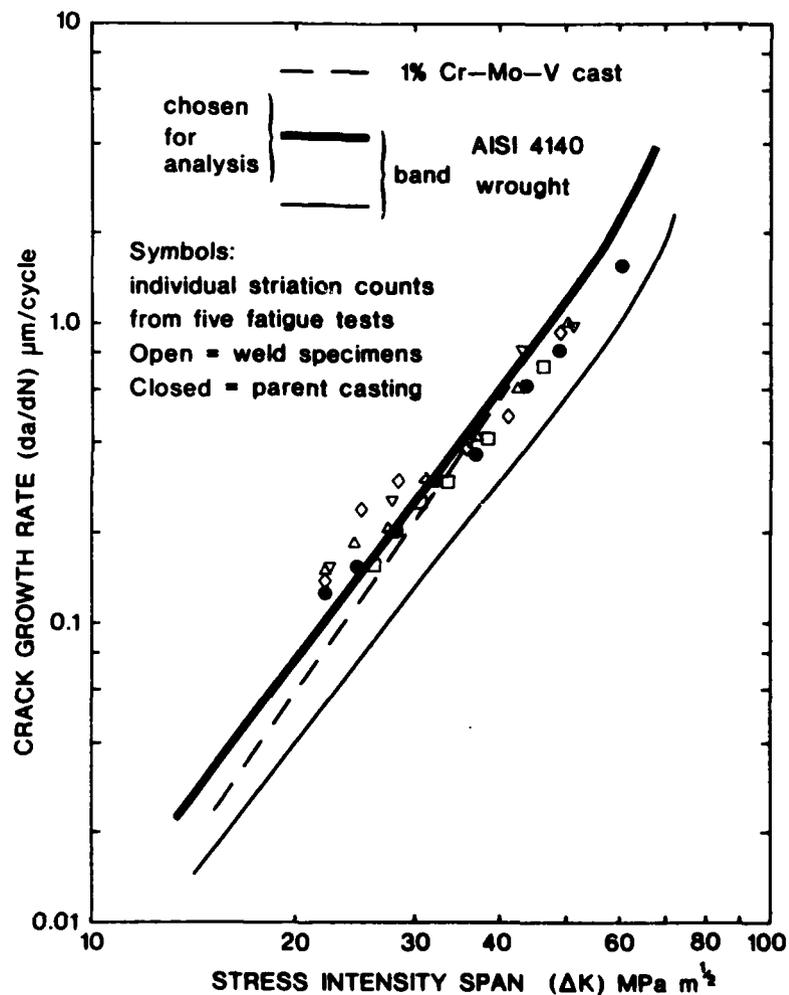
FIGURE 9

Data on fatigue crack growth rate, taken from the literature, tended to be similar for both wrought and cast low alloy steels of the Cr-Mo type, provided that they were tempered to about the same yield strength and the fatigue tests were conducted in air and with similar R values*. Of the results used in Fig. 9 [4,5], the upper-bound curve (shown as a bold line) was adopted for analysis, to make allowance for significant shrinkage porosity in the casting (Fig. 10). The presence of such porosity would have had the effect of raising the overall macroscopic crack growth rate above that indicated by the striation spacings because of numerous local jumps across the voids.

single crack having the same total depth. The results of five tests covering parent casting and weld HAZ, over a wide range of loads, are superimposed on Fig. 9.

Fatigue crack growth rate data for 1% Cr low alloy steels. The 1% Cr-Mo-V cast steel is after Haigh [4] and the band for AISI 4140 is after Thielen and Fine [5]. Test data points are from four welded specimens (open symbols) and one parent specimen (closed symbol).

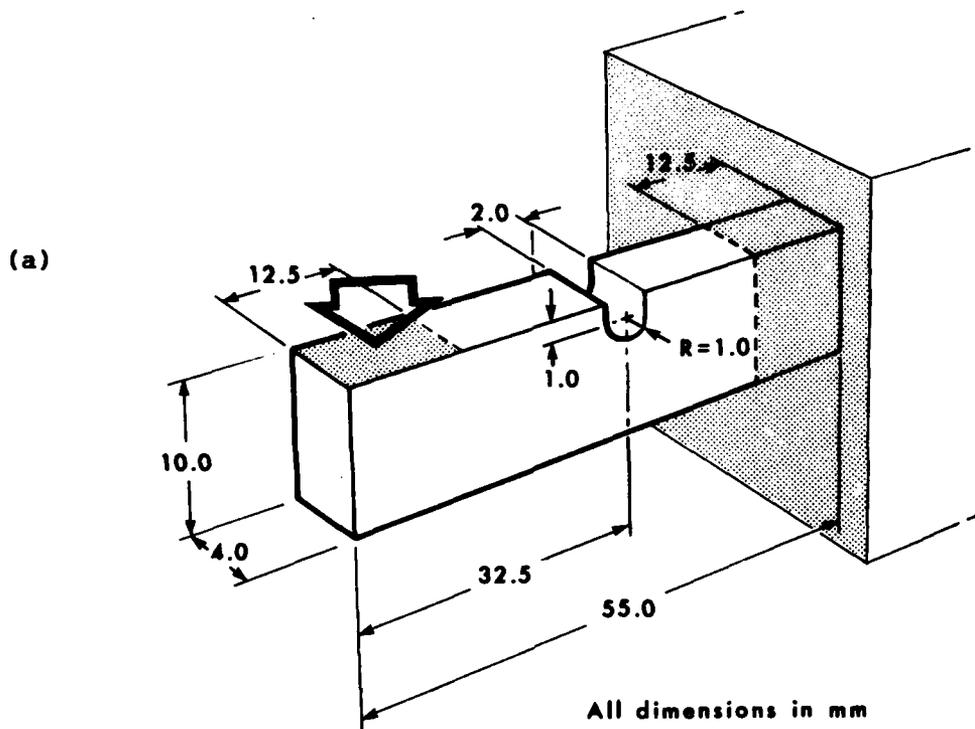
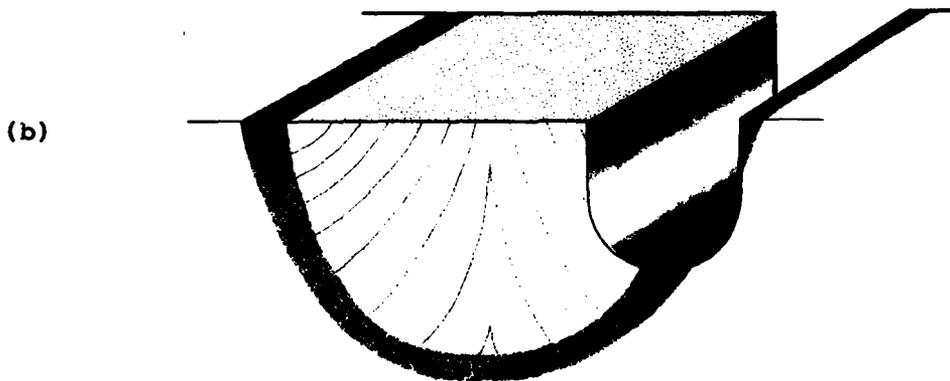
FIGURE 12 (a) Detail of fatigue test specimen.

The value of 300 MPa crack driving stress, and the stress ratio $R=0$ were used as a basis for designing fatigue test specimens and test load levels. The tests used cantilever bend specimens to simulate the loading on the bracket, and with transverse grooves to provide a known stress concentration factor of 1.6 [7,8]. Specimen dimensions are given in Fig. 12. Values of stress amplitude were obtained from surface strains measured under dynamic conditions by strain gauges bonded to the surfaces of a dummy test specimen.

Specimens were either of sound parent material, or had single-pass welds with the grooves along the fusion boundary to sample the most susceptible microstructure (Fig. 12b). In addition to generating conventional S-N fatigue life curves, tests were continued beyond the point of crack initiation in order to obtain crack growth data under known stresses.

(b) Location of notch in welded test specimen, with the root radius of the notch in the weld heat-affected zone.

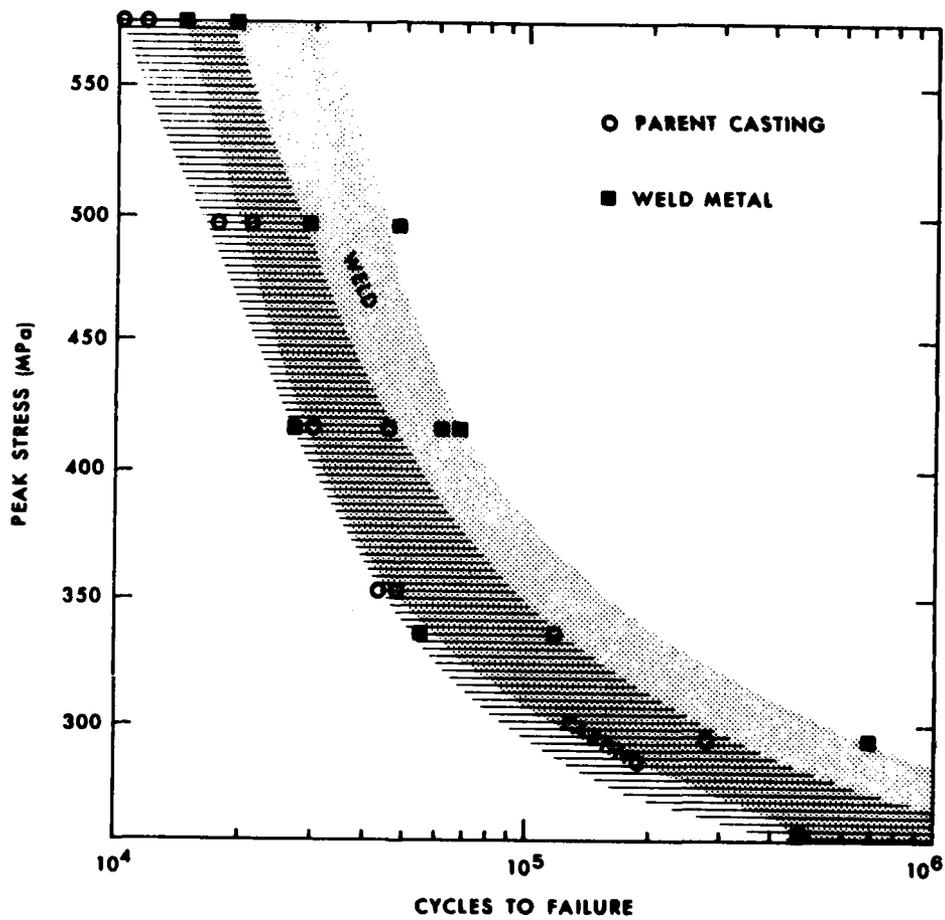
FIGURE 13

The number of test specimens was limited by the amount of material available from frames and, as a result, the S-N data are fewer than desirable for a high level of confidence. Nevertheless, the two bands of results (Fig. 13) show a high degree of consistency and overlap closely. The slight improvement apparent in the weld metal property is encouraging, but not experimentally significant.

Fatigue S-N data generated for sound casting material and from as-deposited Ni-Cr-Mo weld metal.
