AGARDograph No. 278

AGARD Corrosion Handbook Volume 1 Aircraft Corrosion: Causes and Case Histories

AIRCRAFT CORROSION: CAUSES AND CASE HISTORIES

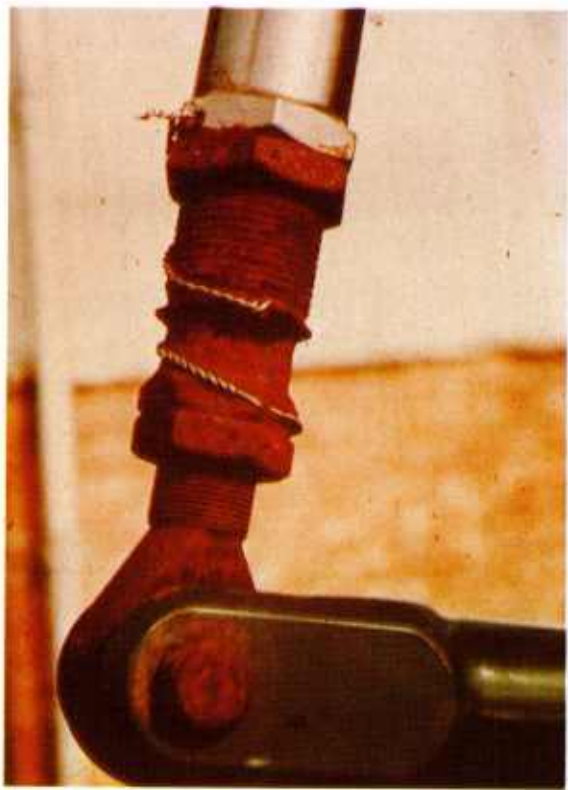
Most of the common engineering metals and alloys produce characteristic corrosion products which allow corrosion to be recognized fairly easily. Probably the best-known form of corrosion occurs on non-stainless iron and steel and is easily recognized by the familiar red iron rust (Figs. 7-1 and 7-2). Figure 7-1 shows rusting on a steel track rod adjuster and eye end, originally cadmium plated but operating in an exposed environment. The cadmium had presumably been totally sacrificed after loss on threads during assembly or maintenance. Use of a supplementary protective material should have prevented this. Figure 7-2 shows a steel jet pipe end cap liner which had been subjected to high temperature oxidation over a long period of time. In this figure the blistering and flaking of a surface protective coating is apparent, and the formation of red rust products in the underlying steel can be seen. The materials chosen for this application had simply proven unsuitable for the environment, though quite possibly they were the best available when the design was established. The fact that the aircraft life had been extended, and these components had been required to operate for much longer times than originally intended is also an important factor.

Fig. 7-1 Rusting on a steel track rod adjuster and eye after damage occurred to the protective cadmium plating

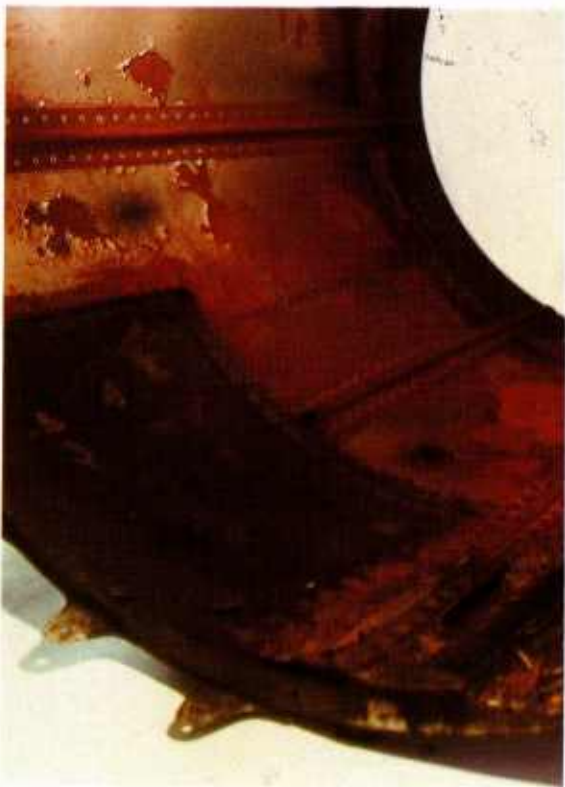
Fig. 7-2 Rusting in a jet pipe end cap liner following damage to its protective coating

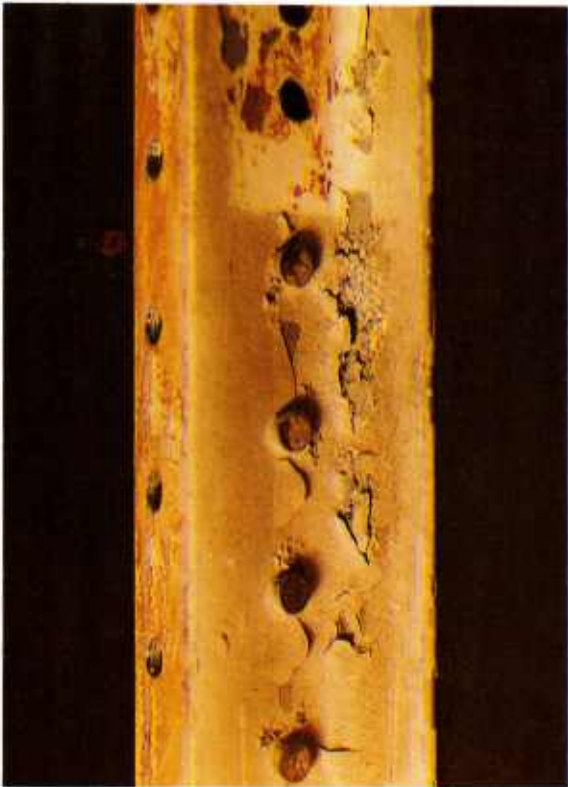
The corrosion products of aluminium and magnesium alloys are evident as white to grey powdery deposits, the latter are often of a fluffy or granular nature. Figure 7-3 shows the surface corrosion damage to an aluminium alloy stringer, where the chromate pre-treatment and primer coat had failed, probably through aging and exposure to moisture. Early identification of aluminium or magnesium corrosion is essential, and frequently the first indications are flaking or blistering of the surface finish. Figure 7-4 shows an area of general surface corrosion on a magnesium alloy skin of a helicopter on which the chromate pre-treatment had locally failed.

Fig. 7-3 Flaking of the chromate pre-treatment and primer on an aluminium alloy stringer and corrosion of the exposed metal

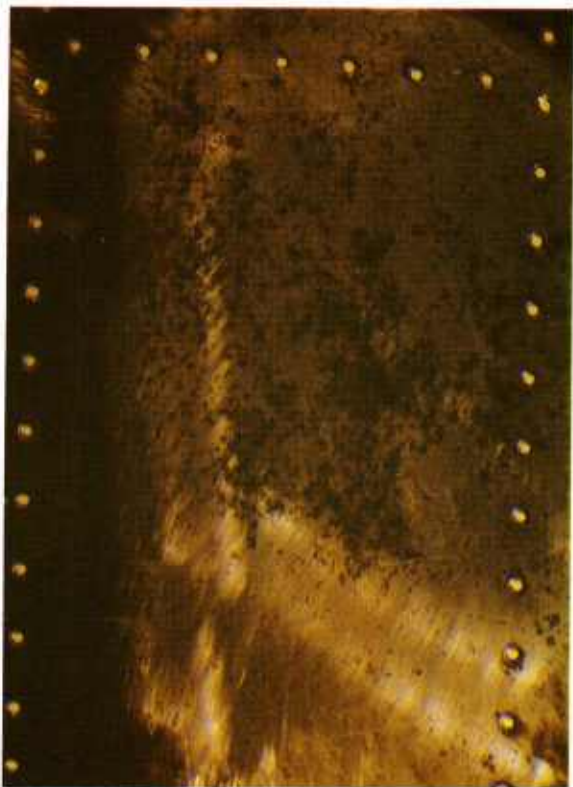
Fig. 7-4 Uniform corrosion in a magnesium alloy helicopter skin after damage to the chromate pre-treatment

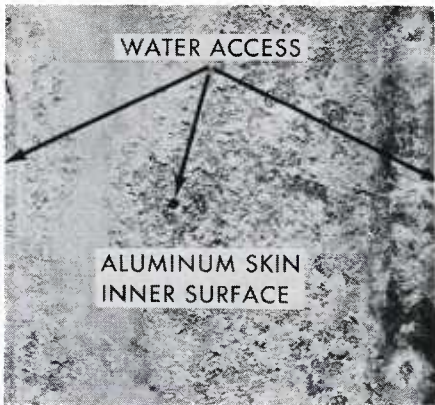
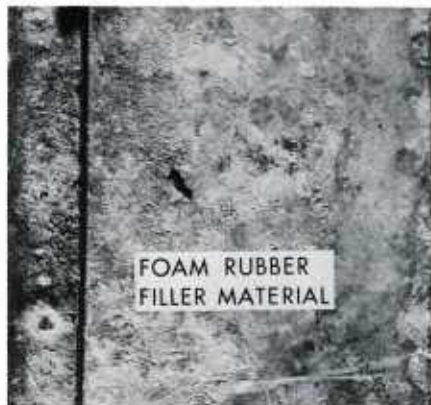
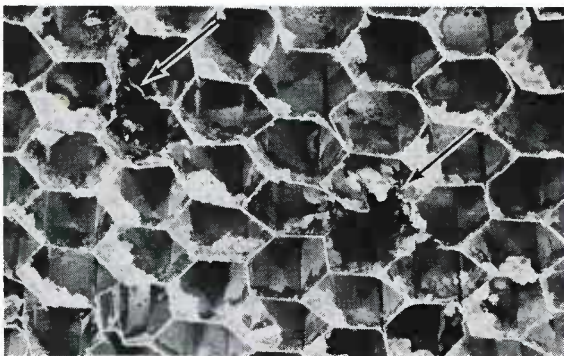
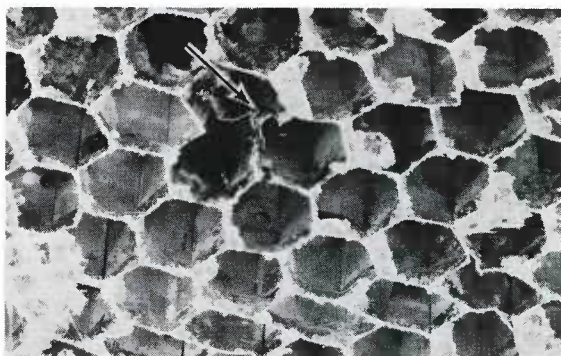
Fig. 7-5 Corrosion damage in an aluminium alloy honeycomb structure from a fighter aircraft
(a) Inner surface of the aluminium skin showing perforations.
(b) Foam rubber filler material.
(c) and (d) Arrows point out areas of severe corrosion damage in the honeycomb.

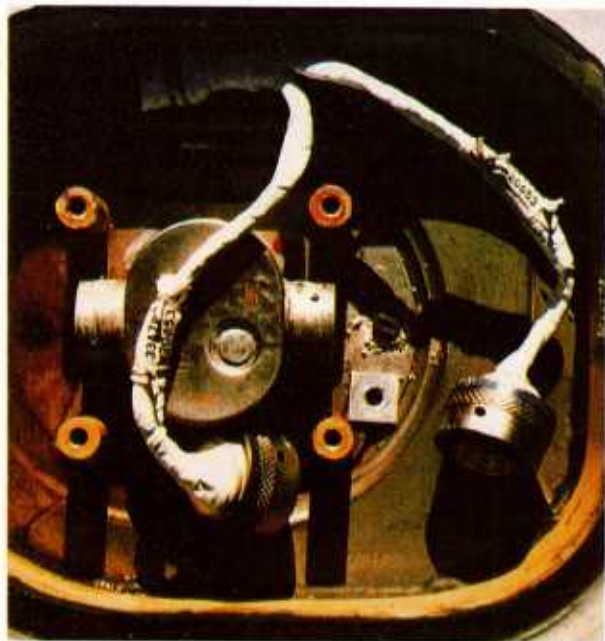
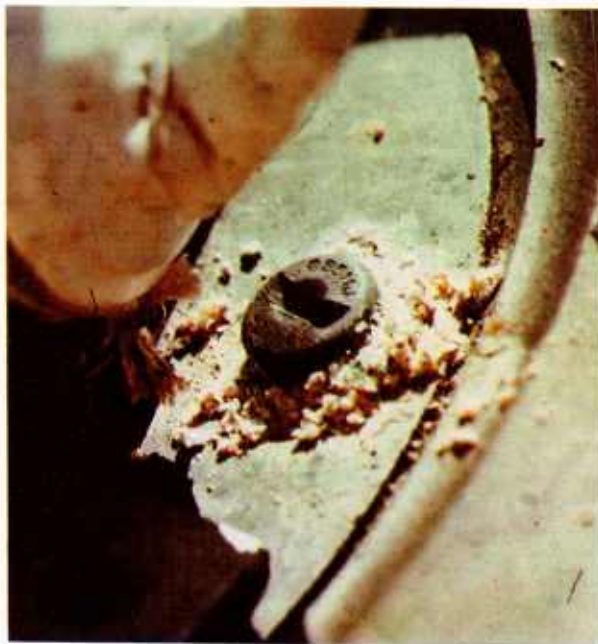
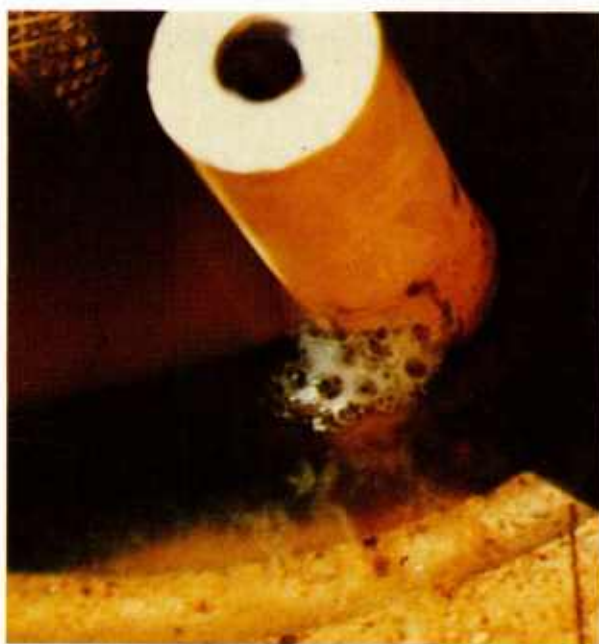
The need to prevent the ingress of water and other corrodents to internal structure and equipment is nowhere more important than with electrical and avionics equipment. In the interests of obtaining specific electrical characteristics, the materials used are often inferior in terms of corrosion resistance, and serious corrosion problems and often malfunction of equipment can occur if the equipment is not properly sealed. Figure 7-6(a-c) shows examples of corrosion of electrical equipment in a military aircraft due to water intrusion around the access door. The general reddish-orange discolouration of the compartment walls and floor, in Figure 7-6(a), indicates that uniform corrosion has occurred in these areas. The close-up photographs of Figure 7-6(b) and -6(c) show local eruptions of corrosion products around a screw and binding post, which are probably examples of galvanic corrosion and crevice corrosion.

Fig. 7-6 Corrosion in a container used to house electrical equipment

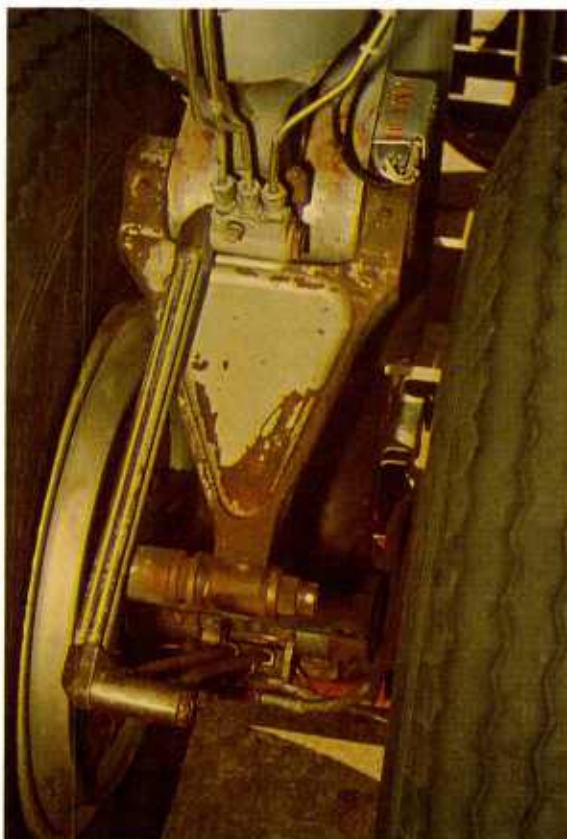
Fig. 7-7 Erosion-corrosion damage on the undercarriage of a transport aircraft

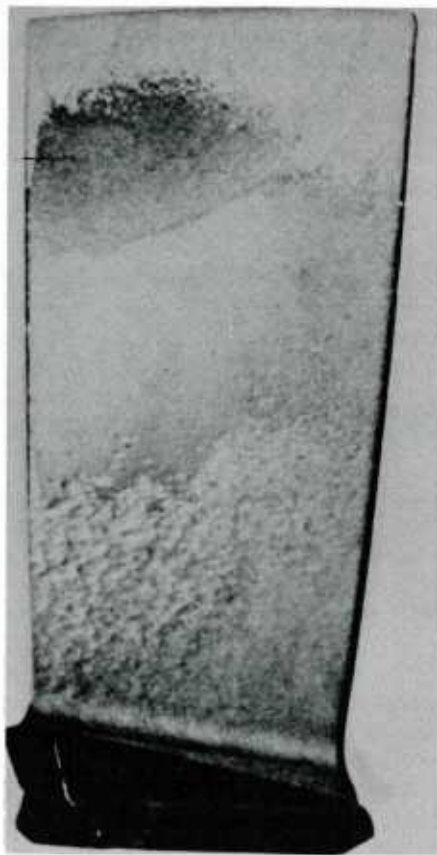
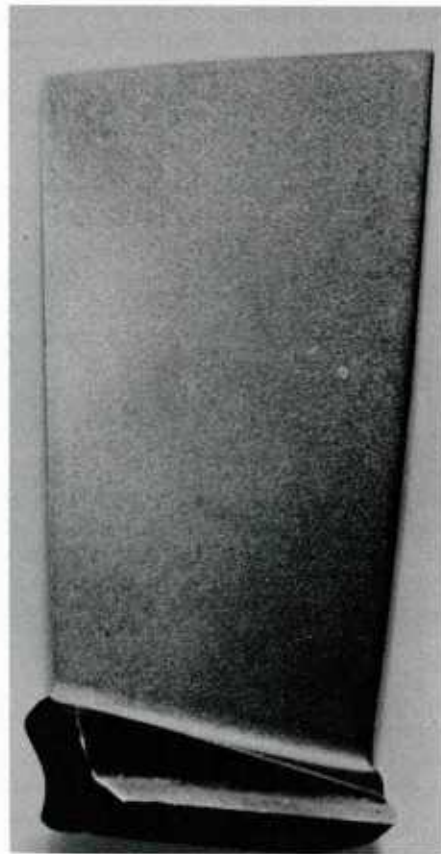
T-58 COMPRESSOR BLADES AFTER 16-1/2 HOURS EROSION TEST (CONCAVE SURFACE)

Fig. 7-8 Erosion-corrosion damage on the airfoil of a fighter aircraft compressor blade

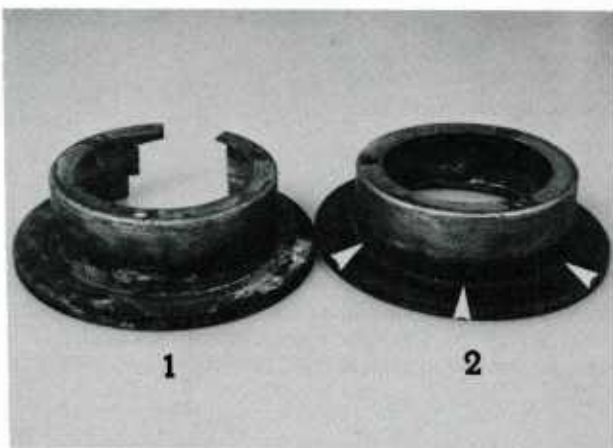
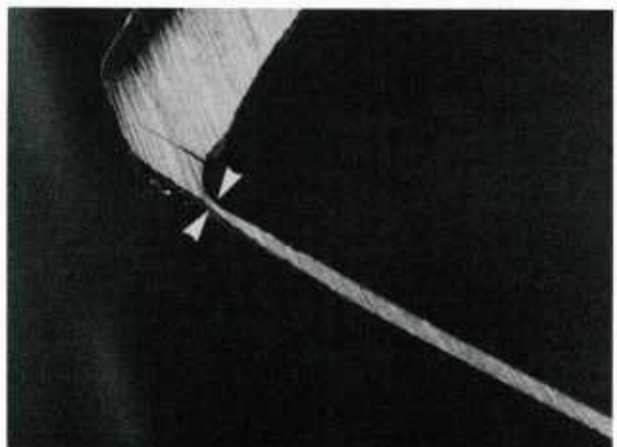
The brake disc assemblies were removed from both main wheels of a light single engine aircraft (Fig. 7-9(a)). Both brake disc assemblies were severely corroded in the fillet radius area between the disc and the sidewall, and there was a 12-15 mm band of corrosion around the outside surface of the wall as shown in Figure 7-9(a).

Fig. 7-9 Corrosion failure of a brake disc assembly

The brake disc assembly number 2 had failed around the sidewall circumference adjacent to the disc; this area was severely weakened due to corrosion to the extent that the wall thickness at the failed section was reduced to approximately one-quarter of the original thickness. Figure 7-9(b) shows the corresponding section through the disc and sidewall of the unfailed assembly, number 1. Even though this particular unit had not failed, a serious loss of material had occurred leading to a reduction of sidewall section thickness, as indicated by the arrows in Figure 7-9(b).

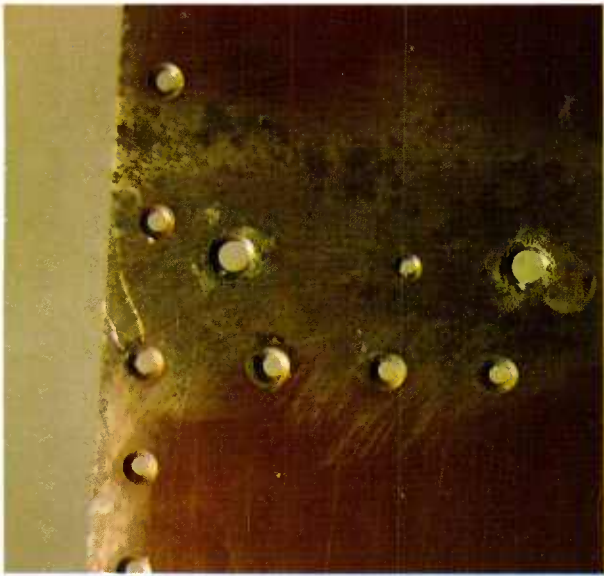
The example of Figure 8-2 shows dissimilar metal, or galvanic corrosion damage at fastener holes where steel bolts fastened through a magnesium alloy skin. The positions of these two materials in the electrochemical series, or galvanic series indicates that a high electrochemical potential would exist between them when in contact, and severe galvanic corrosion could be expected to occur.

Fig. 8-2 Galvanic corrosion around fastener holes used to locate steel fasteners in a magnesium alloy skin

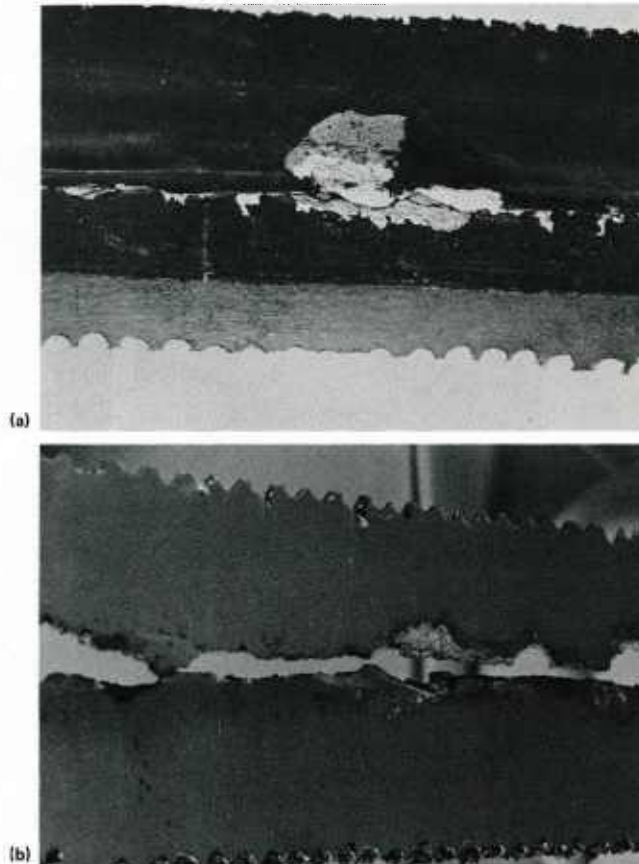
Fig. 8-5 Selected areas of corrosion from Figure 8-4

- (a) Penetration of the aluminium skin viewed from the outside.
- (b) Corrosion and penetration of the aluminium skin viewed from the inside.

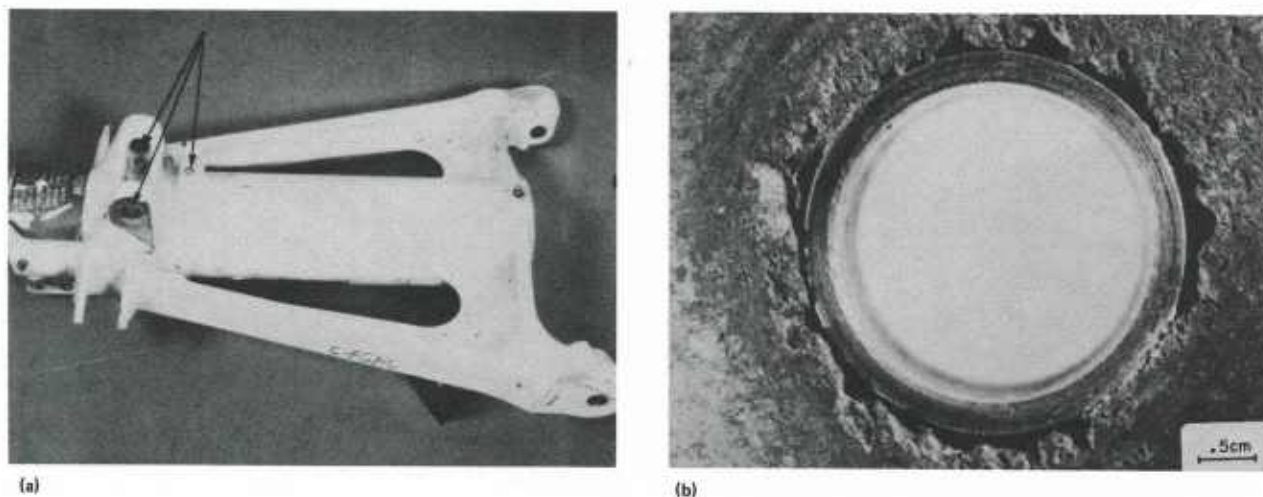
A nose gear strut assembly from an executive twin-engined aircraft was found, during a visual inspection, to be severely corroded around the drag brace attachment lugs. The strut and the areas of corrosion attack are shown in Figure 8-8(a). The strut assembly was a magnesium alloy casting and the lugs contained cadmium plated low alloy steel bushings. The steel type was not revealed to AGARD, but was reported to contain a high chromium content.

Visual inspection of the corroded lugs (Fig. 8-8(b)) showed that the steel bushings were undamaged while severe corrosion of the magnesium alloy which was in contact with the steel had occurred. The preferential corrosive attack of the magnesium at the magnesium/steel interface suggests that the damage was caused by galvanic corrosion, where the magnesium formed the anode of the electrolytic cell and the steel the cathode. The aircraft in question had been operated in a marine environment, and the moist salt laden atmosphere would have contributed to the problem. However even a milder environment would likely give rise to a similar problem given sufficient time.

Fig. 8-8 Galvanic corrosion between a steel bushing and a cast magnesium alloy nose gear strut

- (a) General view showing areas of attack (arrows).
- (b) Close-up of corrosion adjacent to the cathodically protected steel bushing. (Mag. $\times 2$)

Both cadmium and zinc type coatings protect steel by anodic protection, which involves the sacrificial corrosion of the anodic coating to prevent or minimize corrosion in the cathodic steel. However in sea water magnesium alloys are strongly anodic with respect to both steel and cadmium, and therefore cadmium serves no useful purpose in this case other than to protect the bore of the steel bushing. It is doubtful whether magnesium alloy castings would be selected at the present time for a component such as this nose gear strut, which experiences severe conditions and aggressive environments in service. However, in other cases it is important to provide an insulating interface material between magnesium and any steel parts.

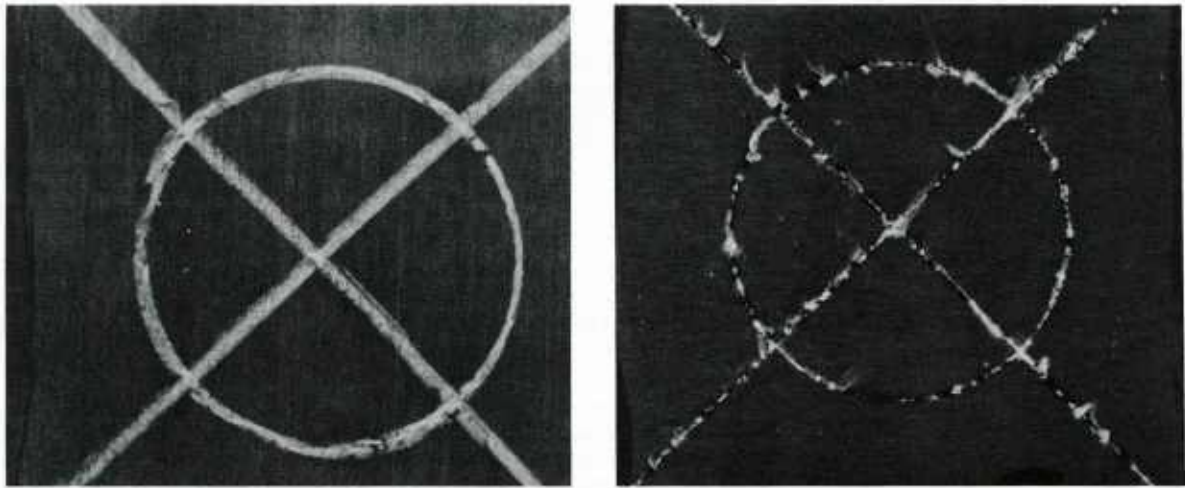
In order to verify that the lost disc might be associated with the pencil marking, laboratory specimens of the high strength aluminium alloy skin material were marked with a conventional graphite pencil and with a grease pencil, and were then exposed to salt mist accelerated corrosion testing. One week of exposure showed no effect on the grease pencilled panel (Fig. 8-9(a)) while the graphite pencilled panel showed severe corrosion damage (Fig. 8-9(b)).

Fig. 8-9 Galvanic corrosion in aluminium alloy wing skin due to conductive markers
(a) Panel after 7 days exposure to salt mist when a grease pencil was used.
(b) Panel after the same exposure when a graphite marker was used, showing galvanic corrosion.

Whether the reported "lost disc" actually fell out of the wing cannot be ascertained, but nevertheless the laboratory trials demonstrate unequivocally that severe galvanic corrosion can occur, even when a thin film of graphite comes in contact with a high strength aluminium alloy. Table 3-2 shows that graphite (carbon) is one of the most noble materials, and will give rise to a strong electrochemical potential when coupled with aluminium alloys. Marking of any aerospace hardware should only be performed with safety-checked markers, such as grease pencils.

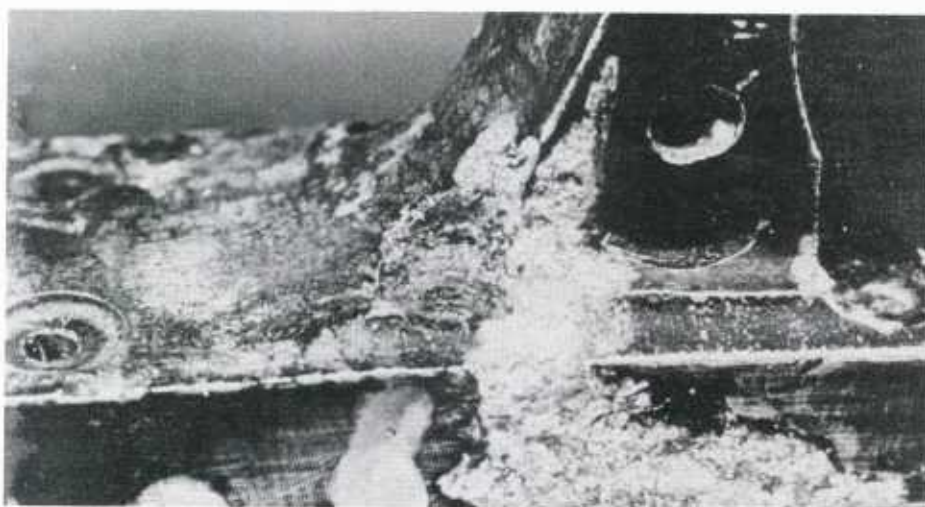
Fig. 9-1(a) Severe pitting in a magnesium alloy casting

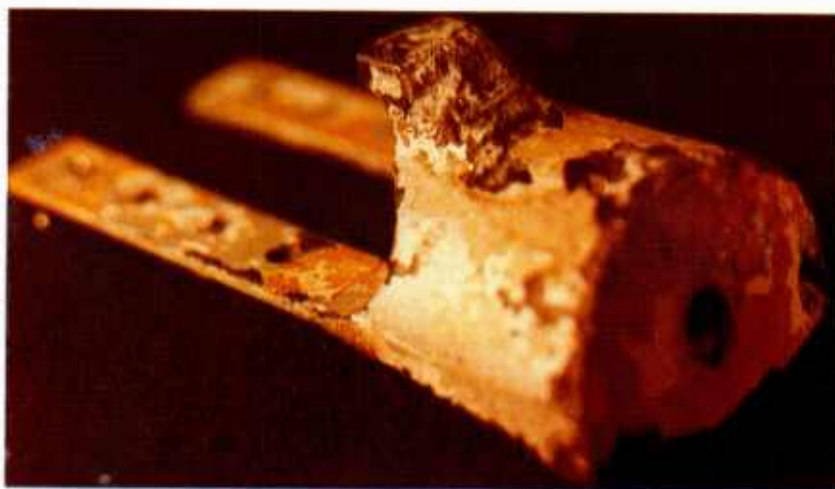
Fig. 9-1(b) Severe pitting in a cast magnesium alloy stringer end cap

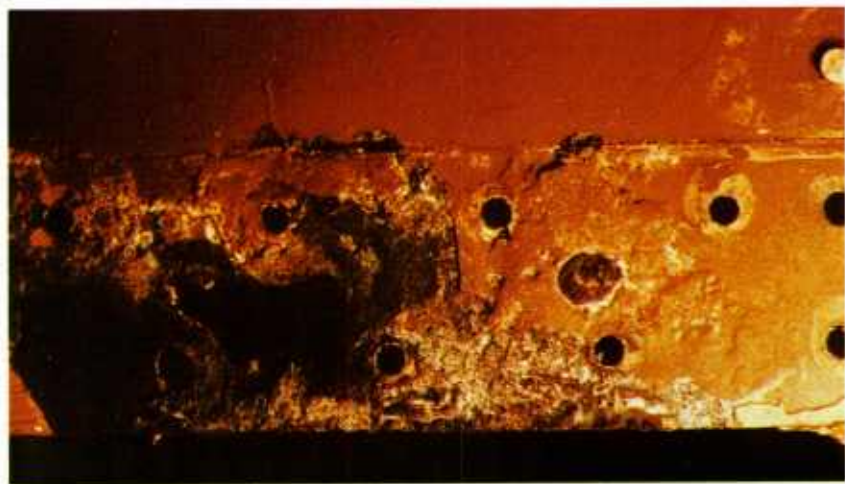
(a) Dismantled joint in a magnesium alloy panel.

Some examples of crevice corrosion are shown in Figures 9-2(a), 9-2(b) and 9-2(c). Figure 9-2(a) shows a corroded and perforated magnesium panel in a dismantled joint area from a transport aircraft structure. The corrosion damage was due to inadequate sealing. Figure 9-2(b) presents a similar case of crevice corrosion at the interface of a magnesium alloy skin joint, which was also due to inadequate sealing. In both examples the most severe damage is away from the edges of the fastener holes which suggests that galvanic corrosion was not the major factor. Figure 9-2(c) shows a situation where both galvanic corrosion and crevice corrosion contributed to the damage. The corrosion damage has occurred at the junction between a magnesium alloy floor panel and aluminium alloy frames and angle plates. This problem was probably aggravated by poor drainage conditions, and inadequate sealing and surface protection.

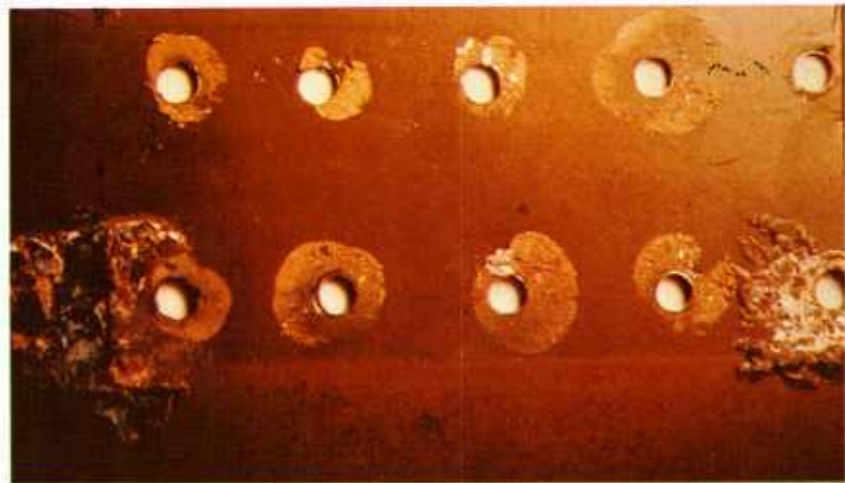
(b) Crevice corrosion in a magnesium alloy skin joint due to inadequate sealing.

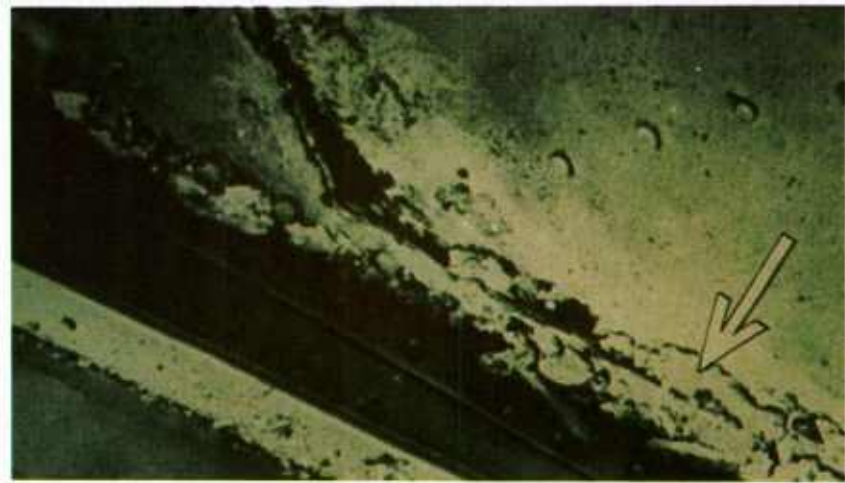
(c) Crevice and galvanic corrosion between a magnesium alloy floor panel and aluminium alloy frame member.

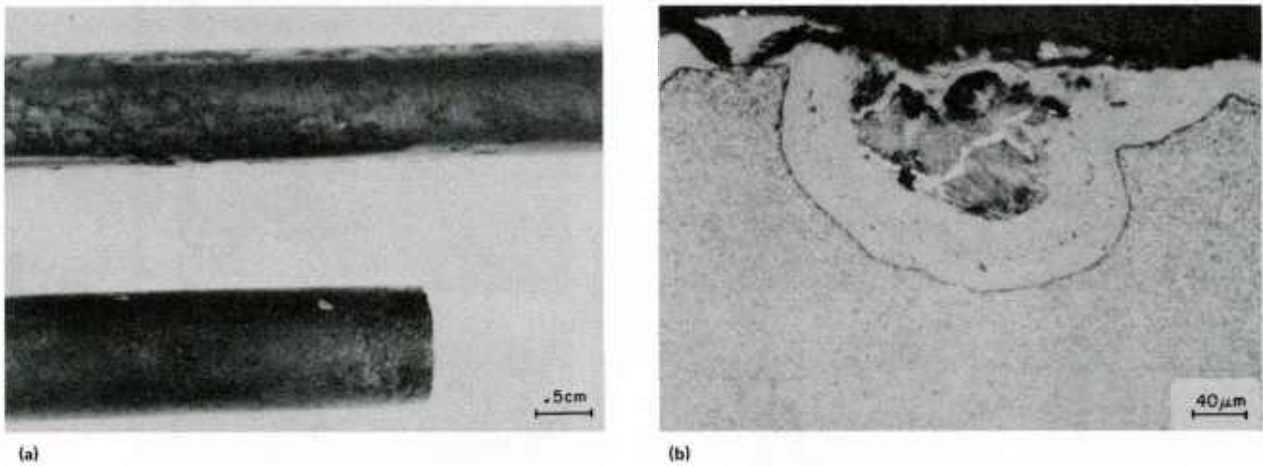
A light single engine aircraft suffered in-flight engine failure and was destroyed in the subsequent forced landing. Engine teardown revealed engine seizure was the result of an exhaust valve failure. The valve stem fractured in fatigue, the crack initiating at pitting corrosion sites on the valve stem. The push rod also showed extensive pitting corrosion. Both parts are shown in Figure 9-8(a).

Figure 9-8(b) shows a typical pit in the valve stem, filled with a complex series of corrosion products containing iron, chromium and silicon oxides, and aluminium, copper, lead, sulphur and bromine compounds. Pitting near the fracture was so severe as to overlap the pits and reduce the section diameter by approximately 0.25 mm. Since this engine continued to run for some time after the valve head had separated and had fallen into the cylinder head, extensive secondary damage resulted from the valve head ingestion and eventually seized the engine.

Teardown revealed extensive pitting of several other valves and push rods. The engine was found to have been inactive for long periods, during which the engine oil was not drained and replaced by inhibiting oil. This improper maintenance resulted in pitting corrosion of the valves and push rods from acid compounds formed in the old engine oil.

Fig. 9-8 Pitting induced failure of an engine exhaust valve
(a) Pitted push rod (top) and pitted and fatigue fractured valve stem (bottom). (Mag. × 2)
(b) Typical corrosion pit in the valve stem near the fracture face. Nital etch. (Mag. × 250)

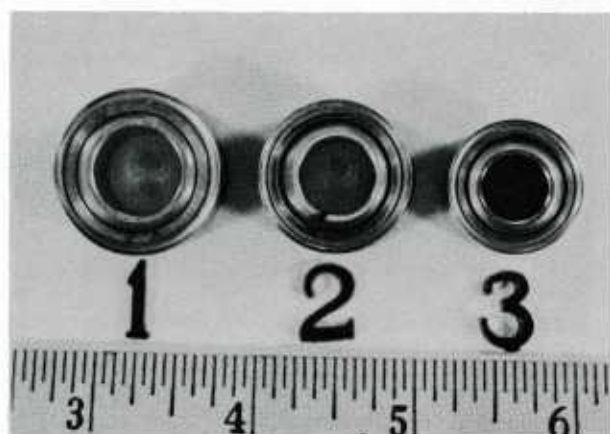
Visual inspections led to the discovery of cracking in several chromium plated type 440C martensitic stainless steel wing flap hinge bearings. Three of the suspect parts were submitted for laboratory examination, and these are shown in Figure 9-9(a).

- (a) Three hinge bearings from a fighter aircraft.
- (b) Bearing number 1, showing crack configuration.
- (c) Bearing number 2, showing crack pattern and fragment missing at end of crack.
- (d) Fracture face of second crack in bearing number 1. Arrow shows probable crack initiation area. (Mag. $\times 5$)
- (e) Corrosion pits on the inner diameter of a bearing which are typical of all three bearings submitted. (Mag. $\times 20$)
- (f) Cross-section of corrosion pit found on bearing showing intergranular cracking at the base of the pit. Picric acid etch. (Mag. $\times 500$)

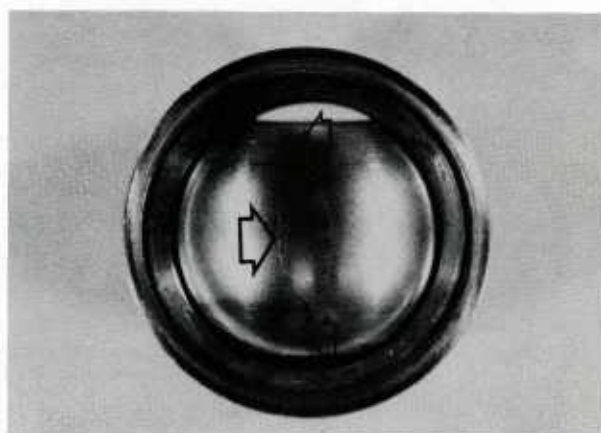
(b)

Bearings 1 and 2 were found to be cracked, while bearing 3 was found to be uncracked. In bearing No. 1, two separate cracks were found; one crack took the path shown in Figure 9-9(b), while the second crack, which is not shown, ran straight across the bearing cross-section. Bearing No. 2 showed the crack path seen in Figure 9-9(c). Further visual examination of the bearing crack fractures showed the cracks were flat and slightly fibrous, as indicated in Figure 9-9(d). The fracture face of bearing No. 2 differed slightly from the two fractures seen on bearing No. 1 in that there was a chip missing on the outer edge of the bearing.

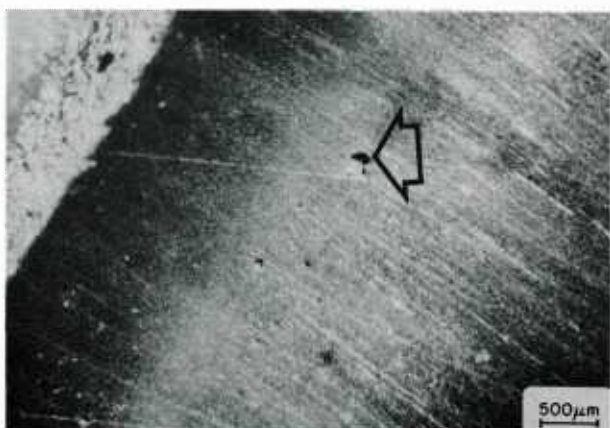
(e)

Optical examination revealed numerous corrosion pits on the inner diameter of the failed bearings, and also on bearing No. 3 which had not failed. A typical example is shown in Figure 9-9(e). Figure 9-9(f) shows a cross-section through one of the corrosion pits, and a network of fine intergranular cracks can be seen emanating from the base of the pit.

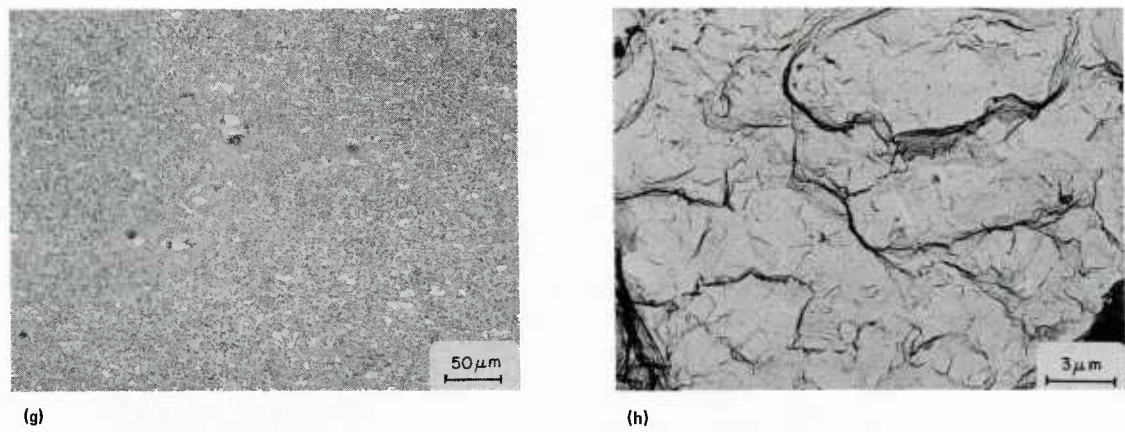
- (g) Microstructure typical of all three bearings. Picric acid etch. (Mag. $\times 200$)
- (h) Electron fractograph of bearing number 1 showing intergranular mode of fracture. (Mag. $\times 3960$)

The microstructure of the bearings is shown in Figure 9-9(g), and shows fine spheroidal chromium carbide together with larger carbide globules dispersed in the tempered martensitic matrix. The material had a hardness of $R_c\ 54-55$, and both the microstructure and hardness were considered acceptable for this class of steel and the intended application. Figure 9-9(h) shows a replica transmission electron micrograph of the fracture surface of bearing No. 1, and indicates an intergranular mode of fracture. Similar observations were made for bearing No. 2, and both fracture surfaces showed indications of corrosion products on the intergranular facets.

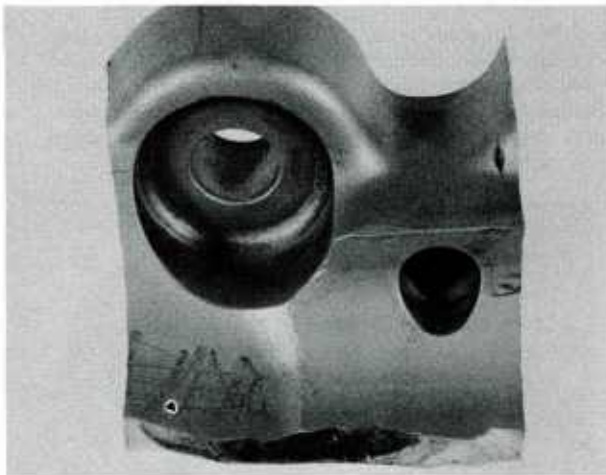
(a)

Fig. 9-11 Pitting corrosion and fatigue of a 2014-T6 aluminium alloy main landing gear wheel

Figure 9-11(a) shows a piece of an aluminium alloy main wheel, while Figure 9-11(b) is the same piece at higher magnification and shows a portion of the fracture surface involved. The fracture surface in this area showed beach marks, characteristic of fatigue, and the fatigue crack could be traced back to an initiation site at a corrosion pit, which is indicated by the arrow 'A'. The adjacent arrow 'B' points to a neighbouring fatigue crack which had also initiated at a corrosion pit. The total length of these two cracks was about 80 mm, and both had propagated through the wall of the wheel until air had escaped and the tyre deflated.

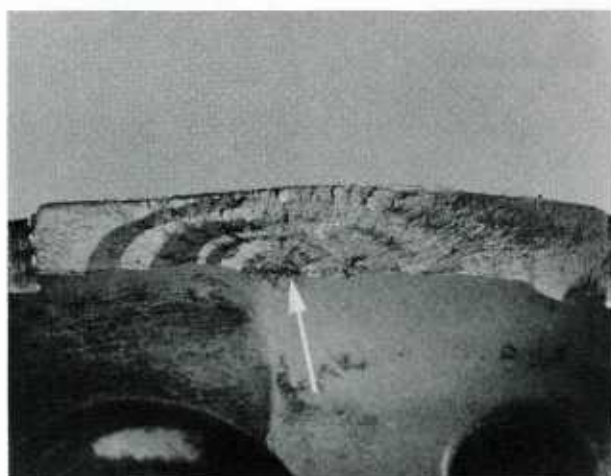
(c)

Figure 9-11(c) shows another example of a fatigue crack originating at a corrosion pit in a main wheel. In all these cases it was observed that the cracks initiated at corrosion pits, and in all cases the corrosion pits occurred in the same area where the wheel was in contact with a stainless steel heat shield. As explained in case history 9-2 above, aluminium alloy 2014 is normally a passive corrosion resistant metal, forming a protective anodic film on exposure to corrosive environments. However, in this case the repeated contact between the stainless steel heat shield and the wheel had resulted in the removal of both the paint finish on the wheel and the anodic film. The bare metal would then be in direct contact with the stainless steel, and in the presence of an electrolyte a corrosion cell would be set up in which the aluminium would be the anode and the stainless steel the cathode. The pitting situation was aggravated by the large cathodic surface area of the stainless steel and very small area of rubbed and unpassivated aluminium anode.

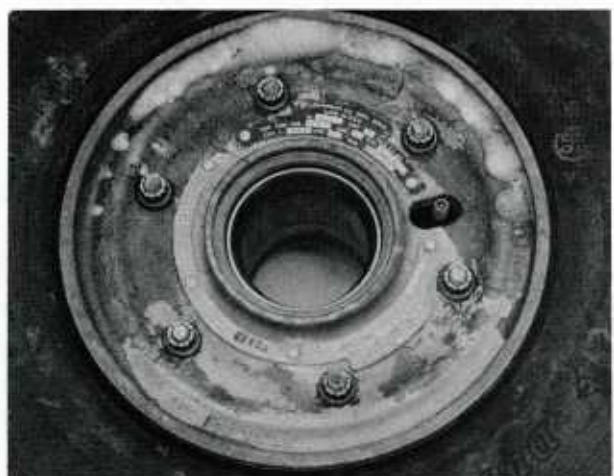
(d)

The problems in the magnesium nose wheels are illustrated in Figure 9-11(d), which shows bubbling in a soap solution which was applied to the wheel in the bead seat radius. In these cases the problems were attributed to excessive porosity due micro-shrinkage and intergranular corrosion in these magnesium alloy castings.

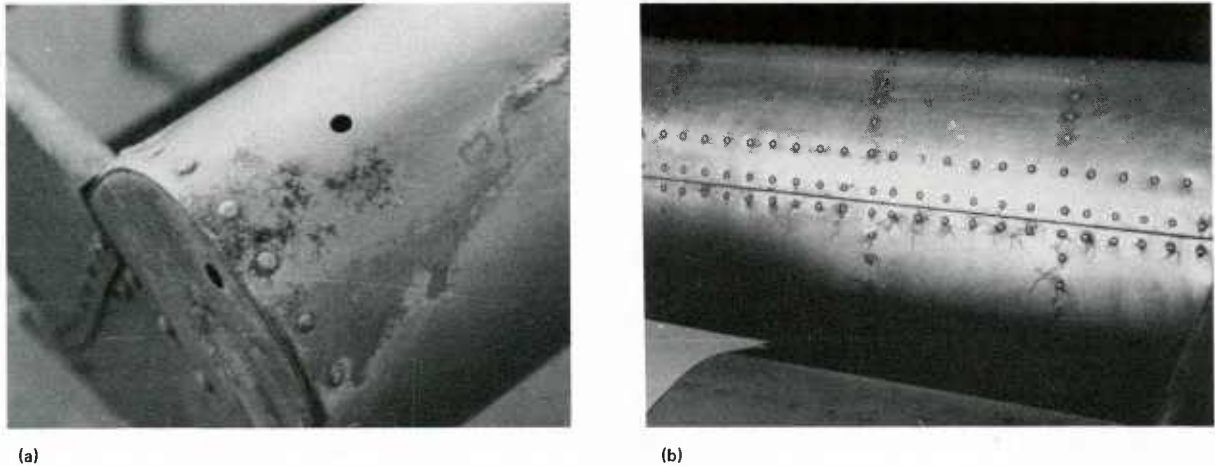
This aircraft had also been operating in the Mediterranean region, and the corrosion damage was again detected during visual inspection. The structure in this case was made from 2024 aluminium and had been protected by a nitro-alkyd resin paint system. Areas of corrosion damage are shown in Figure 9-14(a), and in Figure 9-14(b) after removal of the paint system. The corrosion was largely superficial, although penetration had occurred in one area. The surface corrosion showed the thread-like meanderings of filiform corrosion, and appeared to have originated in the fastener holes, as indicated in Figure 9-14(b).

Fig. 9-14 Filiform corrosion in some 2024 ailerons and flaps

- (a) General appearance of the corrosion showing blistering of the paint.
- (c) Filiform appearance of the corrosion tracks radiating away from fastener holes.

A strontium chromate epoxy primer and polyurethane finish were recommended to replace the nitro-alkyd protection system used previously.

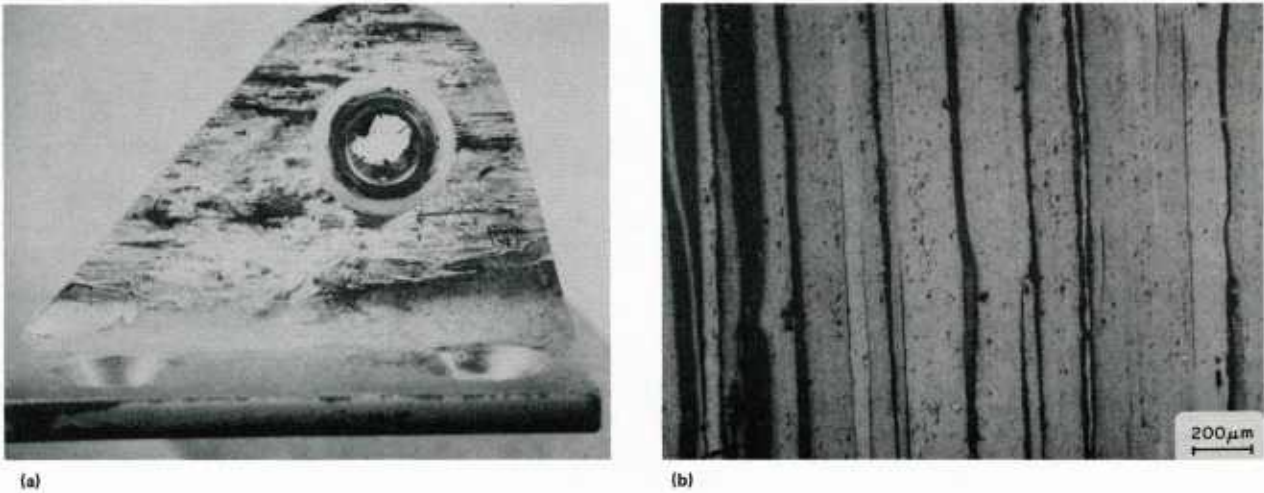
Fig. 10-2 Exfoliation corrosion in an aluminium alloy stabilizer bracket
(a) Heavy surface corrosion of the stabilizer hinge bracket.
(b) Cross-section through the bracket showing the corroded surface grains at the right, and corrosion of elongated grain boundaries only. Keller's etch. (Mag. x 50)

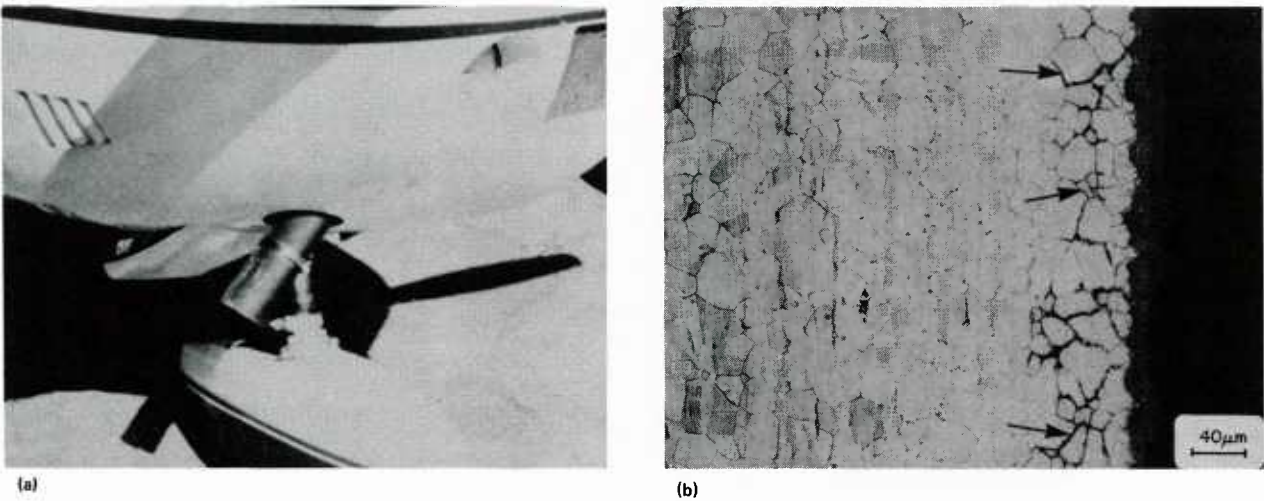
A custom silencing muffler was added to a light aircraft engine exhaust, as shown in Figure 10-3(a). This muffler and most of the exhaust separated in flight, and the unrestrained hot exhaust gases caused an in-flight fire. The exhaust pipe broke near its flange support, the pipe and silencing muffler were otherwise unsupported. Examination revealed the austenitic stainless steel exhaust had suffered intergranular corrosion (Fig. 10-3(b)), and the corrosion cracks had served as stress concentration sites to initiate fatigue. The loading causing fatigue was due to vibration of the cantilevered pipe and muffler, which was excited by fluctuating air loads as well as engine induced vibration.

Intergranular corrosion of austenitic stainless steel exhaust pipes is common, since the cycles of hot and cold exposure to combustion by-products and condensates represents a severe corrosive environment. However, since the pipes are usually well supported and hence subject only to low loads, normally they will not fracture until virtually perforated. In this case, the heavy, cantilevered, unsupported muffler extension created high cyclic stresses. The problem was alleviated by adding an extra support for the muffler. The grade of austenitic stainless steel used in the exhaust was not disclosed in this investigation, and therefore the possibility of sensitizing occurring due to the high temperature of the exhaust gases cannot be ruled out. The oxidation resistance and corrosion resistance of these alloys generally increase with increasing chromium and nickel contents, while microstructural stability improves with lower carbon levels.

Fig. 10-3 Intergranular corrosion and fatigue of a light aircraft engine exhaust
(a) Silencer extension fitted onto the exhaust pipe.
(b) Intergranular attack of the austenitic stainless steel pipe. Kalling's etch. (Mag. x 250)

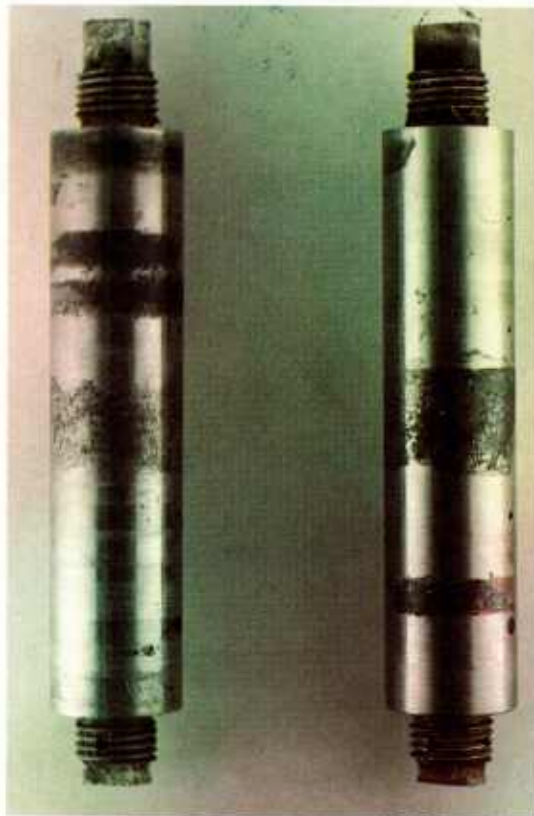
Figure 11-1 shows fretting damage in two flying control hinge pins, in the form of broad bands of deep pitting with associated accumulations of corrosion products. In service these pins would experience a combination of large amplitude displacements associated with deliberate movements of the control surfaces, and small amplitude displacements associated with normal aircraft vibrations in steady-state flight. Thus the damage observed may be due to a combination of wear and fretting corrosion. These problems are probably due to lack of adequate lubrication to alleviate the rubbing action.

Fig. 11-1 Fretting damage in two flying control hinge pins

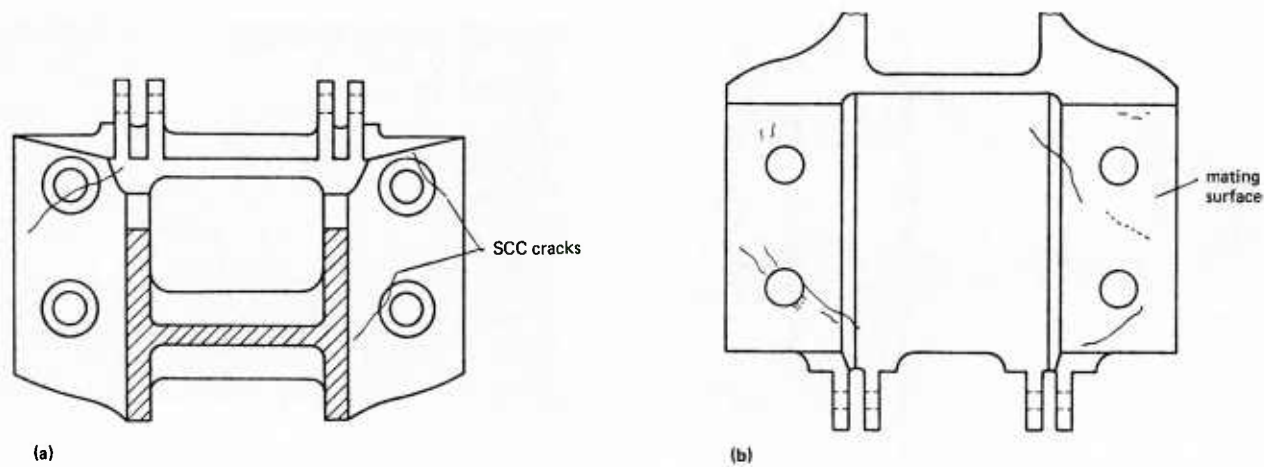
Fig. 13-27 Stress corrosion cracking in the 7079-T6 spars of a vertical fin, case history 13-2.

Several cracks were found in the front and rear spars of a fighter aircraft during a routine inspection using eddy current methods. The locations of the cracks in the parts are shown schematically in Figures 13-27(a) and 13-27(b), which show the front and rear spars respectively. The spars were made from 7079 die forgings, and were artificially aged to the peak strength condition according to the specification QQ-A-367. All surfaces of the spars had been shot peened after machining, and had been treated with a chromate conversion coating and a single layer of zinc chromate primer.

The spars were removed from the aircraft to allow closer visual inspection and the cracks could be seen clearly to be up to several centimetres long as indicated in Figure 13-28(a). Many of the cracks were found to propagate from fastener holes as indicated in Figures 13-27 and 13-28. The front and rear spars were mounted in a jig, and loaded statically to cause failure so that the crack surfaces were revealed. A typical fracture surface observed in the front spar is shown in Figure 13-28(b), and this shows a dull fan-shaped region which appears to have initiated in the radius at the base of a bolt access hole as indicated by the arrow, and a lighter area which was produced by the static overload fracture. The dull area was typical of stress corrosion cracking showing evidence of corrosion and arrest lines indicating that cracking had occurred progressively over a period of time. Metallographic examinations showed that the material had a fine-grained recrystallized microstructure, and the cracks were found to run along grain boundaries, as is expected with stress corrosion cracking in this class of alloy.

It was concluded that the cracking was due to stress corrosion which had occurred because of the use of a stress corrosion prone alloy. While the spars had received corrosion protection treatments, damage to the surface coatings during the installation of bolts had exposed bare metal and stress corrosion had occurred as a result of the high humidity and high sustained tensile stresses arising from fastener installation. To overcome this problem the spars were machined from 7075-T73 forgings, which as discussed in Section 13-5 provide high resistance to stress corrosion cracking. The surface protection system used previously, including shot peening to develop compressive residual stresses, followed by chemical conversion coating and zinc chromate priming, was retained. An alternative solution involving the use of 7175-T736 was also considered in order to maintain high strength, equivalent to or higher than the original 7079-T6 values, together with improved stress corrosion resistance.

(a) Sketch of the front spar showing the location of the cracks.
(b) Sketch of the rear spar showing the location of the cracks.

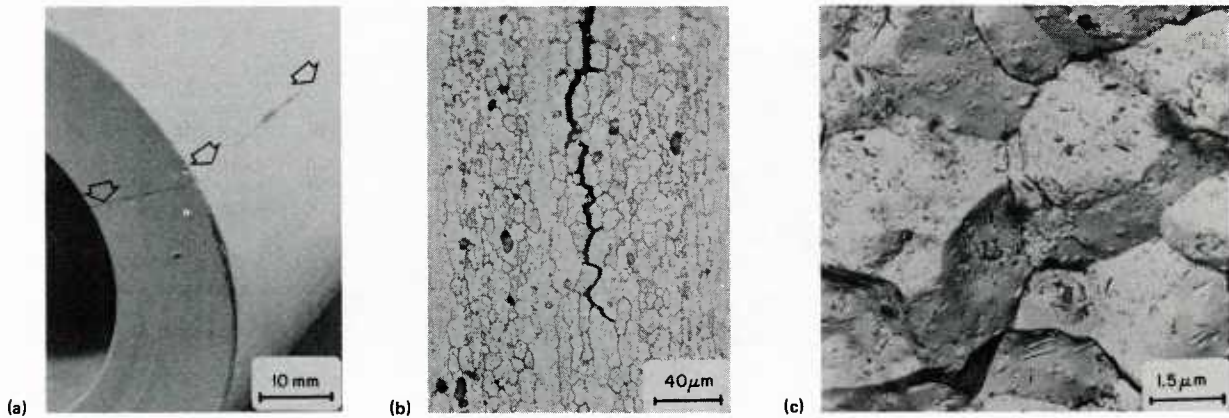
Fig. 13-29 Stress corrosion cracking in a 7079-T6 bearing housing, case history 13-3.

During a major repair of a fighter aircraft a crack was found in the pivot bearing housing at the top end of the vertical stabilizer beam. Figure 13-29(a) shows the crack as it was found by dye penetrant inspection. Figure 13-29(b) shows a metallographic cross section through the tip of the crack, and this shows that the crack follows grain boundaries aligned along the length of the bearing. Figure 13-29(c) shows a replica transmission electron micrograph of the fracture surface, which again reveals the intergranular nature of the fracture surface.

- (a) End of the bearing housing showing the location of the crack.
- (b) Metallographic section through the tip of the crack showing the intergranular nature of cracking.
- (c) Electron micrograph showing the intergranular fracture topography.
