AGARDograph No. 278

AGARD Corrosion Handbook Volume 1 Aircraft Corrosion: Causes and Case Histories

AIRCRAFT CORROSION: CAUSES AND CASE HISTORIES

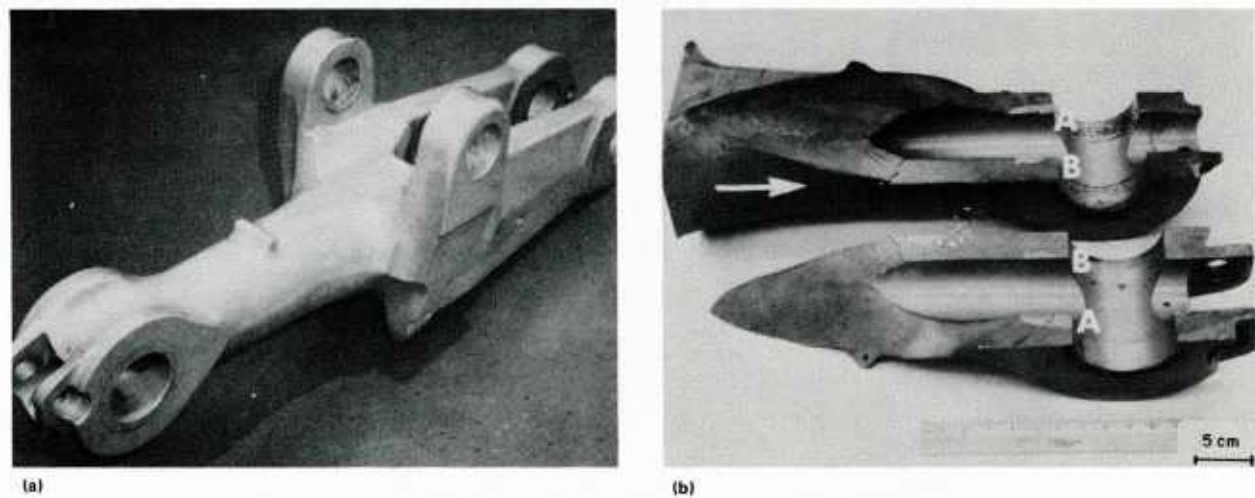
Fig. 13-30 Stress corrosion cracking in a 7075-T6 main landing gear bogie, case history 13-4.

The main landing gear bogie of a large turboprop transport aircraft failed on touchdown, fortunately without causing a serious accident. The part was found to be made from a 7075-T6 forging of the type shown in Figure 13-30(a), and was found to have split along the forging parting plane as indicated in Figure 13-30(b). The tip of the white arrow in Figure 13-30(b) indicates the position of the crack tip in the parting plane, and therefore indicates the maximum extent of cracking in the parting plane. The longest crack was nearly 30 cm long at failure, but since the forging surface had been fully shot peened, the surface residual compressive stresses had prevented the growing cracks from breaking through to the surface and hence revealing themselves to surface inspection. Cracking initiated at the main axle bore, where the most susceptible end grain boundaries on the forging parting plane were exposed by the machining process. Cadmium plated steel bushings were mounted in the main axle bore by interference fit, and corrosion pits were found in the aluminium forging underneath the bushings. Thus even though cadmium plating was used, there appears to have been a sufficiently high galvanic potential in the presence of moisture to initiate pitting attack which led in turn to stress corrosion cracking. The stresses driving SCC in this part were due to the interference fit bushings and residual stress resulting from the post-forge heat treatment operations.

- (a) New and unused bogie.
- (b) Failed bogie beam showing the crack initiation sites (A and B) underneath the shrunk-in steel bushings for the main axle bearings. The arrow tip indicates the maximum extent of the crack in the parting plane.

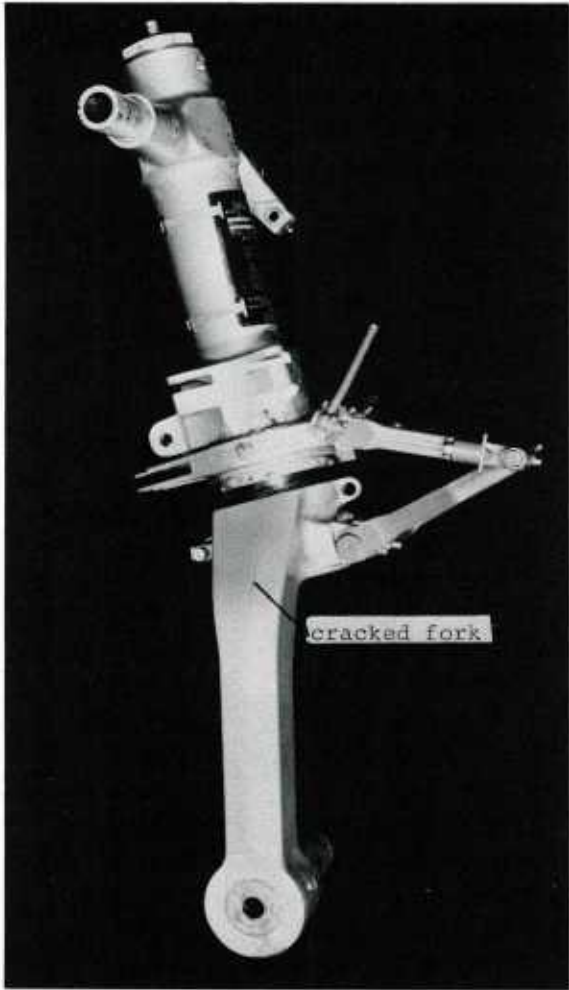
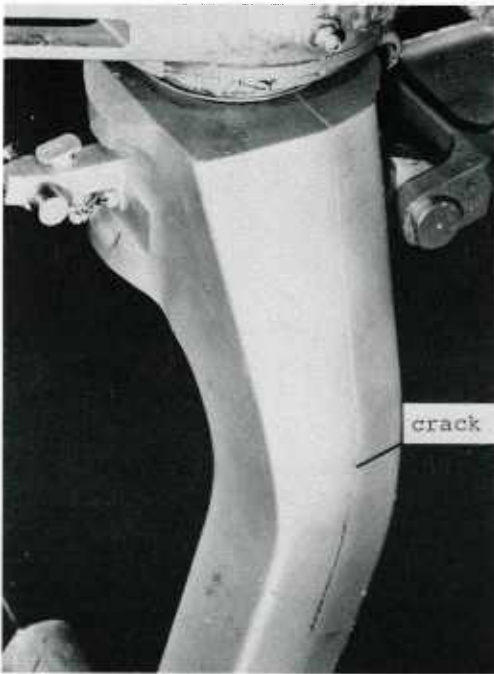
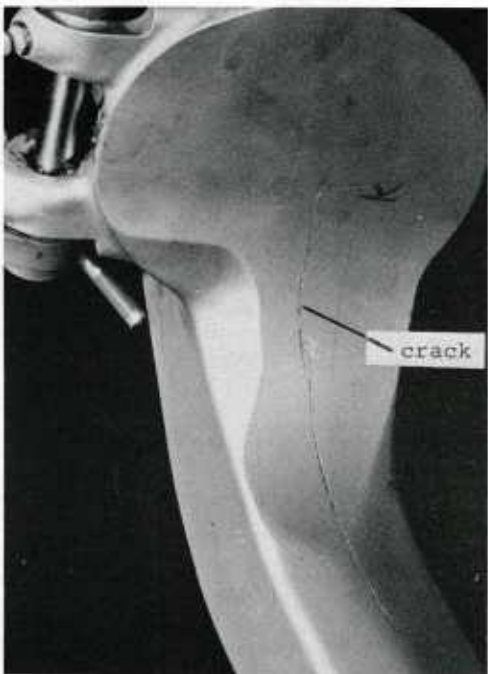
Fig. 13-32 Stress corrosion cracking in a 7075-T6 nose landing gear fork, case history 13-6.

During a post-flight visual inspection of a fighter aircraft a long crack was found in the nose landing gear fork. The part is shown in Figure 13-32, and the crack which can be seen in this figure was found to lie in the parting plane of the aluminium alloy forging. The forging was made from 7075-T6 and its surfaces were treated with a single coat of wash primer plus two coats of acrylic paint.

- (a) Complete landing gear assembly.
- (b) Close-up of the fork outer surface showing the crack.
- (c) Close-up of the fork inner surface showing the crack.

The crack was found to extend through the thickness of the fork, as indicated in Figures 13-32(b) and 13-32(c), and when the crack was opened up it was found to extend over about three quarters of the longitudinal cross section of the fork, as indicated in Figure 13-33. Figure 13-34(a) shows the fracture surface and reveals a dull fibrous fracture typical of stress corrosion cracking, where the crack appears to have started in the upper bore for the nose-landing gear leg attachment and the adjacent bore hole, which was introduced as a weight saving measure. However while the bores may have been effective in respect to weight savings, they provided natural traps for moisture. Figure 13-34(a) also reveals a narrow ribbon of material along both external surfaces which appear to have a lighter appearance than the area affected by SCC, and this suggests that the stress corrosion crack may have propagated over a substantial distance through the NLG-fork before breaking through to the external surfaces. Thus the crack may have been hidden for a substantial period of time prior to visual detection. Figure 13-34(b) shows a metallographic section through the crack tip and demonstrates quite clearly that the crack had propagated along grain boundaries, as expected for SCC in this type of alloy. The intergranular fracture mode was confirmed by scanning electron microscopy.

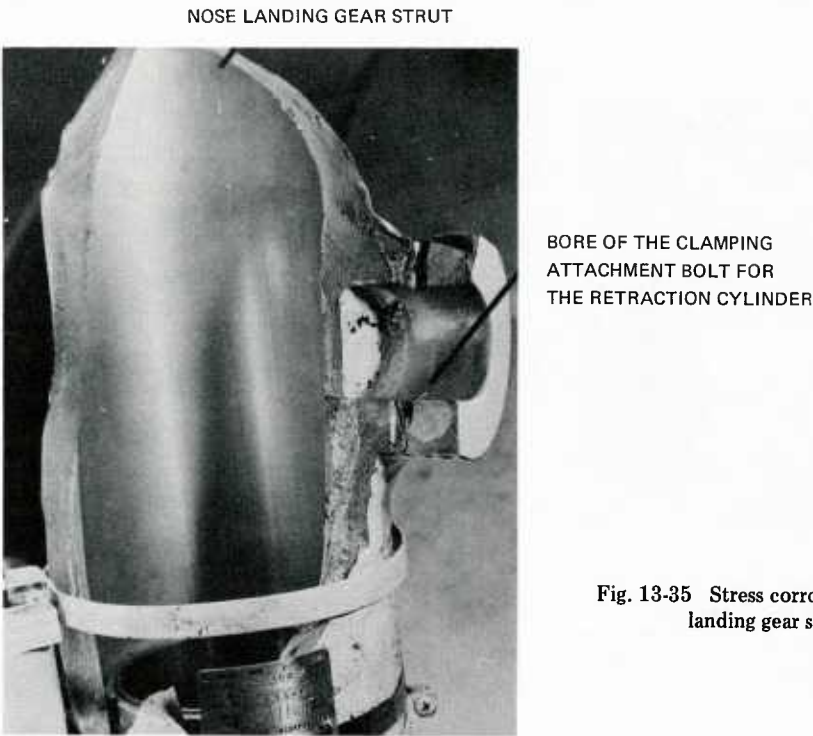
Fig. 13-35 Stress corrosion cracking in a 7075-T6 nose landing gear strut, case history 13-7.

The nose landing gear strut of a fighter aircraft failed during a normal landing procedure after only 30 hours of flight had been accumulated. The failed part is shown in Figure 13-35, and closer examination of the fracture surfaces evident in the failed part revealed that pre-existing cracks had been present prior to the final failure. The fracture surfaces due to these pre-existing cracks are shown in Figure 13-36, and it can be seen that these had initiated at the corners of the bore holes used to locate the clamping attachment bolts for the retraction cylinder.

The failure was a classical stress corrosion cracking problem and was influenced by the use of a susceptible material, the bored holes exposing end grain boundaries, assembly stresses due to interference fit bushings, and superimposed stress concentrations due to the intersecting bores. It was likely that high residual stresses were also present as a result of the T6 heat treatment.

A number of alternative designs were considered to resolve this problem including the use of one of the newer high strength, stress corrosion resistant forging alloys such as 7050-T73. However, it was decided to change to a high strength low alloy steel, AMS-6427 (0.3% C, 0.9% Cr, 0.2% Cu, 0.9% Mn, 0.42% Mo, 1.9% Ni) which provides higher strength together with good stress corrosion resistance. The design was also changed, replacing the clamping attachment bore with a forged steel pin, as indicated in Figure 13-38. The steel forging was protected by a vacuum deposited layer of cadmium plating followed by a layer of epoxy primer and a single coat of polyurethane paint.

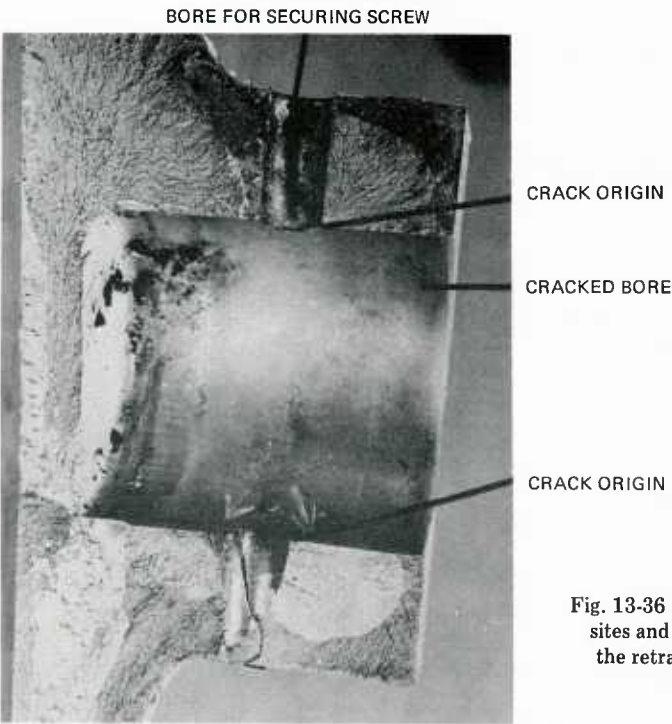
Fig. 13-36 Close-up of the stress corrosion crack initiation sites and the internal surface of the bore used to locate the retraction cylinder. Pitting can be seen at the base of this hole, case history 13-7.

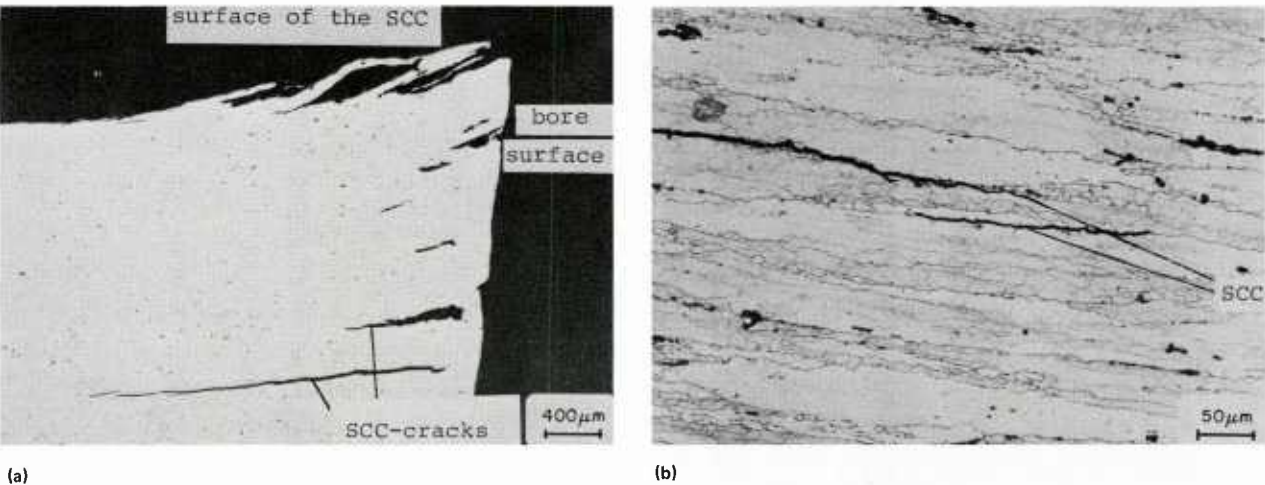
Fig. 13-37 Cross sections through the nose landing gear strut adjacent to the retraction cylinder bore and bolt hole, case history 13-7.

Metallographic examinations showed that a series of cracks was present in the landing gear strut, lying in planes between the axis of the cylinder bore and the axis of the securing bolt hole (Fig. 13-37(a)). Figure 13-37(b) shows the tip of the longest crack of Figure 13-37(a), and this etched micrograph shows that the cracks follow the grain boundaries of the large pancake shaped grains. Some fine recrystallized grains lie around the perimeters of these larger grains.

- (a) Showing multiple stress corrosion cracks.
- (b) Shows the tip of the lower crack in (a) above and indicates that the crack path is intergranular.

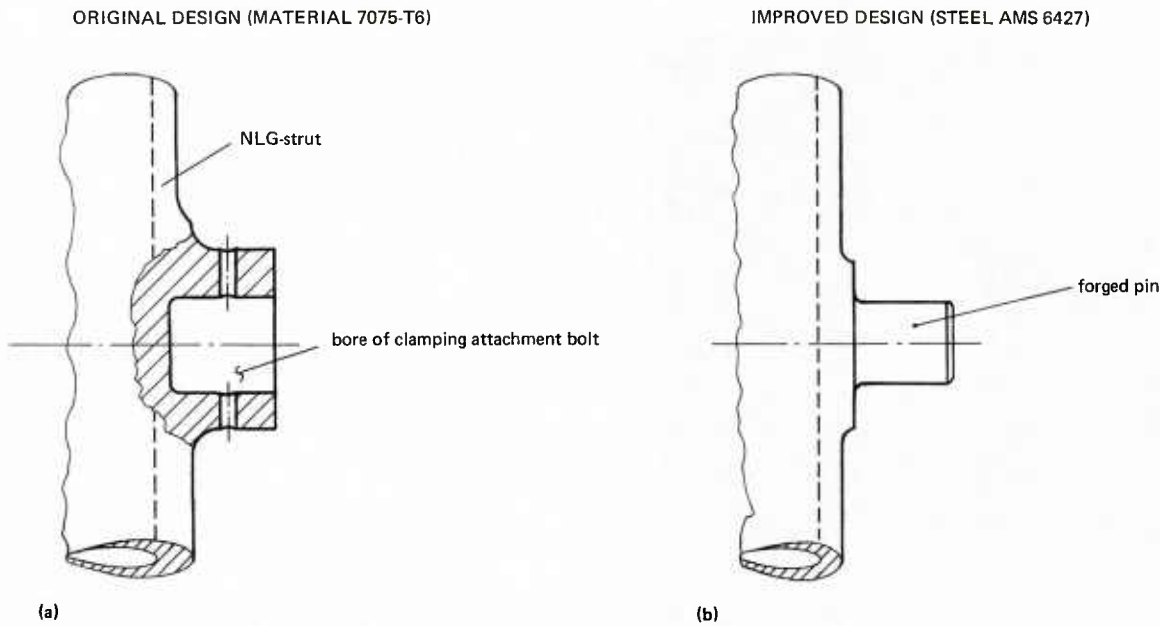
Fig. 13-38 Design details of the nose landing gear strut, case history 13-7.

- (a) Original design.
- (b) Modified design.

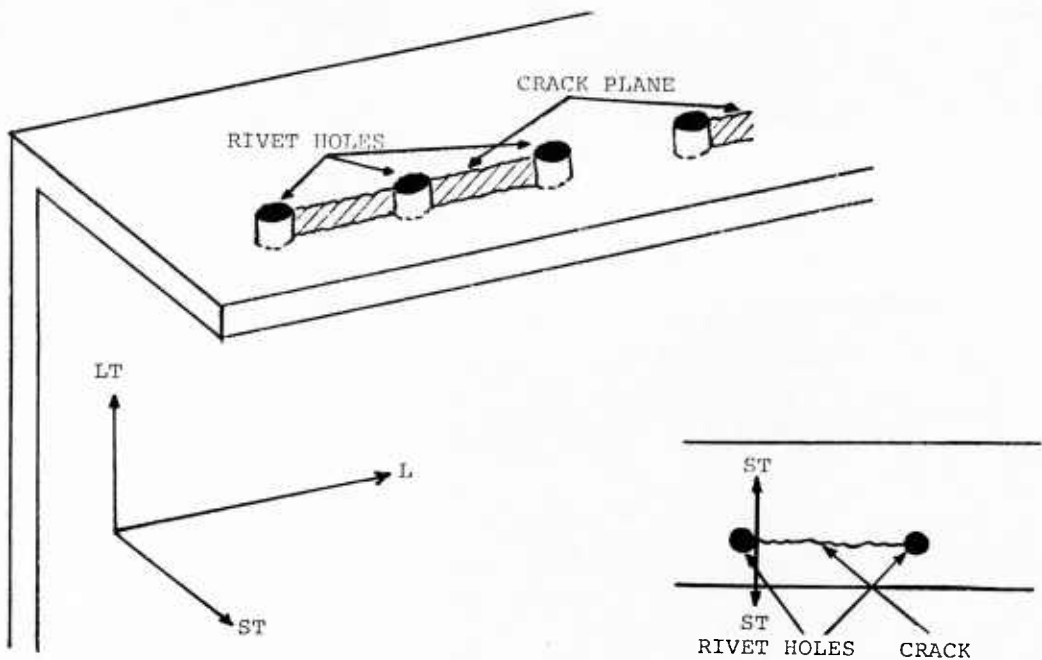
Fig. 13-40 Orientation of the crack plane with respect to the principal directions in the fuselage frame, case history 13-8.

A spectrographic analysis showed the alloy contained 3% Mg, 5.1% Zn, 1.8% Cu, 0.18% Cr and lesser amounts of Fe, Si and Mn. The alloy concentrations were consistent with specifications for 7075 and the alloy hardness indicated the material was in a T6 strength condition. A microstructural evaluation of the grain structure showed a heavily wrought structure of pancake shaped grains, where the crack plane was coincident with the plane containing the longitudinal-long transverse directions, and the short transverse direction was normal to the crack plane as indicated in Figure 13-40.

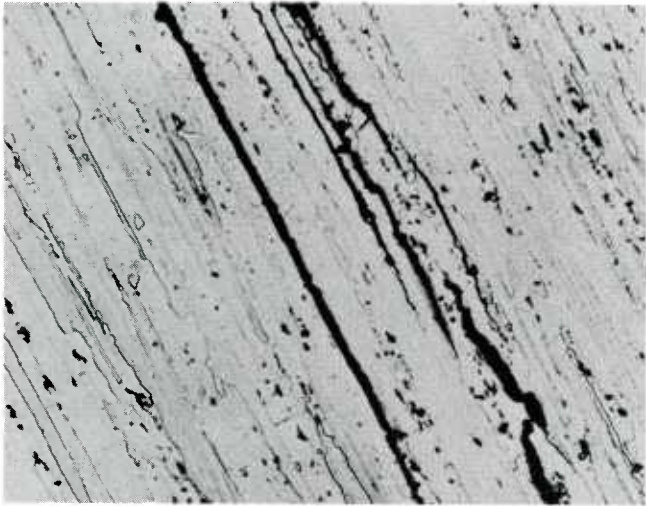
Fig. 13-41 Metallographic section indicating the intergranular crack path in the fuselage frame, case history 13-8.

Figure 13-41 shows a metallographic section normal to the LT direction and cracks can be seen running in the longitudinal direction along grain boundaries. The fracture surfaces were corroded, and in most cases they showed no recognizable feature other than flat grain boundary surface facets, as shown in Figures 13-42(a) and 13-42(b), and secondary cracking (Fig. 13-43). In a few cases striation like markings were present immediately adjacent to the fastener holes and in most cases the surfaces of the fastener holes contained corrosion pits. The failure analysis report made no mention of sealants or other forms of corrosion protection in the fastener holes and no information was given on the fastener materials used. However it was concluded that cracking was due to stress corrosion, initiating at corrosion pits in the bore of the fastener holes. The stresses were believed to be due to assembly and operating loads and a stress analysis showed that stresses in the ST direction in the region of the fastener holes were in excess of the threshold values for stress corrosion cracking given in Reference 13-1, Table 13-1.

It was recommended to replace these fuselage frames with 7075-T73 to prevent SCC. However, since there was evidence of fatigue in some areas and since threshold stress intensities for fatigue in 7075-T73 are slightly lower than for 7075-T6 it might be preferable to replace this alloy completely with a higher strength stress corrosion resistant alloy such as 7050-T73. Wet assembly of fasteners should also assist by excluding moisture from the fastener holes.

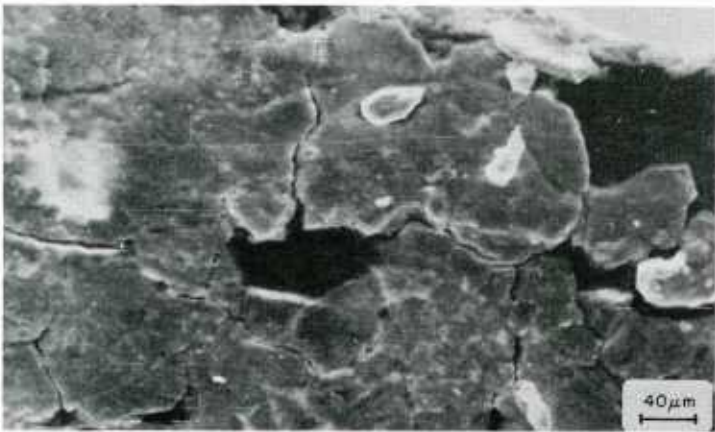
Fig. 13-43 Scanning electron micrograph of a fracture surface from case history 13-8, showing secondary intergranular cracking.

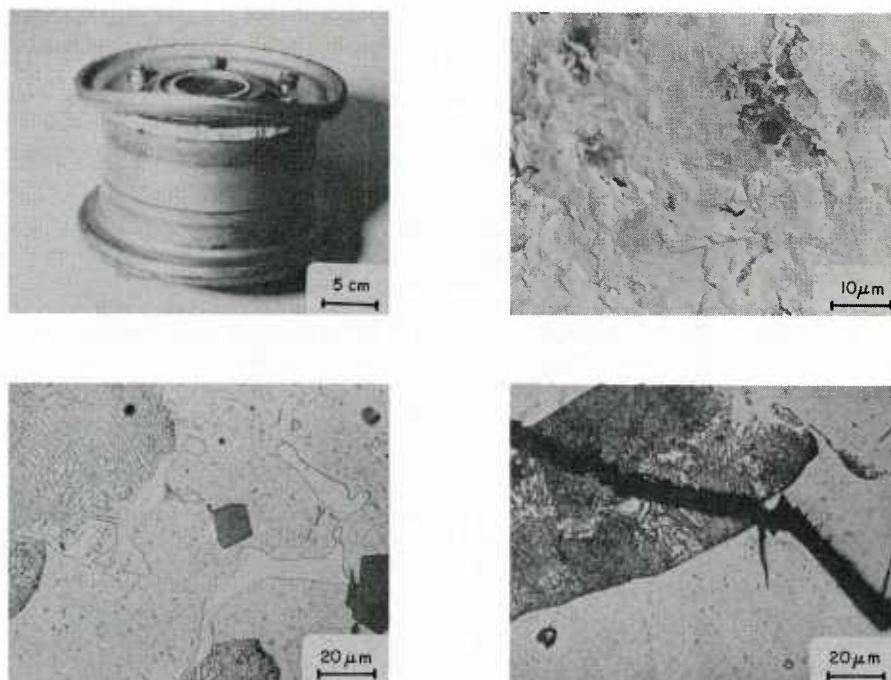
Fig. 13-47 Stress corrosion cracking of a magnesium alloy nose wheel, case history 13-12.

A magnesium alloy nose-wheel of a fighter aircraft failed and caused a tire blow-out. The wheel was produced as a casting using the MgAlZn alloy, AZ-91C, and this failed through the formation of a major crack in the fillet between the flange and the rim. This crack had caused the flange to be partly torn from the wheel body, as shown in Figure 13-47(a). Visual inspection revealed corrosion pits and small cracks in the fillet between the flange and the rim at the surface of contact with the tire-bead. The fractographic investigation failed to reveal any indications of fatigue or intergranular failure. The fracture surfaces were dirty and severely damaged, and the only recognizable features were lamellar components of the microstructure protruding from the fracture surface at various angles, as indicated in Figure 13-47(b).

- (a) Fractured wheel.
- (b) Fracture surface topography.
- (c) Microstructural constituents.
- (d) Section through a crack showing transgranular propagation.

A microstructural examination of the alloy revealed a magnesium alloy matrix containing various precipitated phases. These included: (a) pools of eutectic containing lamellar particles of the compound Mg_3Al_2 , (b) coarse white particles containing zinc which may have been $Mg_3Al_2Zn_3$ or $MgZn_2$, and (c) grey angular particles of a manganese bearing compound $MgMnAl$ or Al_4Mn . These constituents can be seen in Figure 13-47(c). Figure 13-47(d) shows a crack cutting through a patch of lamellar eutectic and propagating transgranularly through the magnesium solid solution matrix. Some secondary cracking can be seen propagating out of the main crack, and this appears to be following specific crystallographic planes.

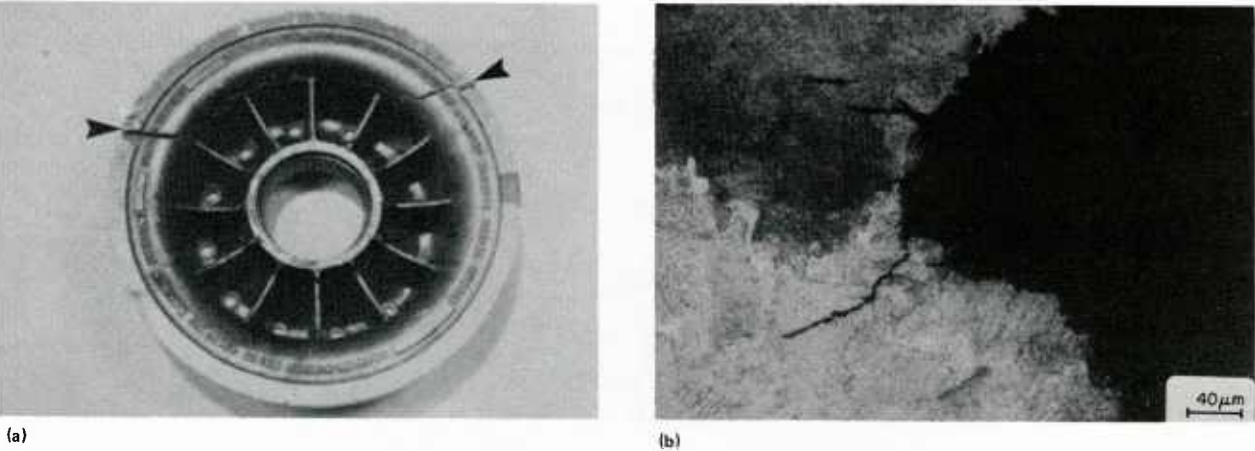
A large rim section was found broken from the rim of a STOL transport aircraft main wheel after landing (Fig. 14-8(a)). The cause of fracture was found to be corrosion fatigue cracking which had grown completely through the rim section. Cracking initiated from the tyre bead seat radius, and the corrosion products were typical of a marine environment.

Fig. 14-8 Corrosion fatigue of a magnesium alloy (AZ-91C) main landing gear wheel
(a) General view of the failed wheel and the crack indicated by arrows.
(b) Section through a typical pit showing multiple corrosion fatigue cracks.
Nital etch. (Mag. $\times 250$)

These experimental low pressure tyre wheels allowed salt moisture to penetrate the tyre bead seat area between tyre and rim, aided by frequent tyre changes. The wheel was a magnesium alloy casting (AZ-91C) and fatigue crack initiation occurred at the base of deep corrosion pits. Figure 14-8(b) shows a typical pit with multiple crack origins.

Such failures are not likely to occur until the cracking is substantial and then only when side loaded during taxiing, since tyre pressure loads are small. Dye penetrant or eddy current inspection to detect cracking during tyre changes would prevent in-service failures. In this case the frequent experimental tyre changes increased the availability of the corrosive media to the growing undetected cracks.

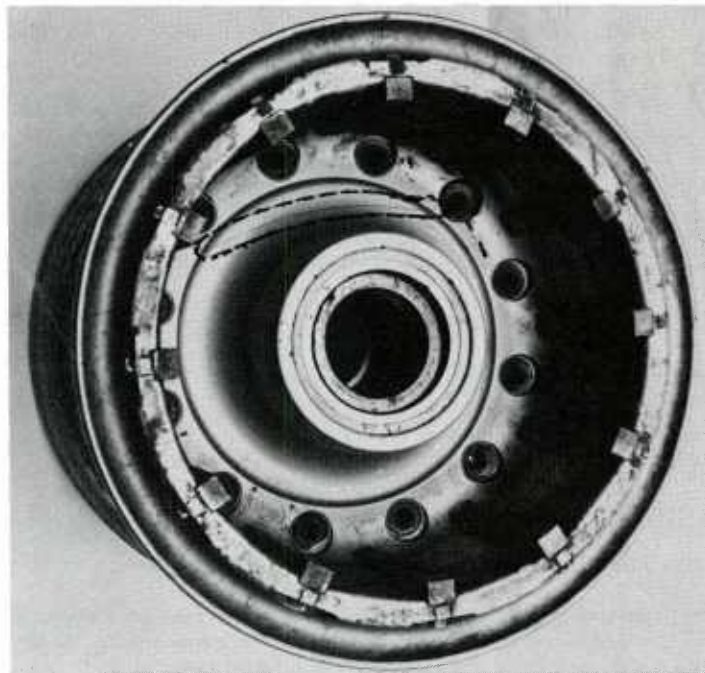
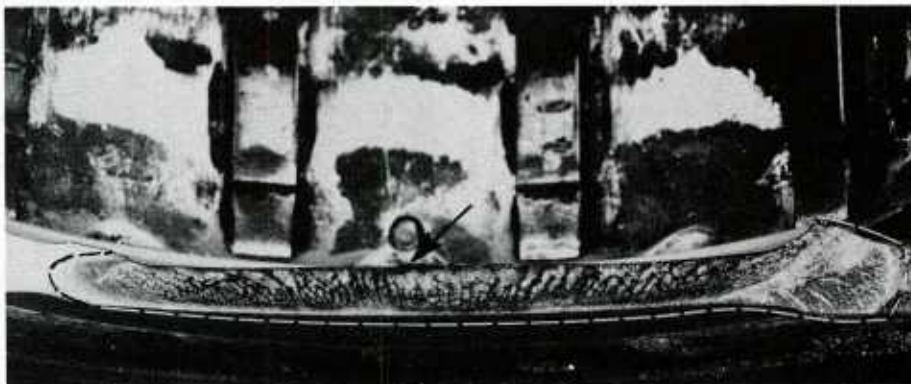
Long cracks were found during visual inspection of a fighter aircraft main landing gear wheel. The cracks were approximately 125 mm long and were found to run between the rim of the wheel and a bolt hole, as shown in Figure 14-9(a). The crack initiation site is indicated by the arrow in Figure 14-9(b).

Heavy surface corrosion was observed over most of the wheel and polished sections, such as that shown in Figure 14-9(c), showed several through cracks and partial cracks initiating from corrosion pits. The cracks were found to propagate in a predominantly intergranular mode, as indicated in Figure 14-9(c).

Fig. 14-9 Corrosion fatigue of a magnesium alloy (QE-22A) main landing gear wheel

- (a) General view of the wheel showing the crack.
- (b) Fracture surface showing the crack initiation site indicated by arrows.

QE-22A, like other magnesium alloys, is subject to general and pitting corrosion in industrial, marine and moist environments. However, with suitable surface treatments and painting, it performs satisfactorily in all types of natural environments with the exception of continuous immersion in water (Ref. 14-7). The alloy has low susceptibility to stress corrosion cracking (Ref. 14-8). The wheel in question had been operated in the Mediterranean region, and exposure to a warm moist salt atmosphere was no doubt a factor in the failure. The critical crack had initiated on the exterior surface of the wheel, which fortunately was visible, and this probably occurred in an area where the corrosion protection system was damaged. Regular inspection and repair of the paint system should have prevented this failure. Because of the clear evidence of corrosion and the indications of fatigue striations on a heavily corroded fracture surface the failure was attributed to corrosion fatigue.

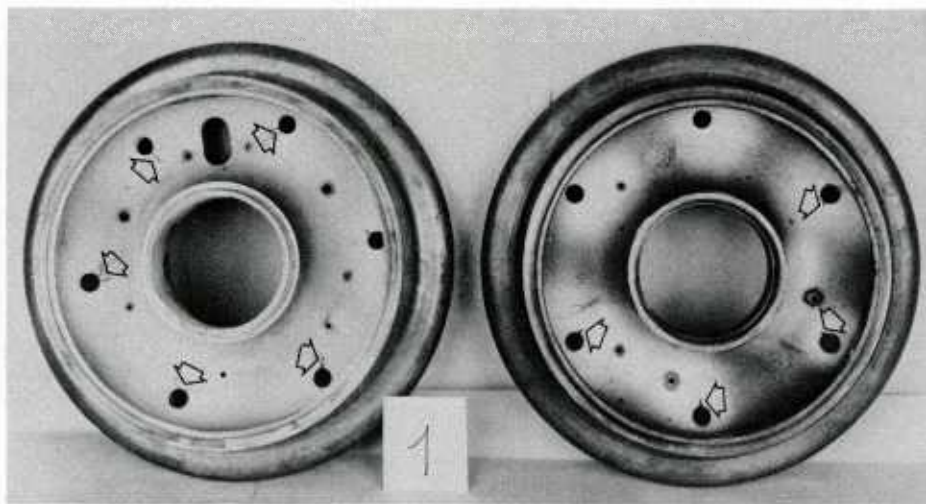
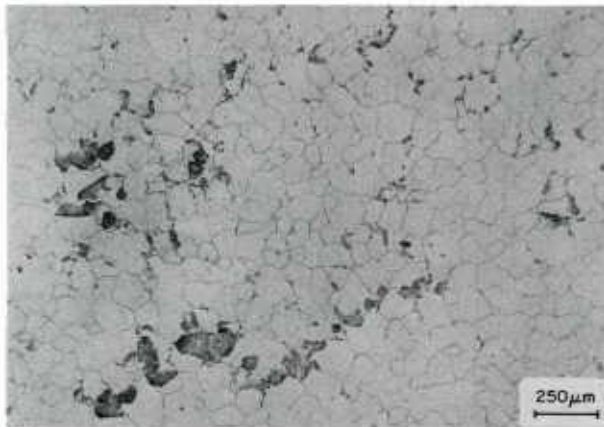
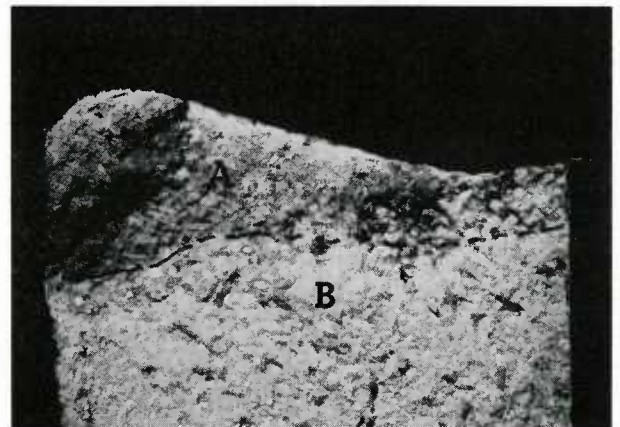
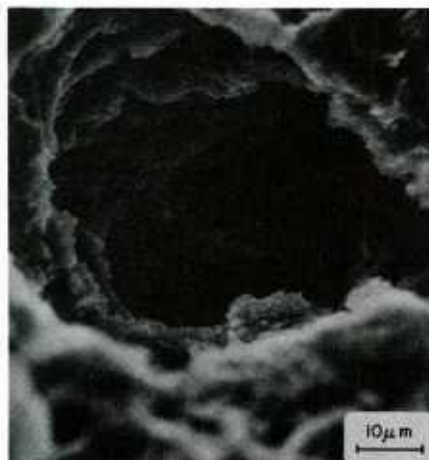
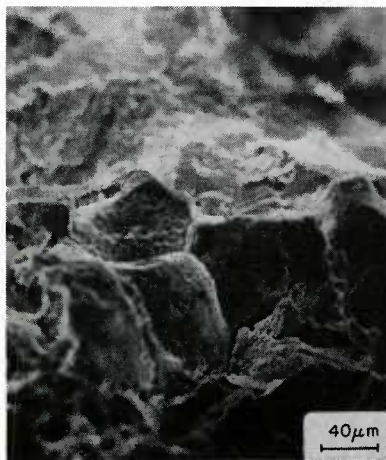
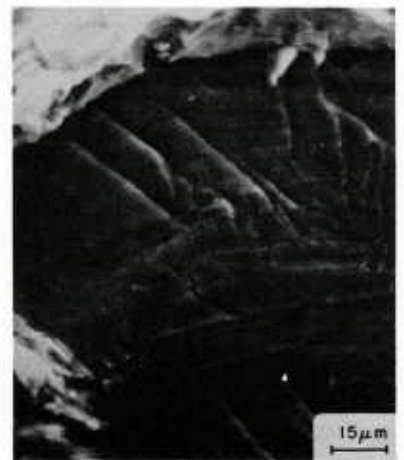
Multiple cracks were found propagating out of bolt housings during a visual and liquid penetrant inspection of the nose wheels of a fleet of fighter aircraft. Many wheels were found to be affected, and typical cracks are indicated by the arrows shown in Figure 14-10(a).

Several cracks were opened in the laboratory, and these showed a dark zone, covered by corrosion products, which extended up to the bright overload zone produced during opening (Fig. 14-10(c)). The inner surfaces of the bolt holes were also examined. These were found to contain deep corrosion pits of the type shown in Figure 14-10(d). Examination of the fracture surfaces using a scanning electron microscope showed that intergranular cracking had occurred in the initiation regions (Fig. 14-10(e)), while transgranular fracture had occurred at longer crack lengths (Fig. 14-10(f)). Both the intergranular and transgranular zones were badly corroded, but fatigue striations were clearly visible in the transgranular areas (Fig. 14-10(f)).

Pitting attack in the bolt holes may have been influenced by galvanic effects, or by crevice conditions existing between the wheel and the steel bolts. However, the presence of heavy corrosion across the fracture faces and the clear evidence of striations suggests that corrosion fatigue was responsible for at least the later stages of crack propagation. This aircraft had operated in the Mediterranean region which is also a significant factor. This, and the two preceding case histories, suggest that magnesium alloy castings are not good choices for aircraft wheels.

Fig. 14-10 Corrosion fatigue of a magnesium alloy (AZ-91C) nose wheel

- (a) General view of two wheels showing cracks (arrows) growing out of bolt holes.
- (b) Microstructure of the AZ-91C magnesium alloy. (Mag. $\times 45$)
- (c) Fracture surface showing the corroded (dark) pre-cracked area 'A', and the bright final fracture zone 'B'.
- (d) Inner surface of a bolt hole showing a deep corrosion pit. (Mag. $\times 1200$)
- (e) Intergranular cracking in the initiation zone. (Mag. $\times 260$)
- (f) Fatigue striations in a transgranular portion of the fracture surface. (Mag. $\times 650$)

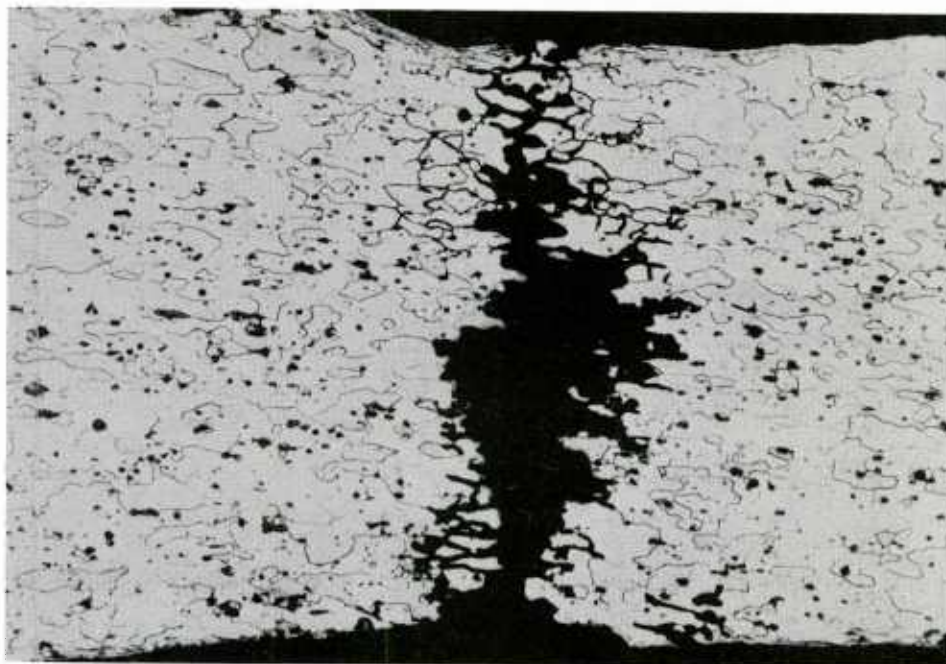
Fig. 15-6 Typical perforation corrosion caused by micro-organisms. Alloy: 2024 (Al-Cu-Mg)

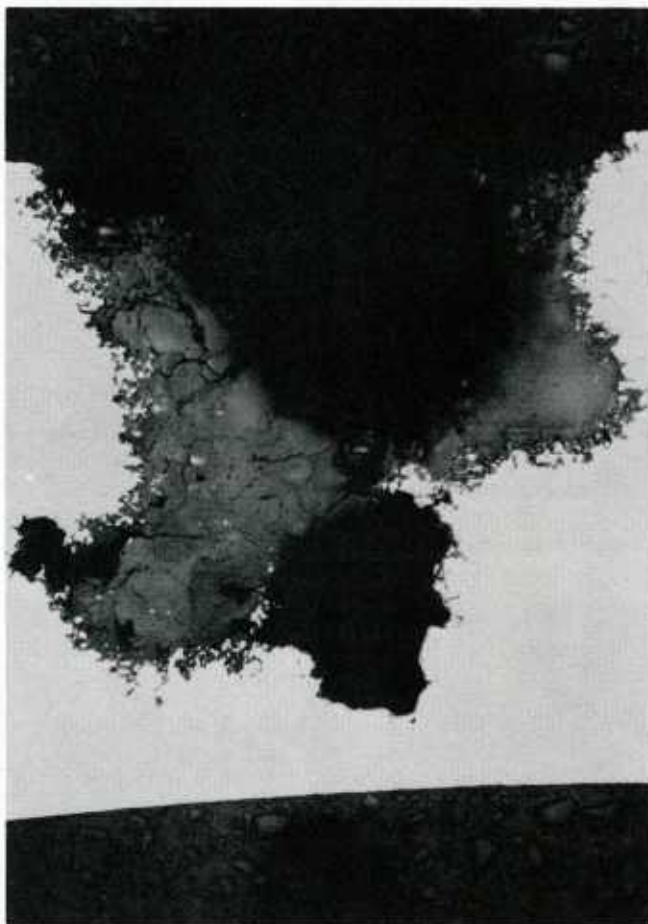
Fig. 15-7 Typical microbiological corrosion.
Alloy 5052 (Al-Mg)

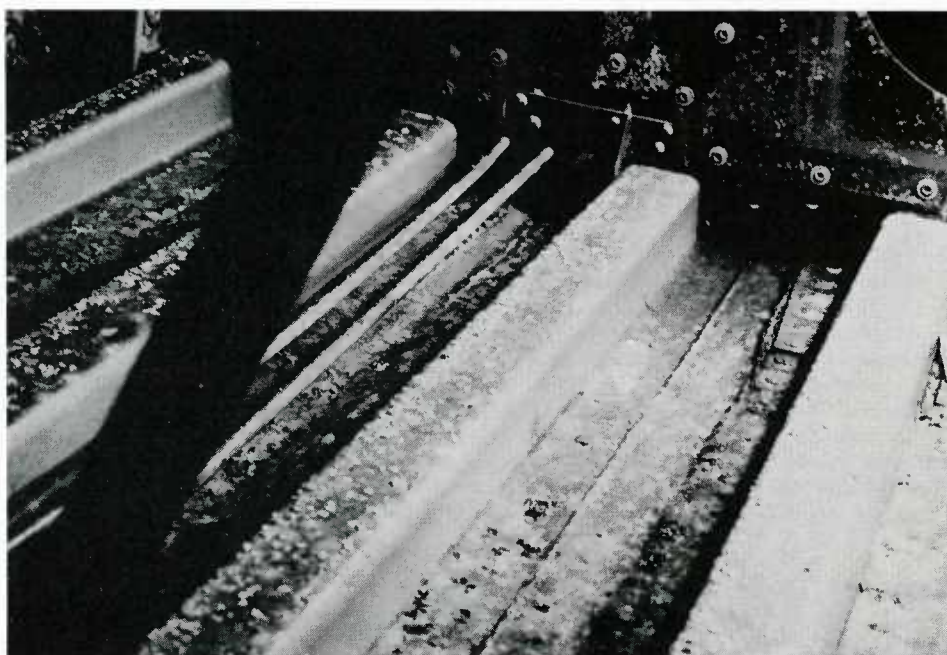
Fig. 15-8(a) Typical view of integral fuel tanks with microbiological corrosion

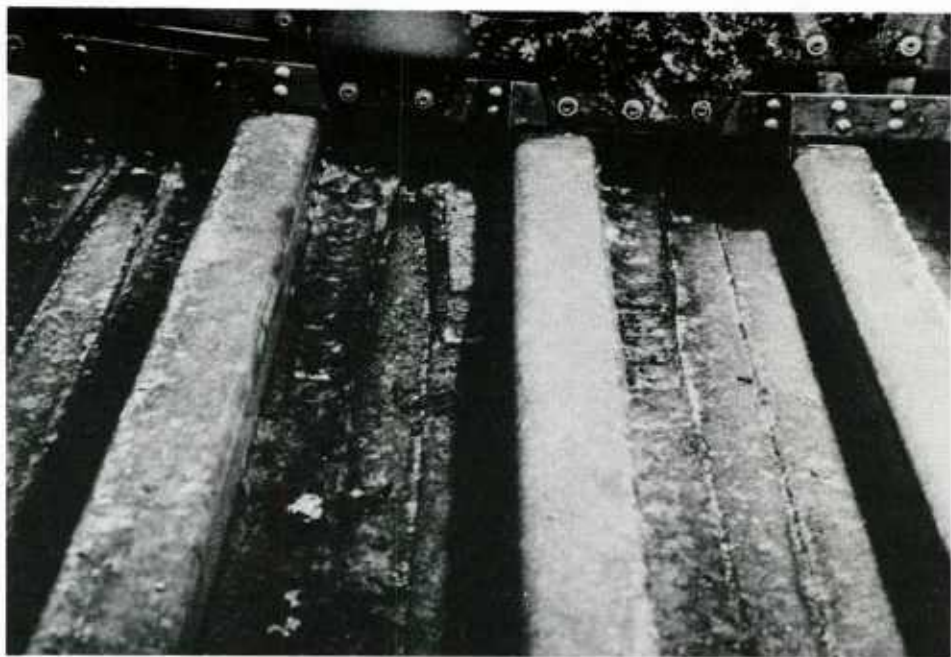
Fig. 15-8(b) Typical view of integral fuel tanks with microbiological corrosion

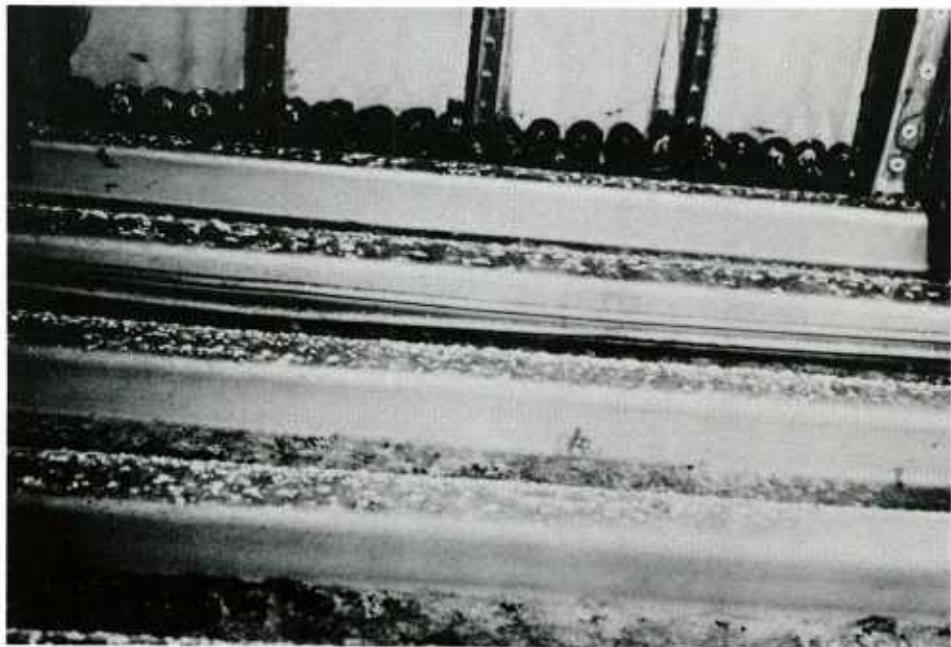
Fig. 15-9 Typical view of integral fuel tanks with microbiological corrosion
