AFWAL-TR-84-3115

ACCELERATED CORROSION TESTING OF GRAPHITE/EPOXY COMPOSITES AND ALUMINUM ALLOY MECHANICALLY-FASTENED JOINTS

S. D. Thompson,
B. L. White
Survivability/Supportability Group
Structures and Dynamics Division

June 1985
Final Report for Period May 1980 - December 1984

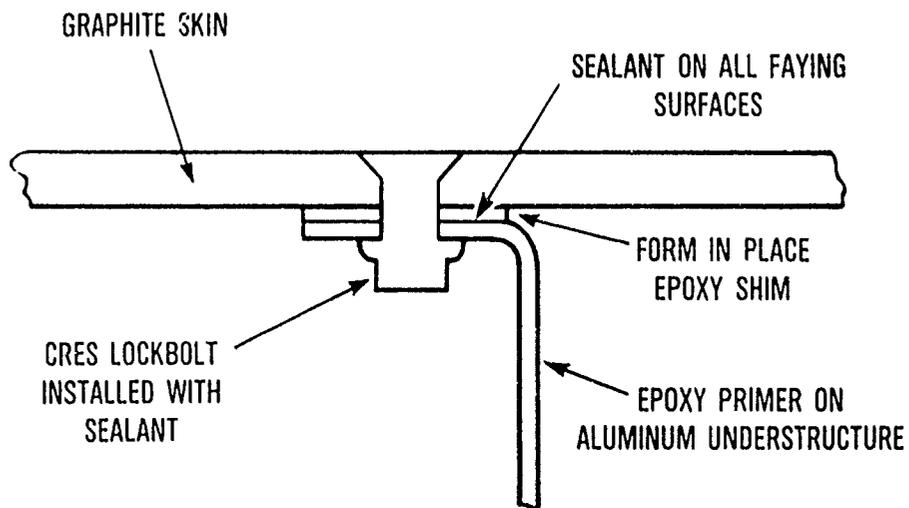
- A-286 CRES AND TITANIUM FASTENERS WET INSTALLED WITH SEALANT
- LIQUID SHIM AND SEALANT ON GRAPHITE TO ALUMINUM FAYING SURFACES
- SEALANT ON UNDERSTRUCTURE FAYING SURFACES TO PREVENT ENTRANCE OF GRAPHITE DUST
- FIBERGLASS PLY ON INNER SURFACE OF COMPOSITE SKINS

Figure 1. Sketch of F-16 Aircraft Corrosion Protection Scheme

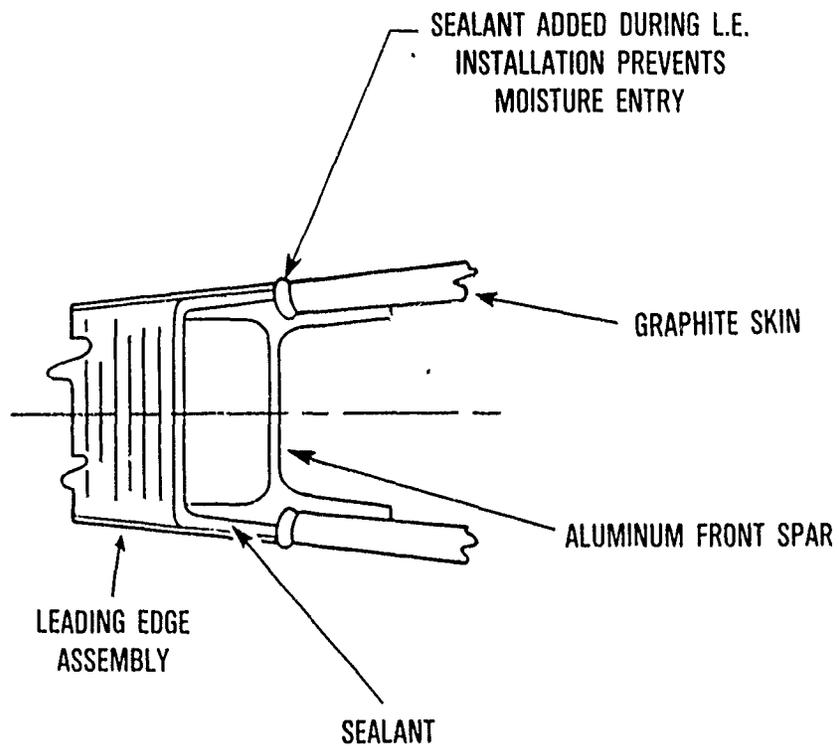
Figure 2. Leading Edge Installation to Prevent Moisture Entry to Front Spar-Skin Joint on the F-16 Aircraft Vertical Stabilizer

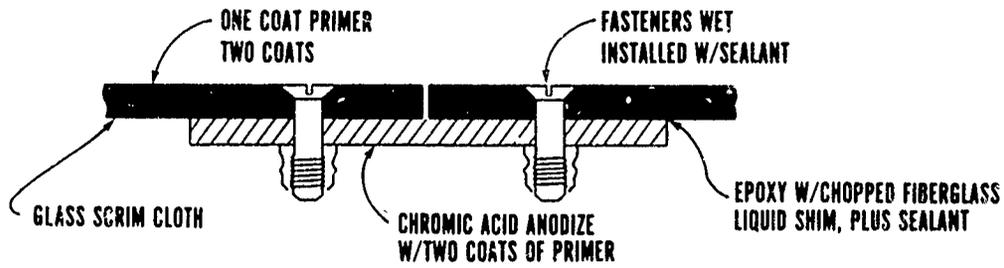
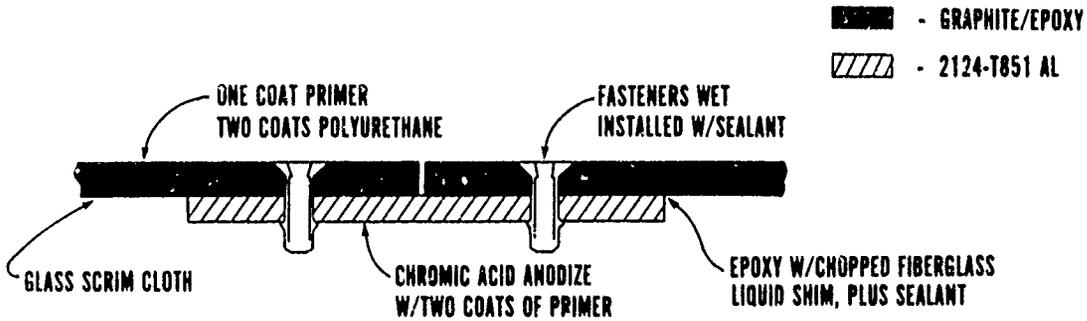
(NAS 1154V4 TITANIUM FASTENER SPECIMEN DESIGN)

(A-286 CRES BLIND FASTENER SPECIMEN DESIGN)

Figure 3. Protected Lap-Joint Specimen Configuration
