N-1742

January 1986

Technical Note

Experimental Polyurethane Foam (PUF) Roofing Systems- III: Naval Station, Roosevelt Roads, Puerto Rico, and Naval Facility, Cape Hatteras, North Carolina

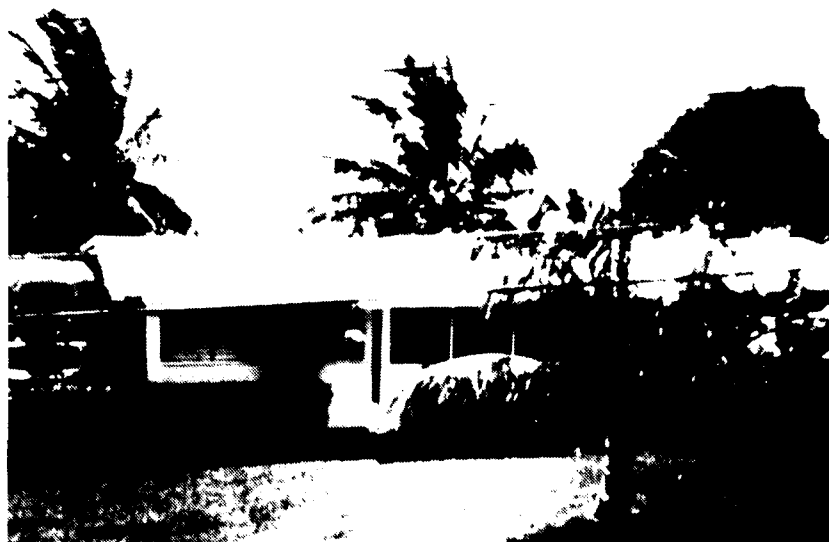
Figure 1. Typical experimental house with low slope concrete roof deck. Note tropical foliage, which is often dense, and roof mounted TV antenna. Naval Station, Roosevelt Roads, P.R.

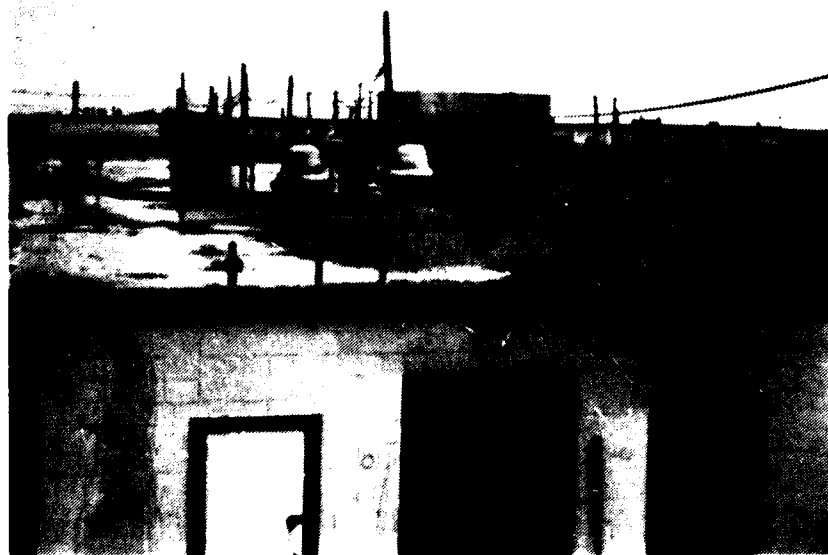
Figure 2. Overview of old BUR on Galley, Naval Facility, Cape Hatteras, N.C.
