N-1744

January 1986

Blistering of Asphalt Pavement Overlay on Runway 14-32 at MCAS Beaufort, South Carolina

NAVAL CIVIL ENGINEERING LABORATORY PORT HUENEME CALIFORNIA 93043

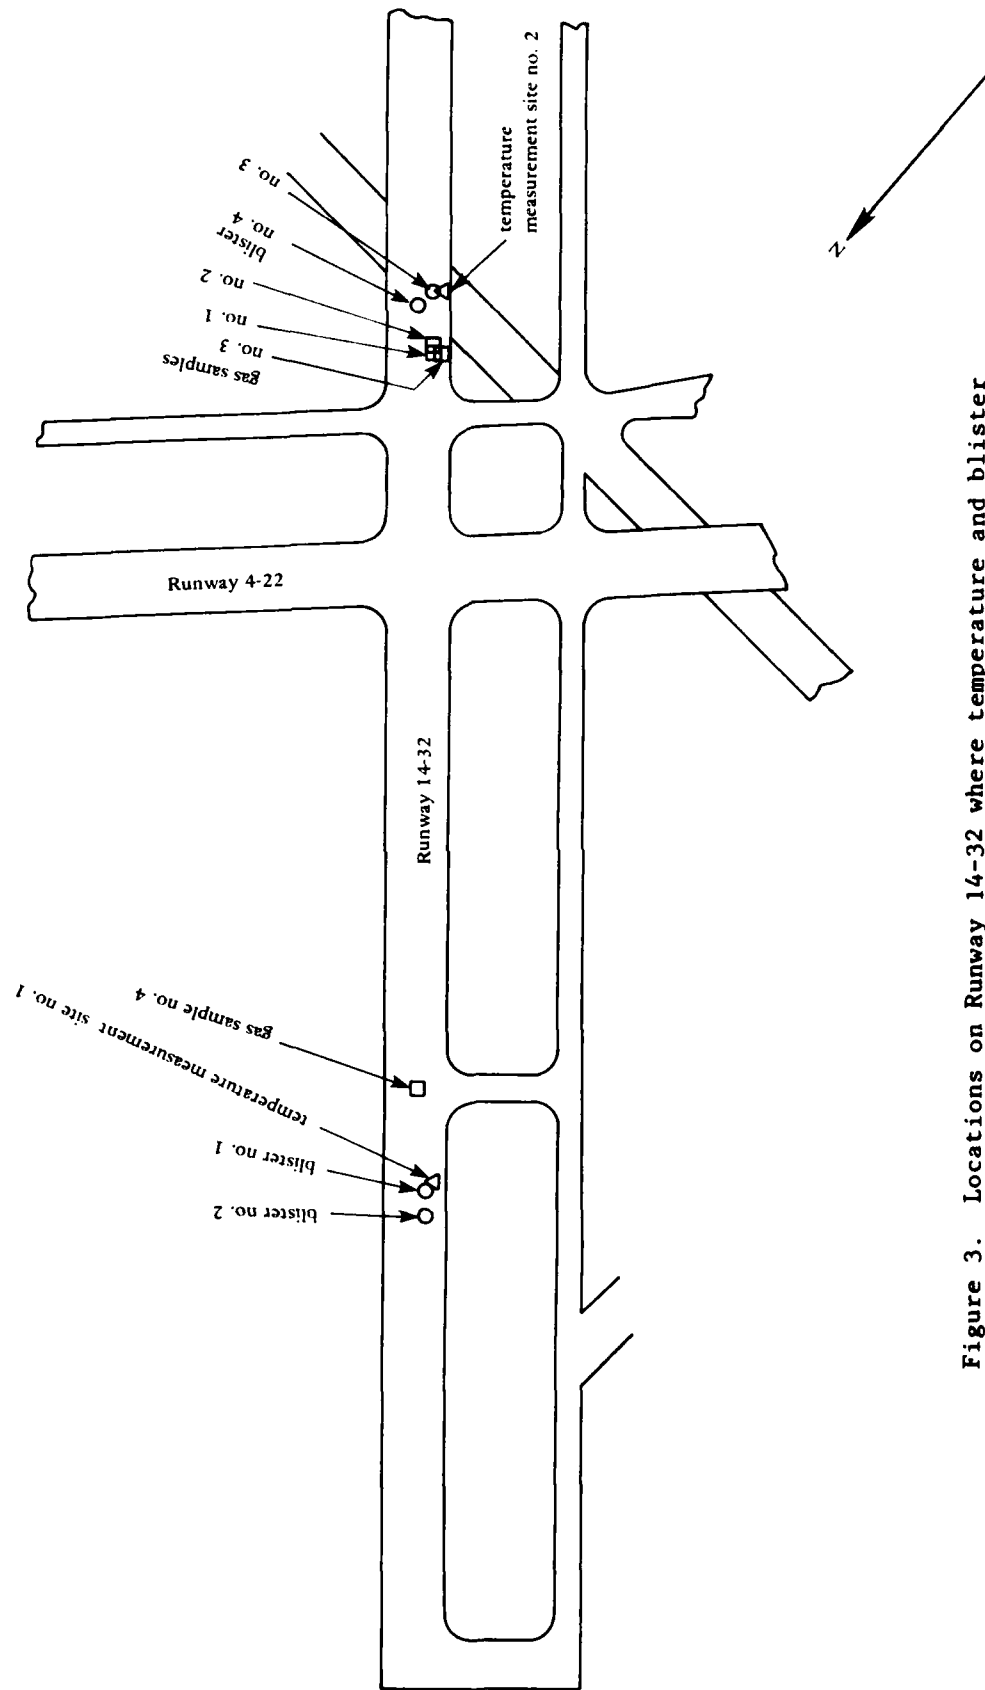
Figure 3. Locations on Runway 14-32 where temperature and blister behavior measurements were made and where gas and AC overlay samples were taken.

The locations where measurements of pavement temperature profiles and blister elevation changes were made and where samples of the asphalt overlay were taken are shown in Table 2. Locations and ambient conditions for the four blister gas samples are shown in Table 3. The locations on Runway 14-32 where the measurements and samples were taken are shown in Figure 3.

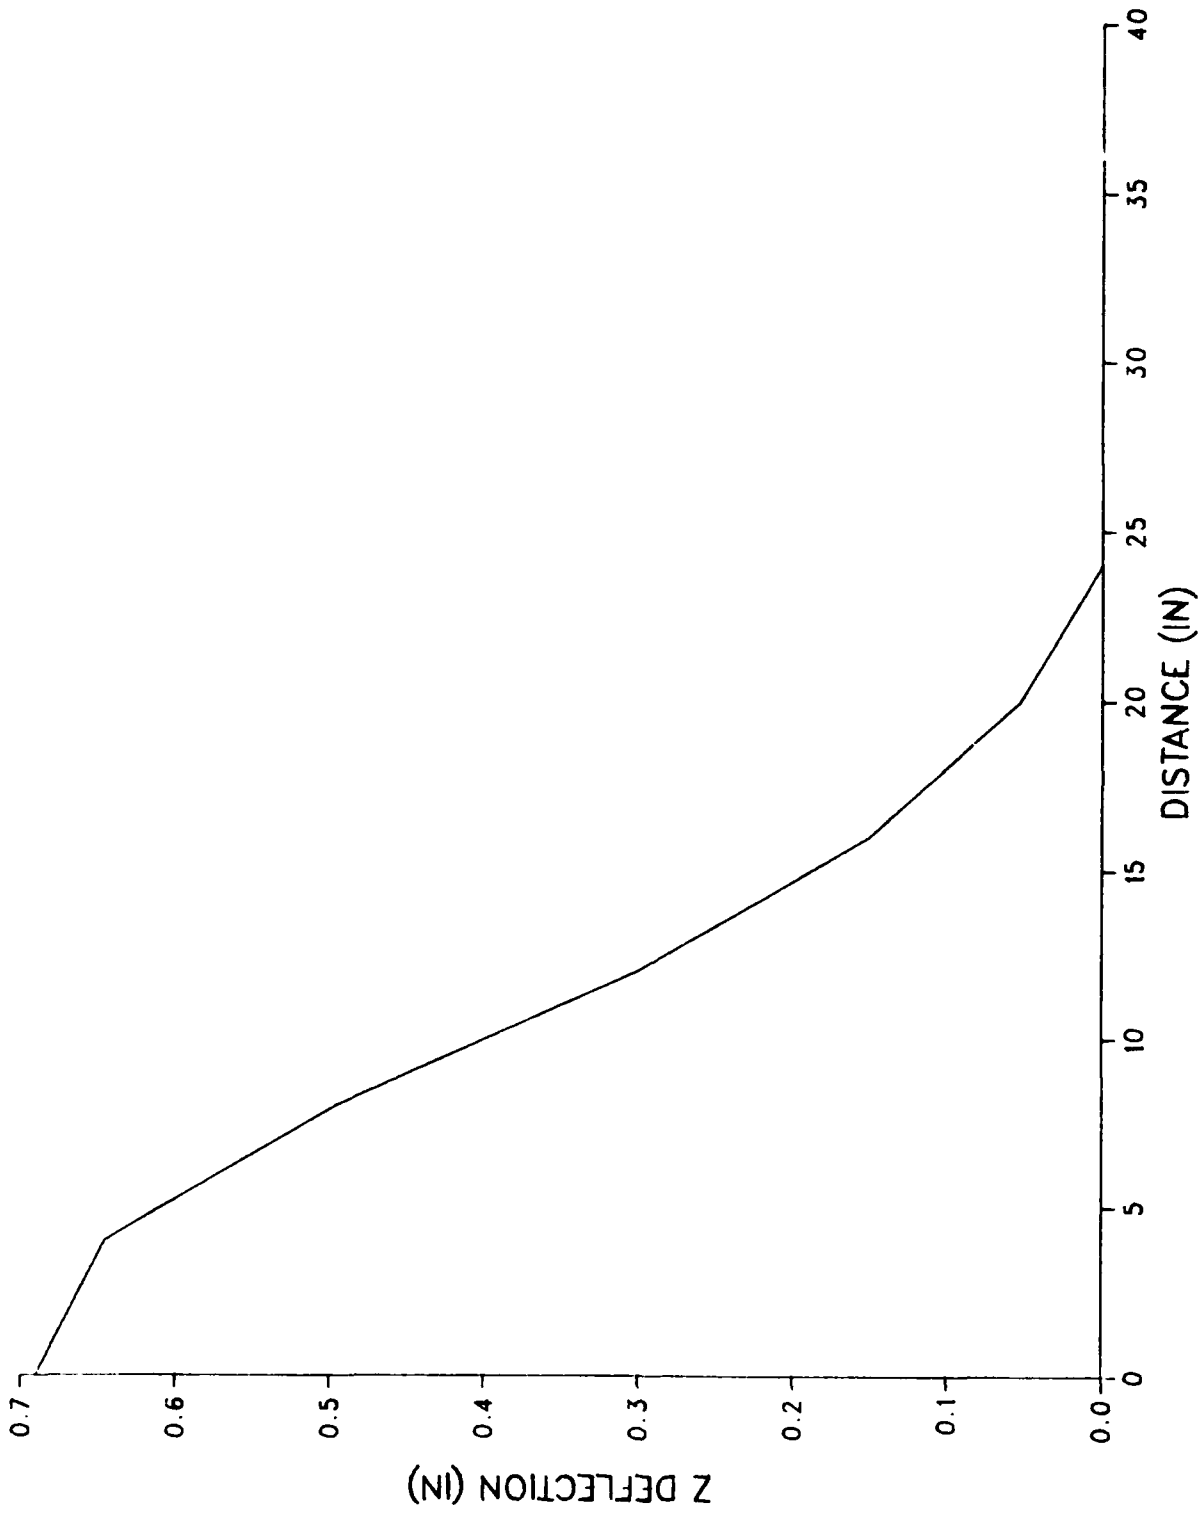
Figure 21. Average half profile of the surface of blister 1.

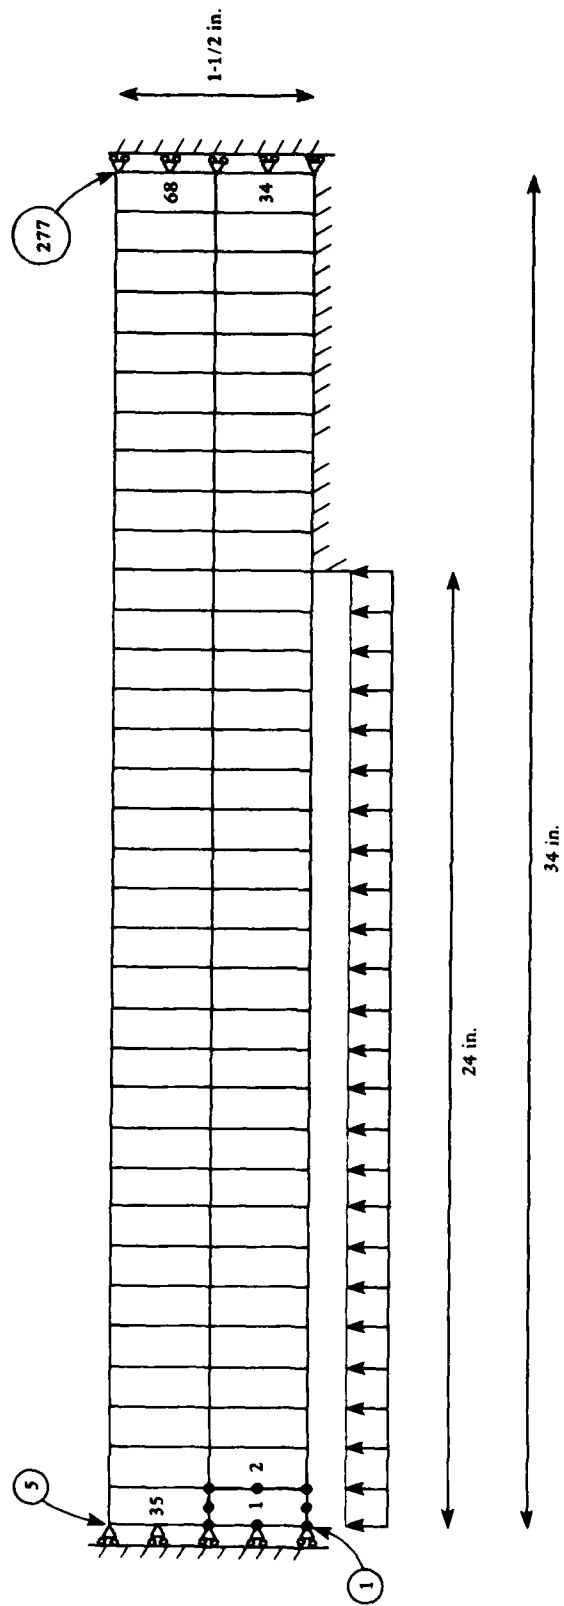
Calculations were made to determine the magnitudes of the internal pressures that are required to raise the blisters at various temperatures. These are pressures that are needed to overcome both the weight, bending stiffness, and membrane tension of the overlay at the respective temperatures. The ADINA finite element program (Ref 4) was used to determine the required internal pressures. The characteristics and behavior of blister 1 was chosen for simulation with the finite element model. Heights along the four radials were averaged (with the vertical expansion of the pavement subtracted out) to determine an approximation of the deformed shape. The profile obtained by averaging the data is shown in Figure 21. The finite element mesh shown in Figure 22 was used to model the symmetric half of a 24-inch radius blister in the 1-1/2-inch overlay.

Figure 22. Finite element mesh used to simulate the characteristics of blister 1.
